Vibration Monitoring Assessment Report (August 2022)

Tweed Valley Hospital Project, Cudgen NSW

A101021.0286.00 | VIB37.Rev0 | Date: 17/10/2022

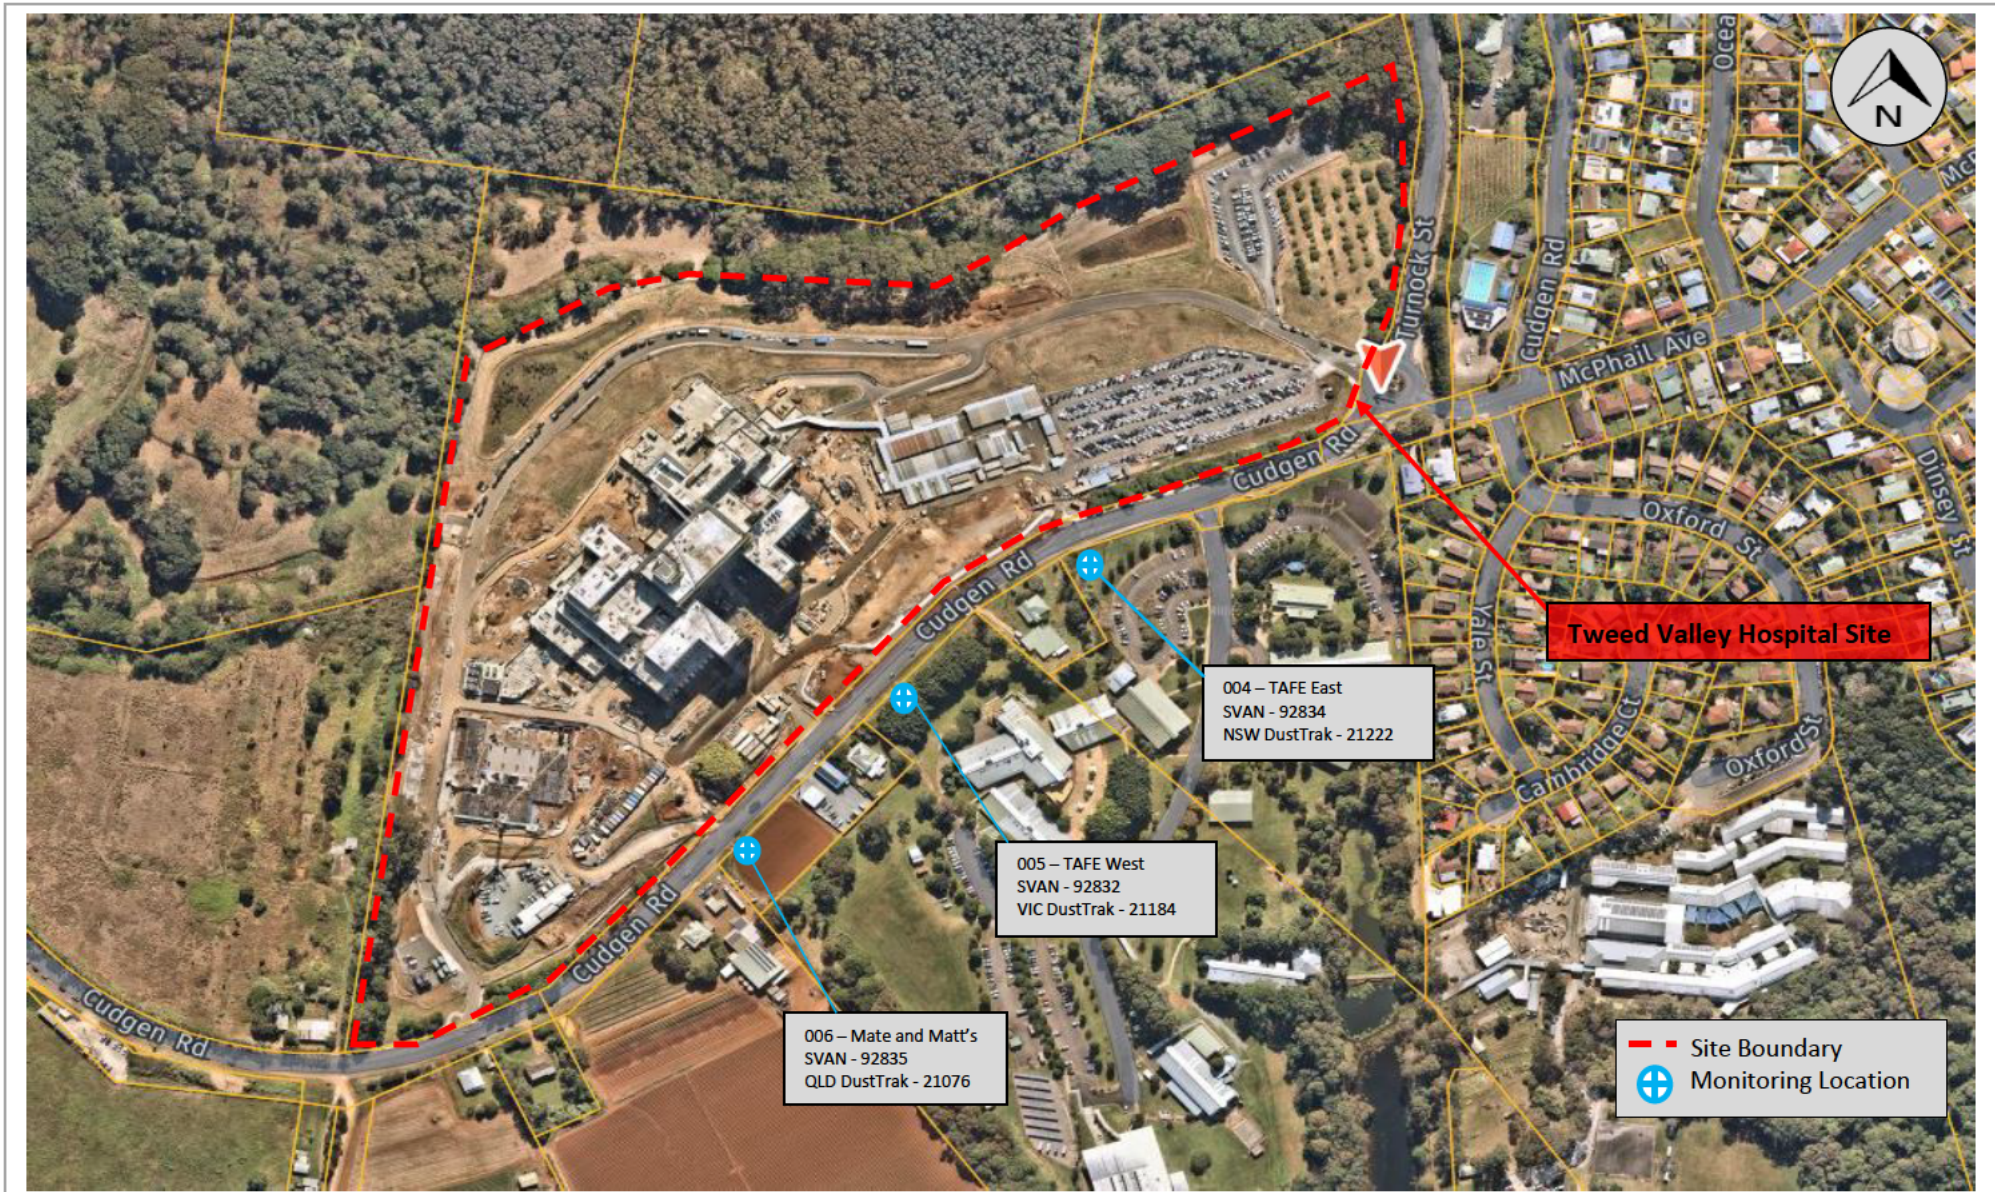
Aerial photograph of the Tweed Valley Hospital Project at Cudgen, NSW (as of 29th July 2022).

On 11 January 2022 monitor 001 was moved to location 006, monitor 002 was moved to location 005 and monitor 003 was moved to location 004 (refer to *Appendix I – Aerial Photograph*). The monitors were relocated due to scheduled road upgrade works, being undertaken by CD Civil along Cudgen Road. The monitoring locations were moved to the boundary of the nearest sensitive receivers to ensure the roadworks are compliant with the Tweed Valley Hospital Management Plan – Noise and Vibration.

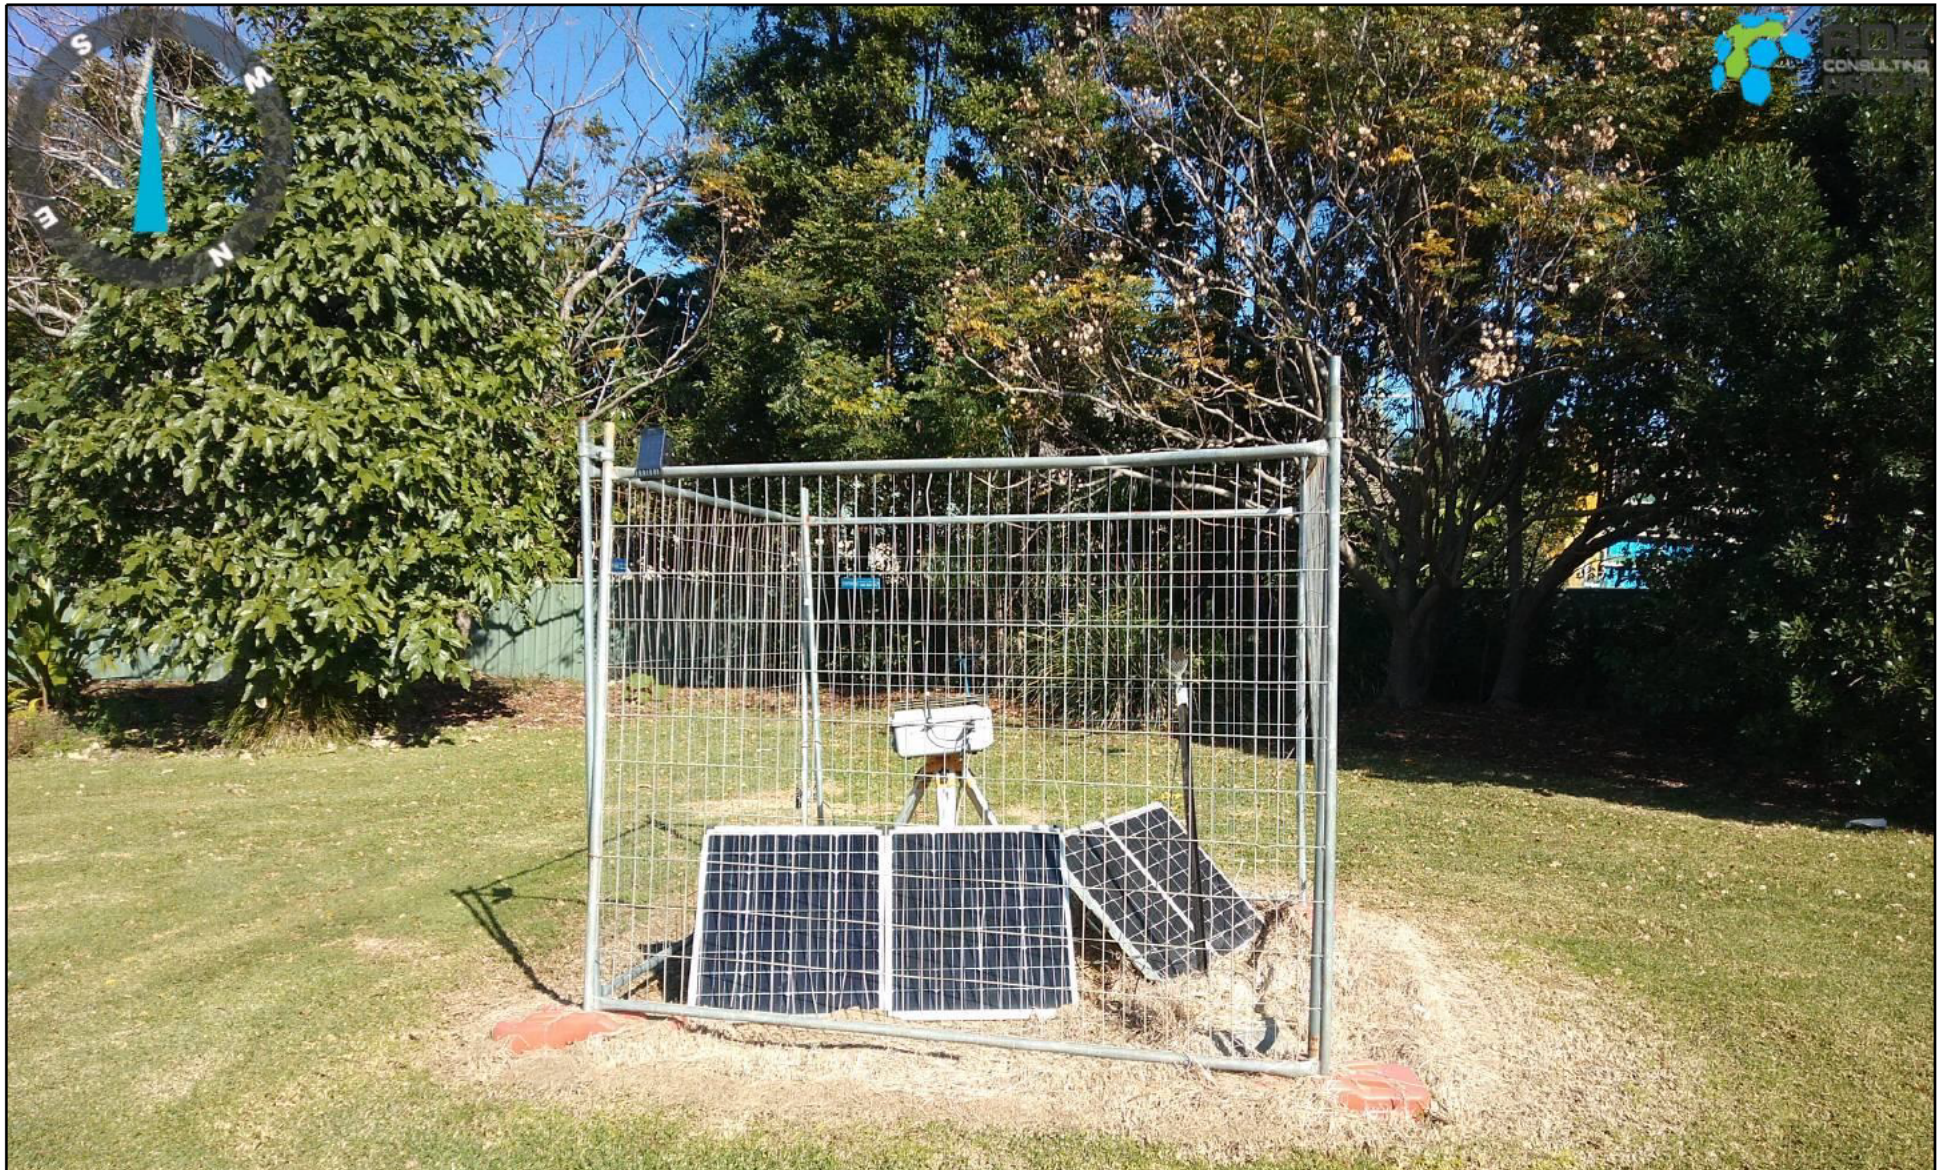
Photograph 1 Representative photograph of monitoring location 004 – TAFE East, as observed 16/08/2022

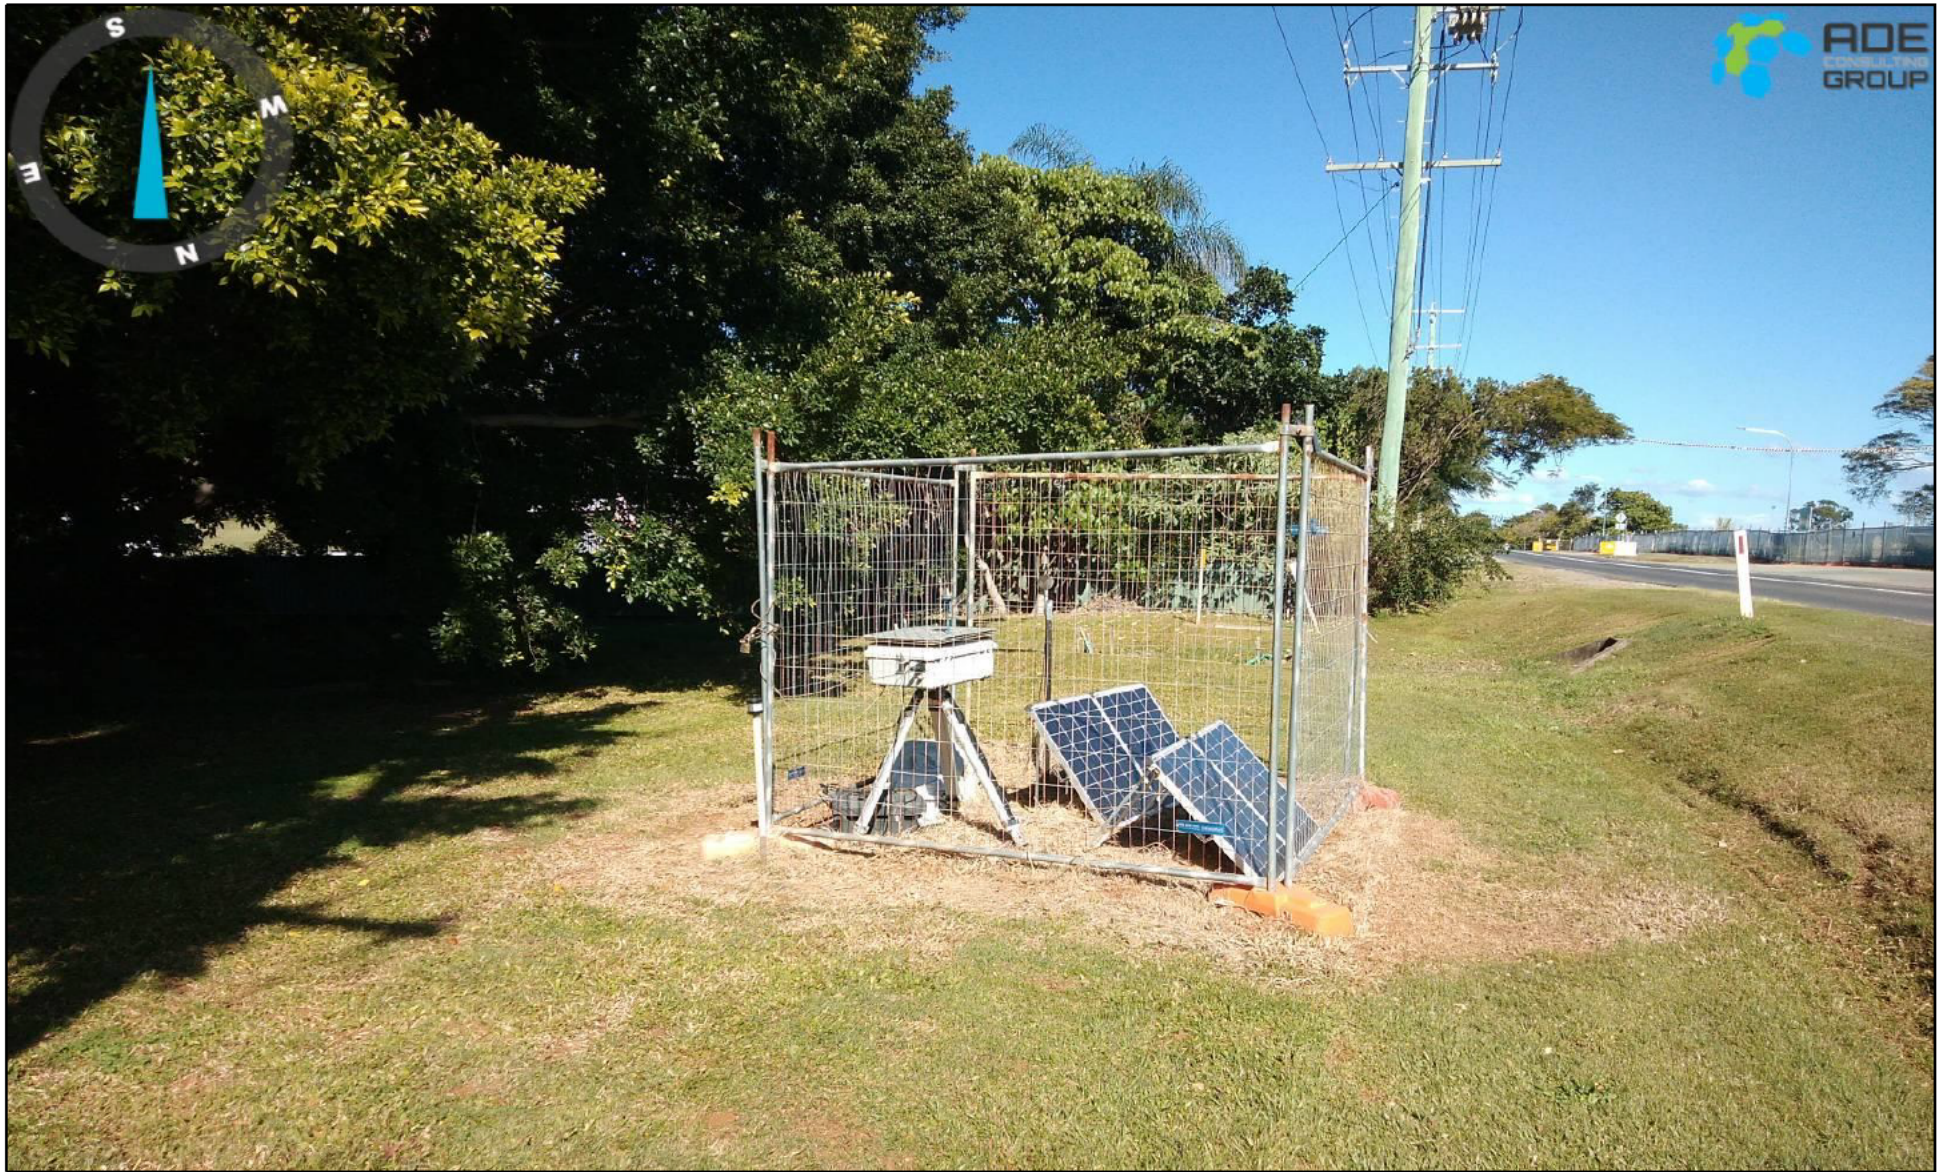
Photograph 2 Representative photograph of monitoring location 005 – TAFE West, as observed 16/08/2022

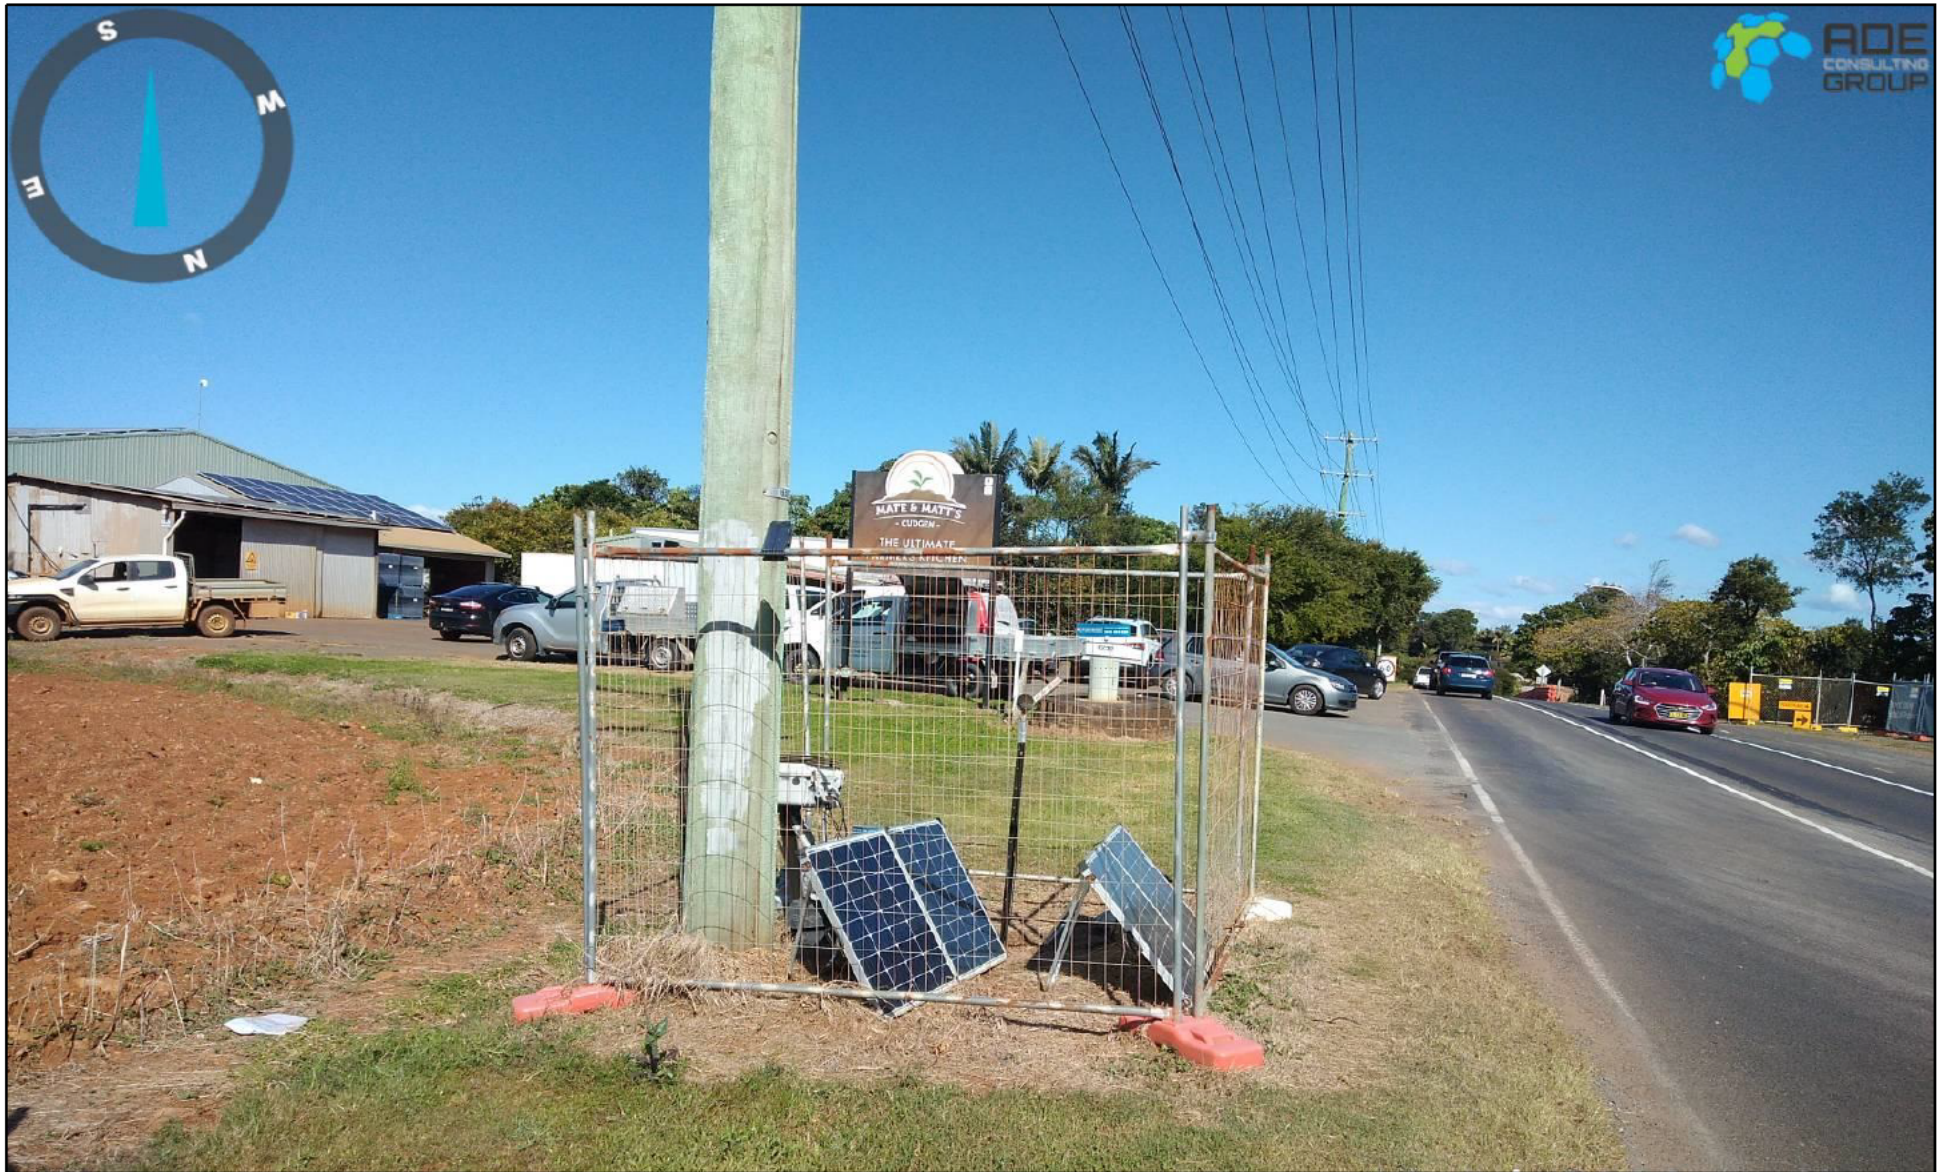
Photograph 3 Representative photograph of monitoring location 006 – Mate and Matts, as observed 16/08/2022
