Vibration Monitoring Assessment Report

771 Cudgen Road, Cudgen NSW

Prepared for: Lendlease Building Pty Ltd

Job Number: A101021.0286.00 VIB44.Rev0 | Date: 11/04/2023

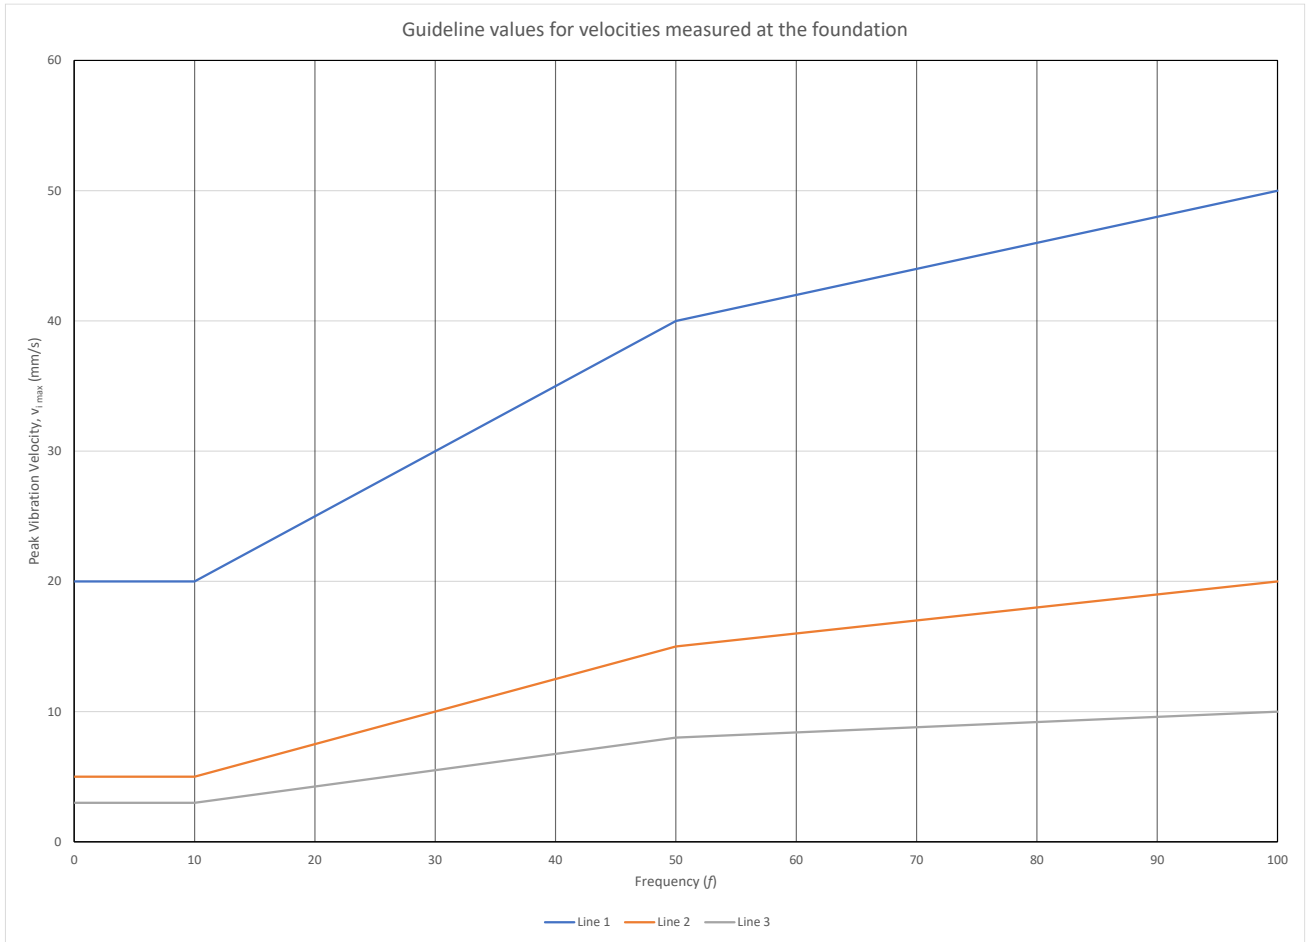
Figure 1 Illustration of the DIN4150 guideline. Structural sensitive to vibration is a function of frequency and velocity

A graphical representation of **Table 4** is shown below in **Figure 1**.

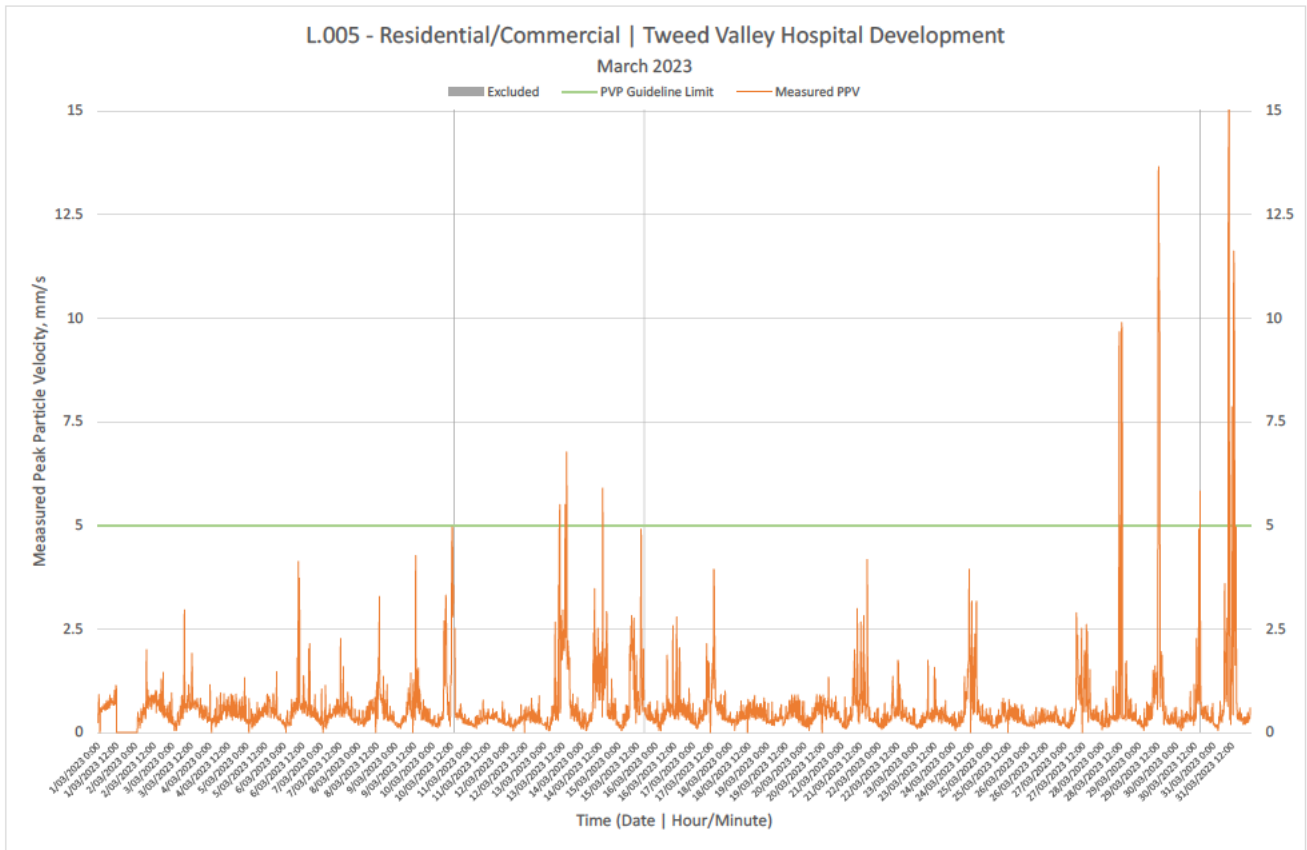
Figure 2 below presents the velocity (PPV mm/s) at Location L.005 situated by a residential and commercial receiver.

Figure 2 Velocity over time (Logger 005 - Residential/Commercial)

An increase in vibration intensive activities occurring along Cudgen Road during the road’s upgrade works has increased the energy recorded and measured at the ground sensors location. Peak events infrequently exceed the recommended velocity levels *at the sensor* and may be likely to exceed at the receiver in some minor instances, however low to no impact is likely based on data analysis.

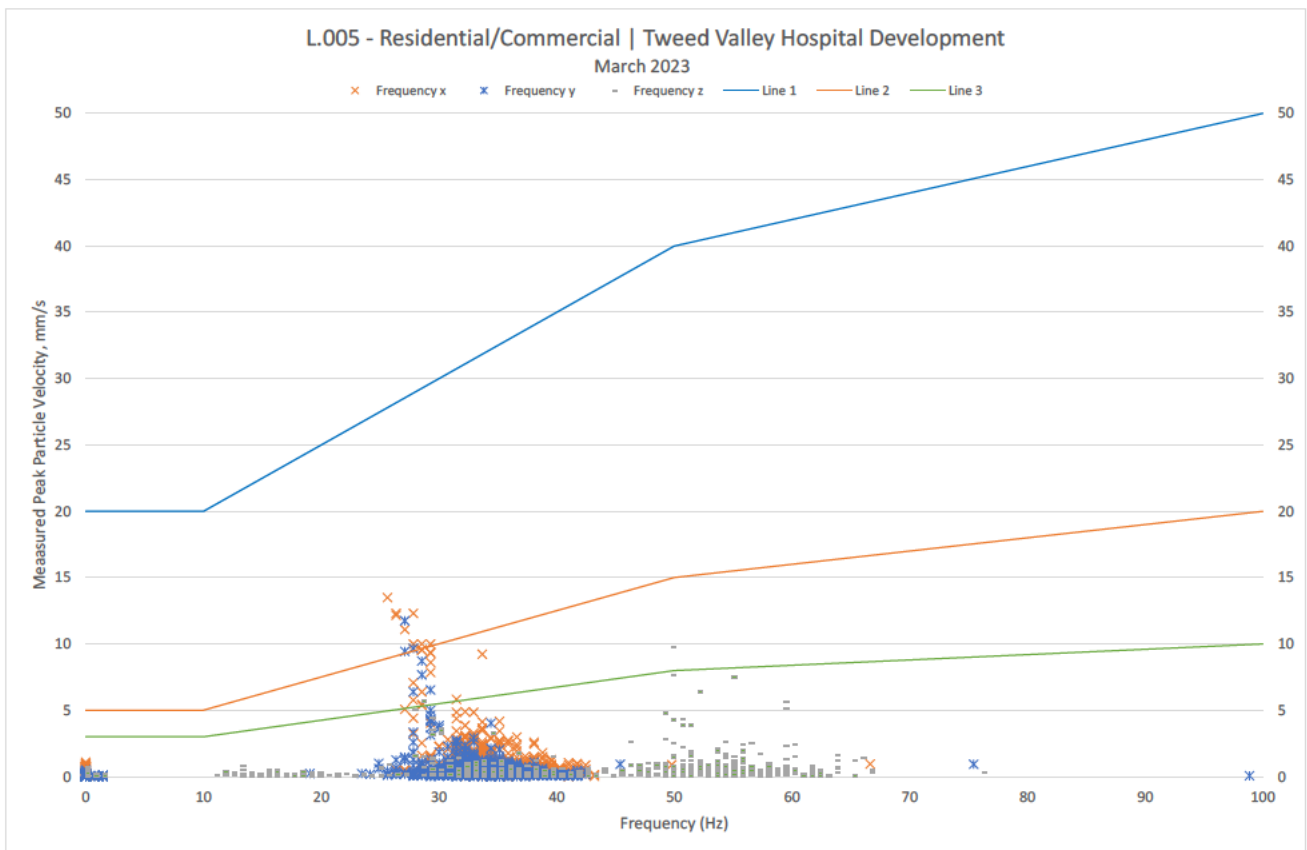
Figure 3 Frequency over Velocity (Logger 005 – Residential/Commercial)

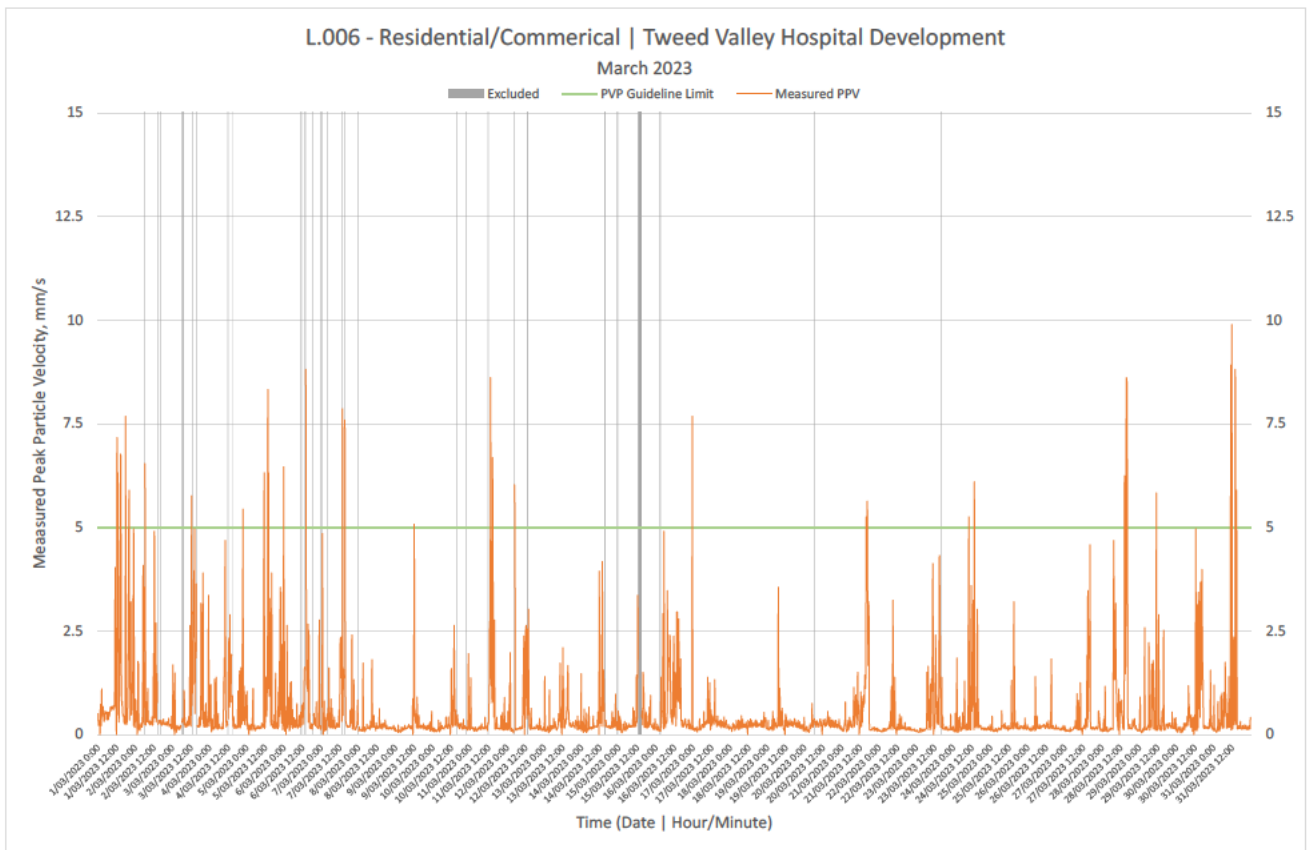
Figure 4 below presents velocity measurement data measured at the Mate and Matts commercial/residential premises, nominated as Location L.006.

Figure 4 Velocity over time (Logger 006 – Residential/Commercial)

Works near the sensor and farm/commercial related events are judged to be the likely origin of the increase in vibration energy at this location. Grading works were in close proximity to the device throughout March, as noted in the photograph provided in Figure 5.

The increase in construction activities utilizing heavy plant equipment is the origin of the measured energy, however ADE acknowledges that Logger L.006 is positioned near a farm field with irrigation which may influence both noise and vibration readings. In addition, trenching and grading activities proceeded throughout March at this location in close proximity to the devices.

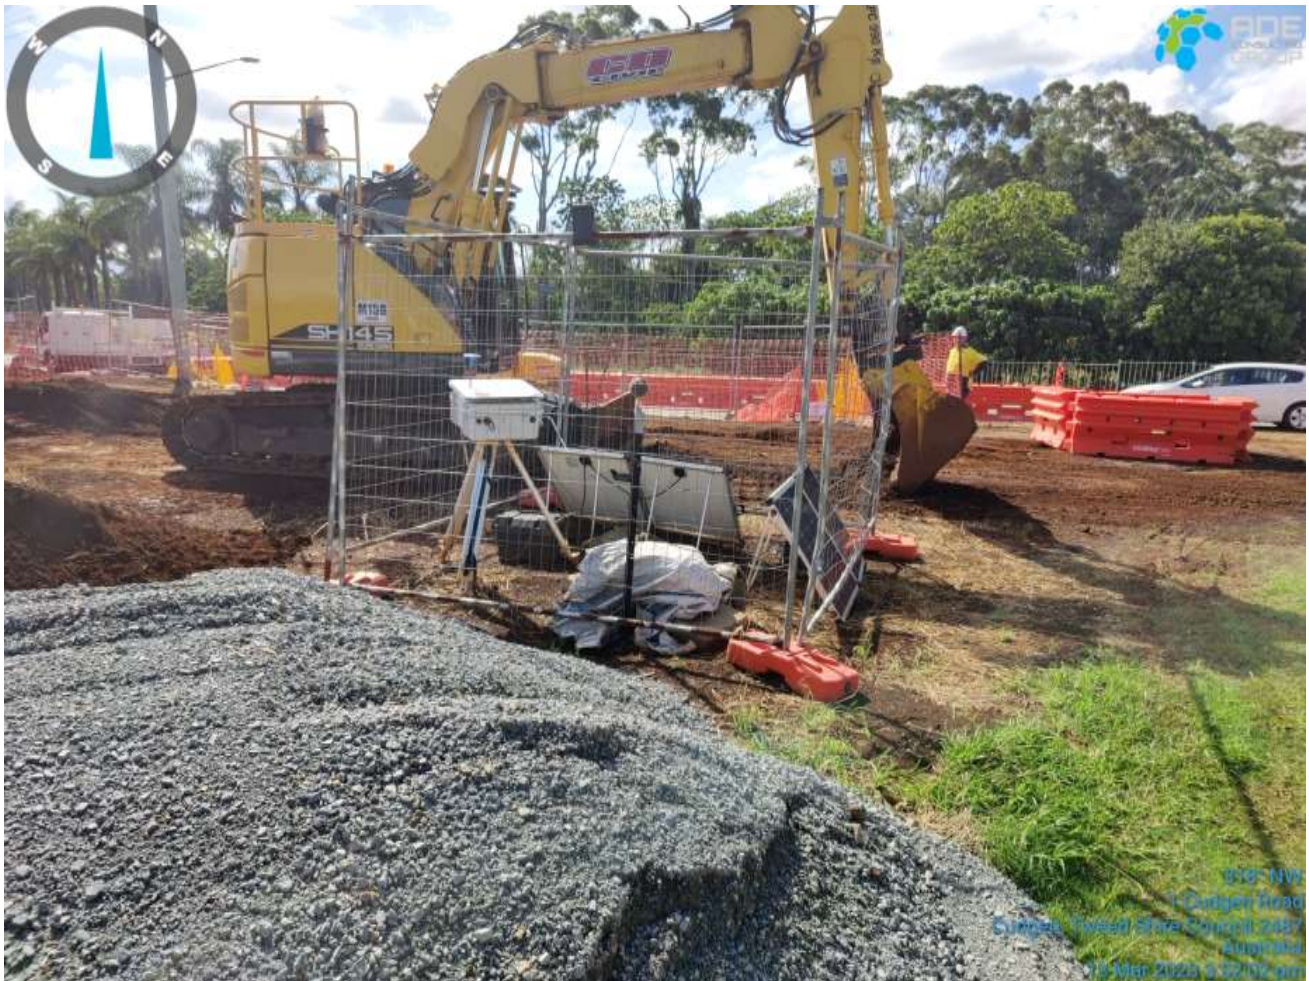
Figure 5 Image: L.006 in close proximity to works, 13 March 2023 15:52 hrs

Trenching works utilizing an 8T tracked excavator with a bucket attachment and 5T roller was in use in distances of approximately 2 - 10 m from the vibration sensor.

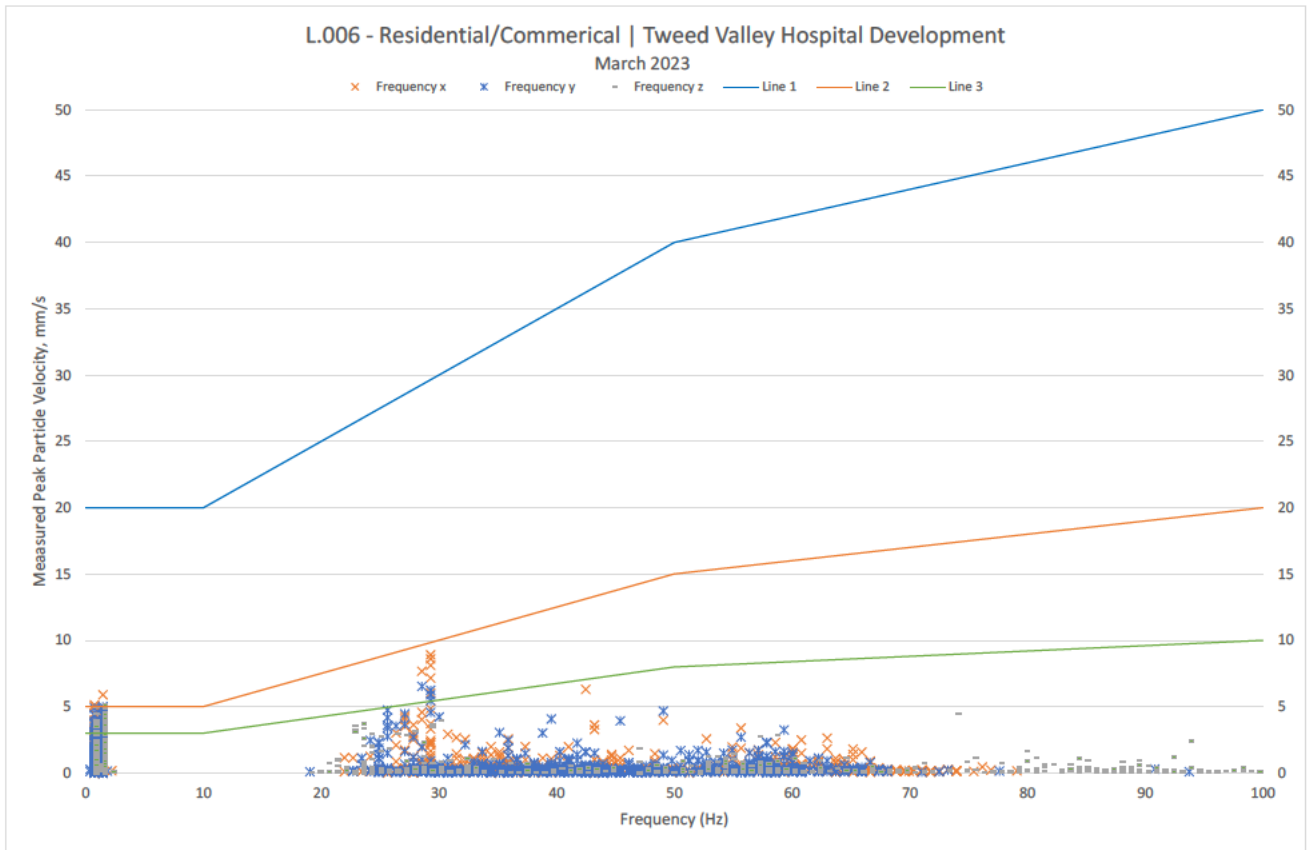
Figure 6 below illustrates the frequency for each axis over the velocity of each axis for Logger L.006. The data shows that high frequency over low velocity is indicative of extraneous data captured at the site, and likely not of site origin.

In regards to cosmetic damage or structural concerns, no impact to any of the structures near to this location is anticipated as frequency thresholds are lower than the limitations outlined in both the British and German Standards.

Figure 6 Frequency over Velocity (Logger 006 – Residential/Commercial)

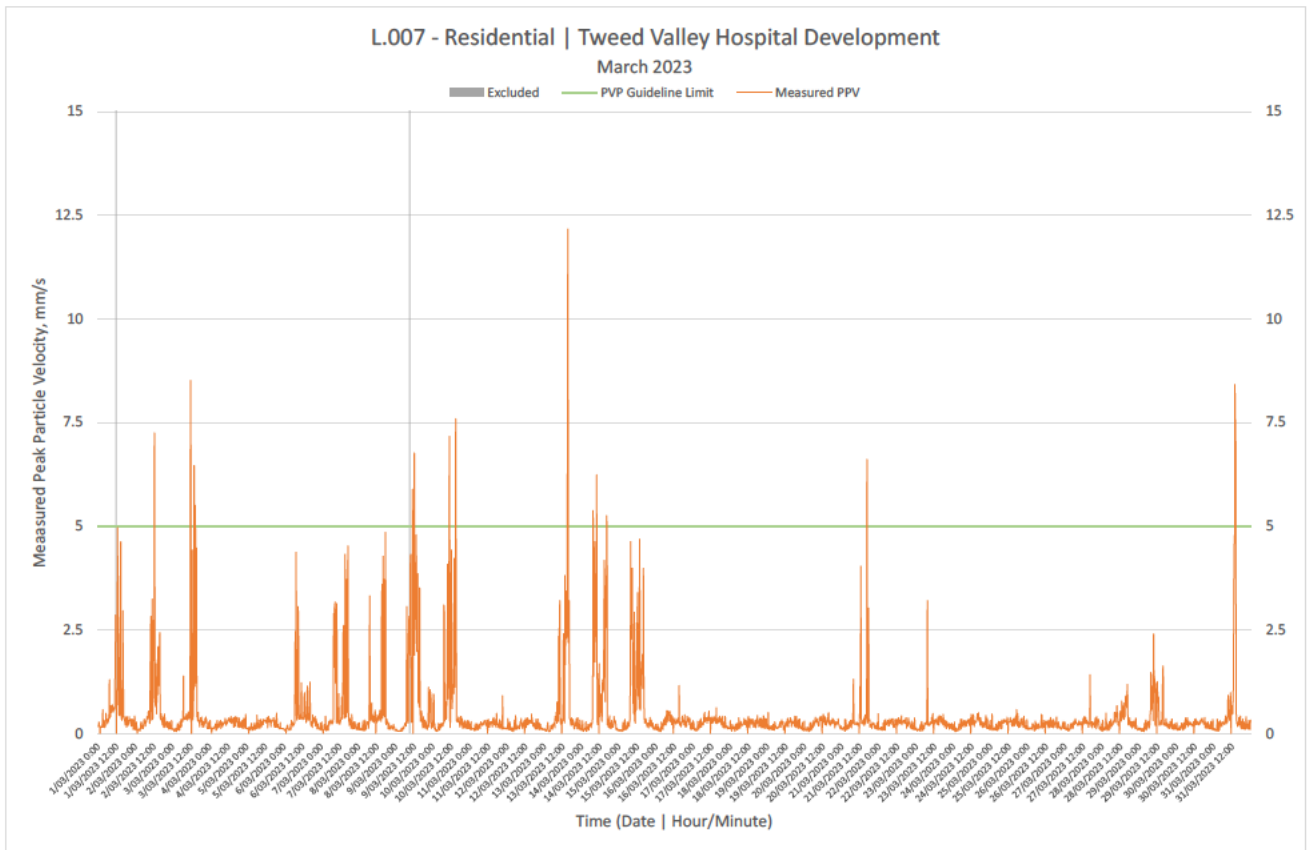
Figure 7 below presented velocity data for the logger located in close proximity to a residential premises.

Figure 7 Velocity over time (Logger 007 – Residential)

The increase in vibration energy outlined in both **Figure 7** and **Figure 8** is indicative of increased activity with the roadway including trenching works.

Most of the velocity levels exceeding 5 mm/s (the recommended velocity guideline for residential premises) is below the DIN4150 Line 2 guidelines. The guidelines and limitations outlined in **Section 2** are infrequently exceeded at the loggers location and no structural concern or impact is anticipated throughout the March period.

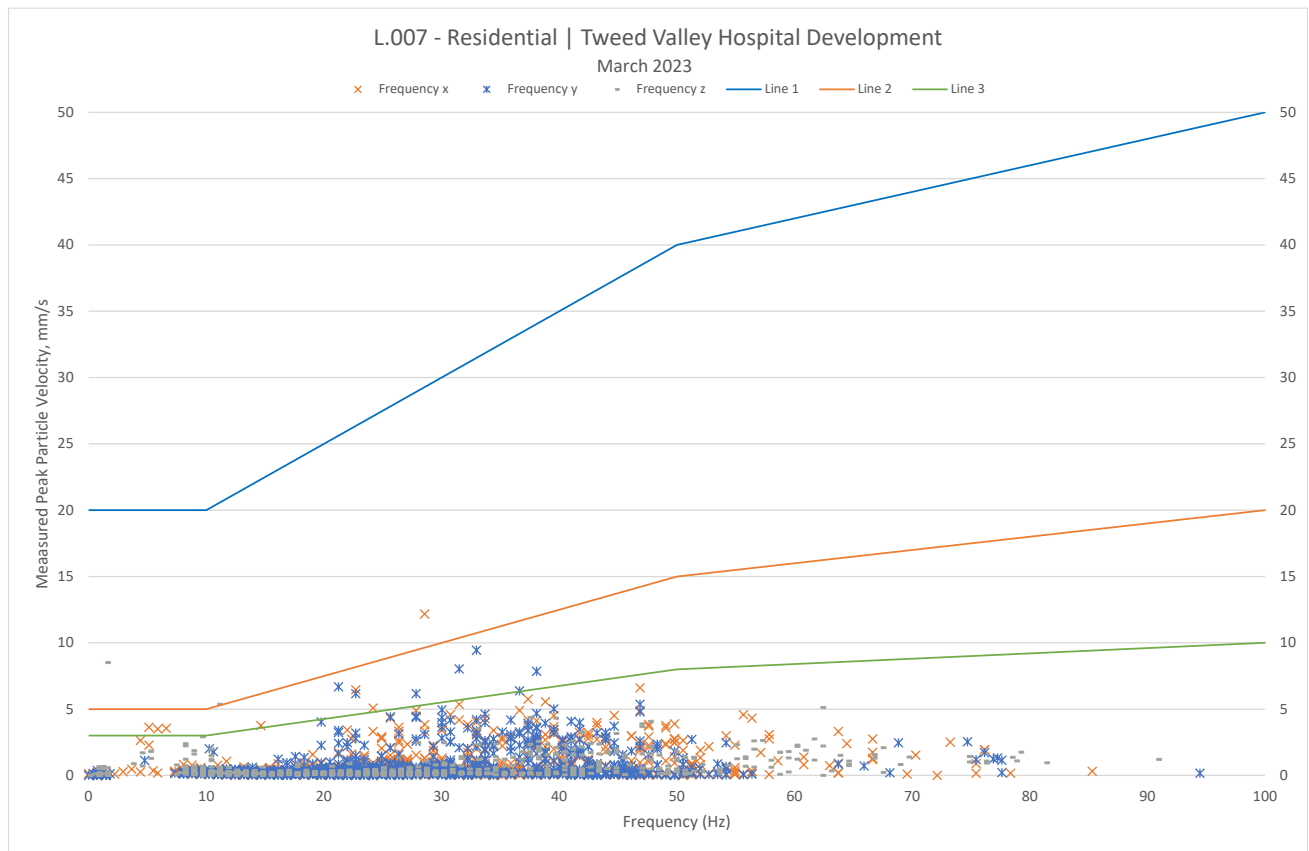
Figure 8 illustrates the Frequency over Velocity for the data collected and analysed at Location L.007.

Figure 8 Frequency over Velocity (Logger 007 – Residential)

Where a structure may be considered dilapidated, low to mid frequencies may cause some minor cosmetic damage, however this is not anticipated based on analysis of the data.

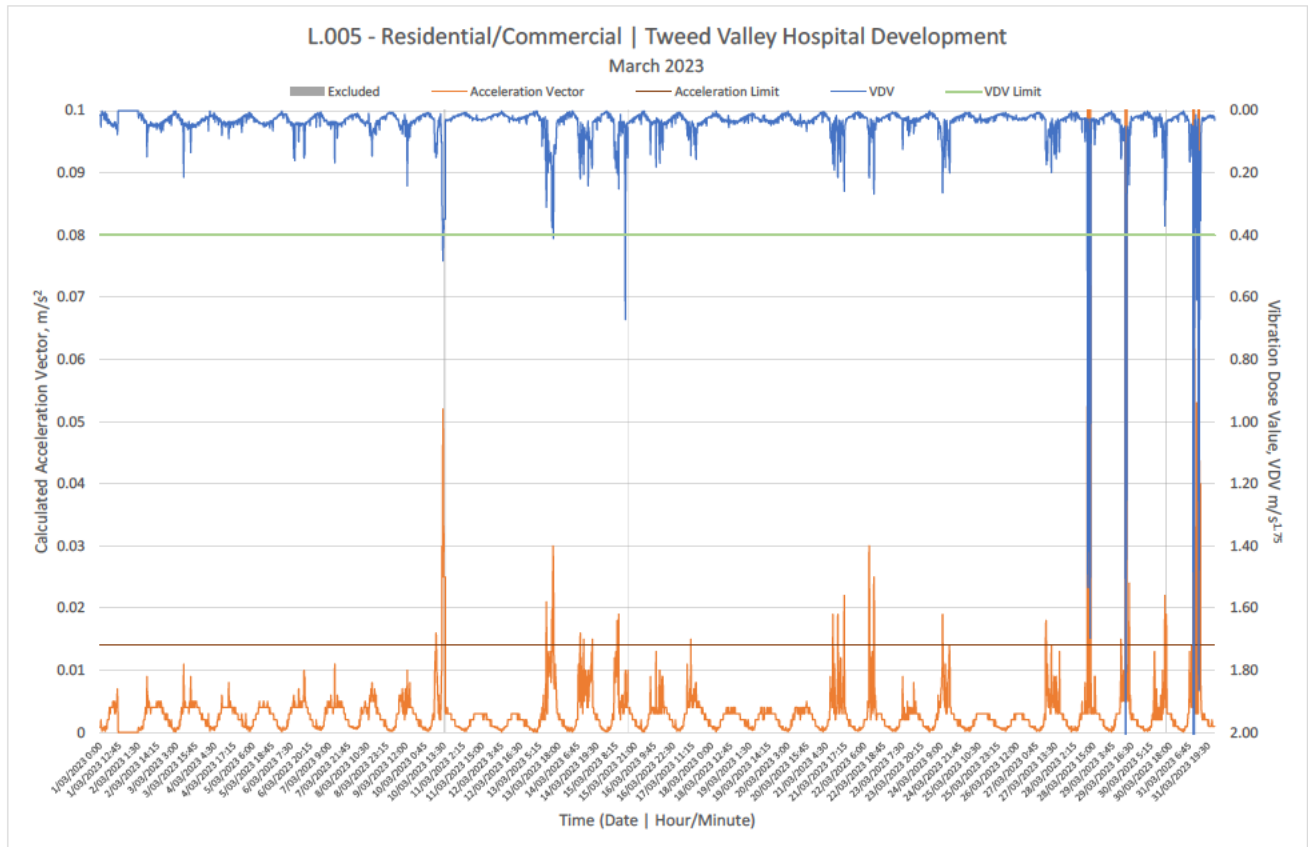
Figure 9 below presents VDV and weighted RMS Acceleration (α_{rms}) data measured at L.005.

Figure 9 Acceleration and Vibration Dose Value over time (Logger 005)

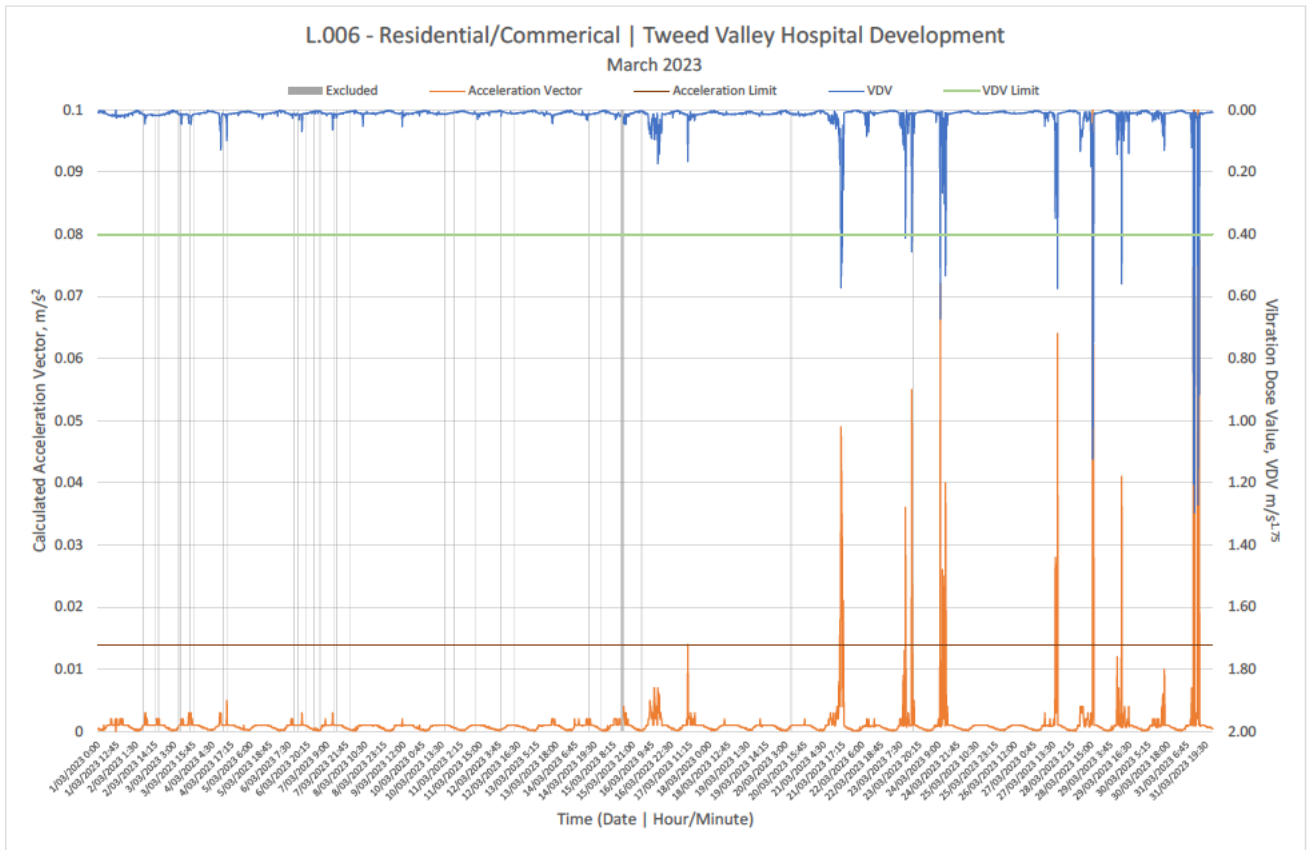
The vibration impact at the commercial and residential premises is presented below in Figure 10. Generally, the measured data which is considered extraneous in nature (including ADE influence) has been removed from the data analysis and the graph.

The occupants at this location are less likely to have experienced any increase of perceptible vibration during the days where heavy plant equipment was in use, and the likelihood of adverse comment is not considered probable during these activities at this location during March.

Figure 10 Acceleration and Vibration Dose Value over time (Logger 006 – Residential/Commercial)

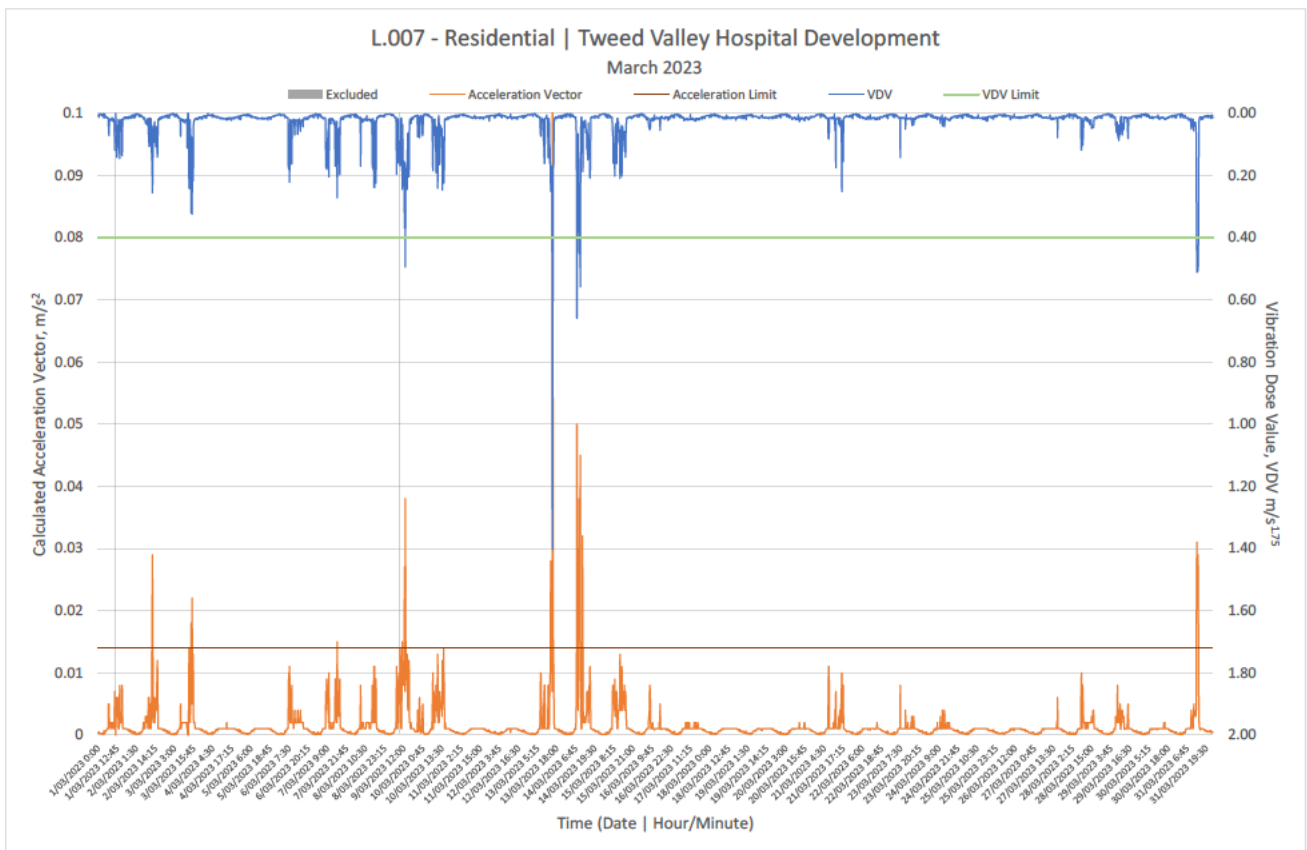
Figure 11 which follows presents the increase in perceptible vibration at the southwestern residential receiver nominated as Location L.007.

Figure 11 Acceleration and Vibration Dose Value over time (Logger 007 – Residential)

The occupants at this location (L.007) are likely to have experienced an increase of perceptible vibration during the days when heavy plant equipment was in use and the likelihood of adverse comment is probable.

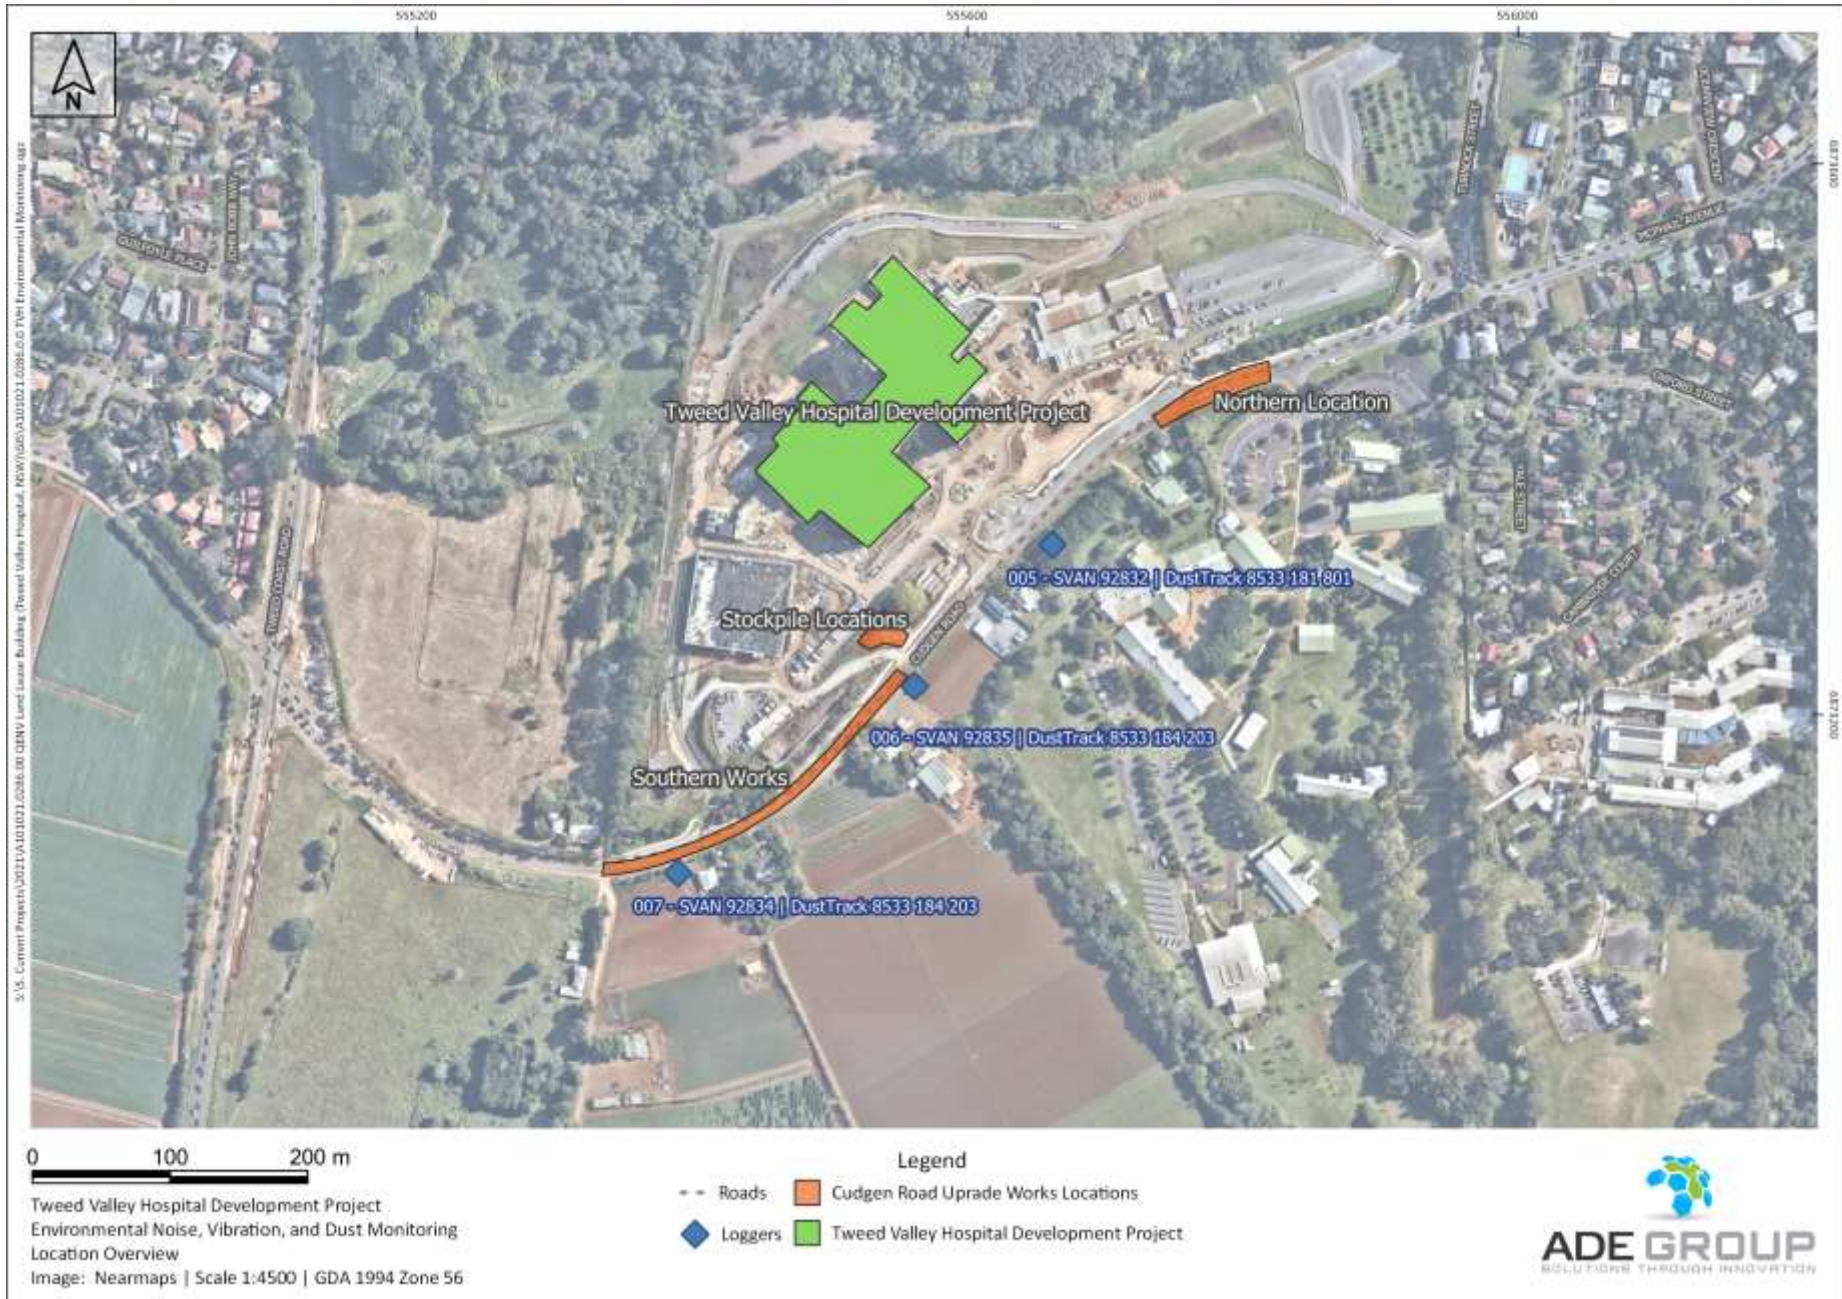
Appendix II – Aerial Photograph

ADE Monitoring locations, site location (including CD Civil's Cudgen Road Upgrade works) are presented below.

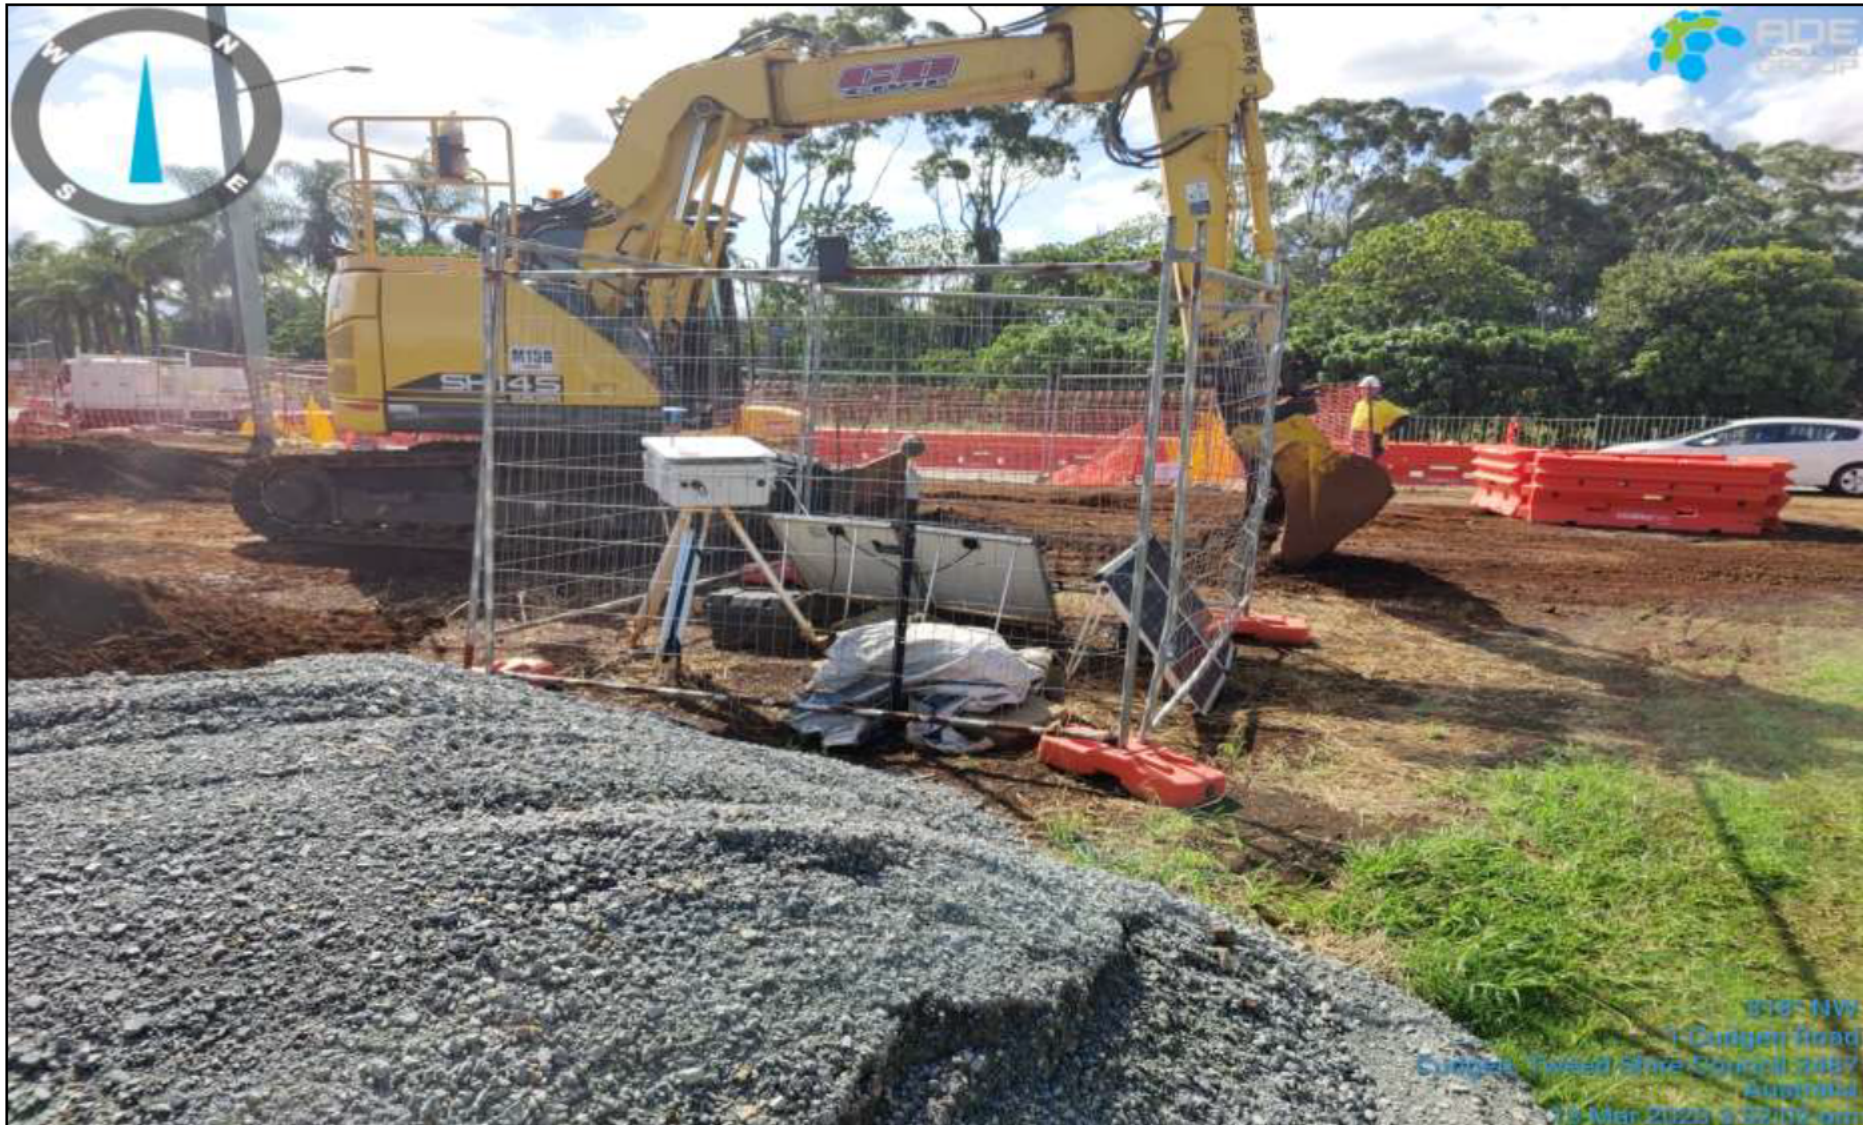
Photograph 1 Representative photograph of monitoring location 007 – Residential, as observed 13/03/2023

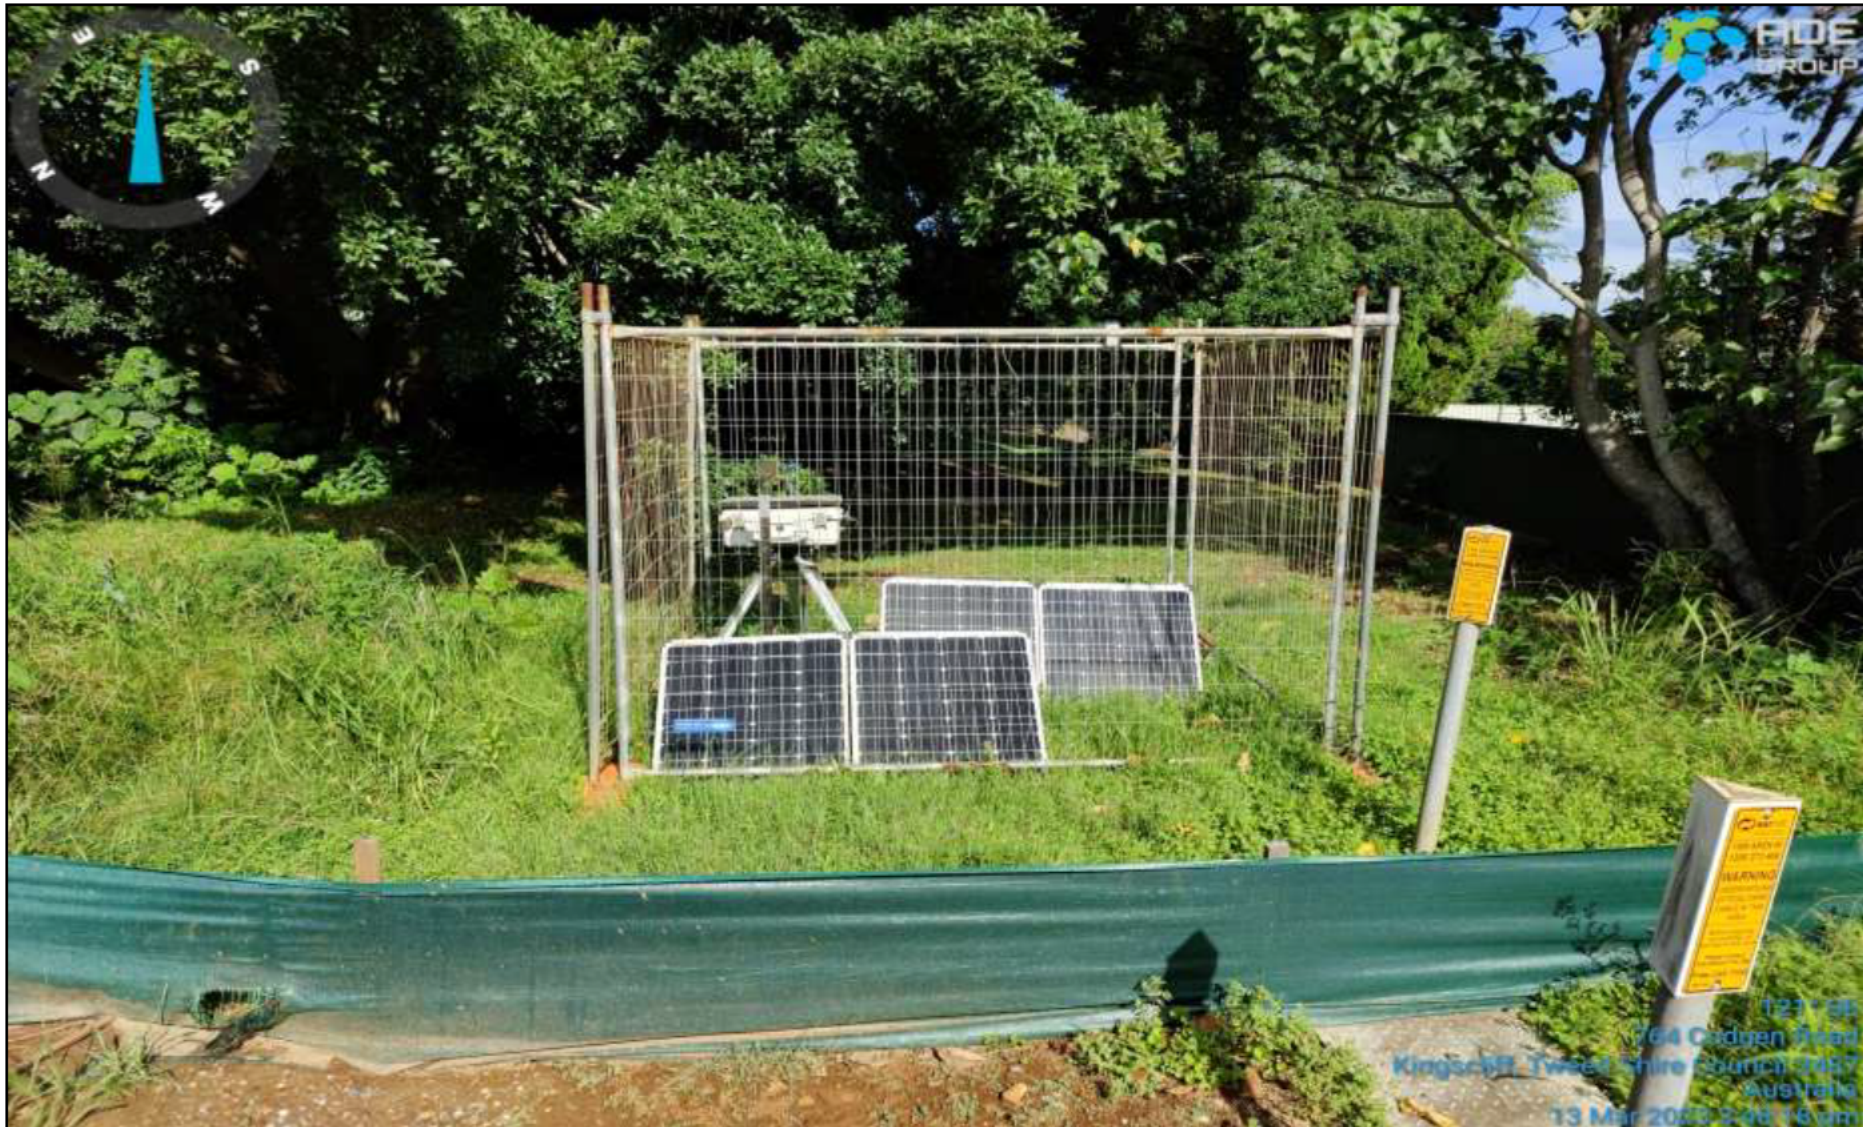
Photograph 2 Representative photograph of monitoring location 005 – Solar Industry, as observed 13/03/2023

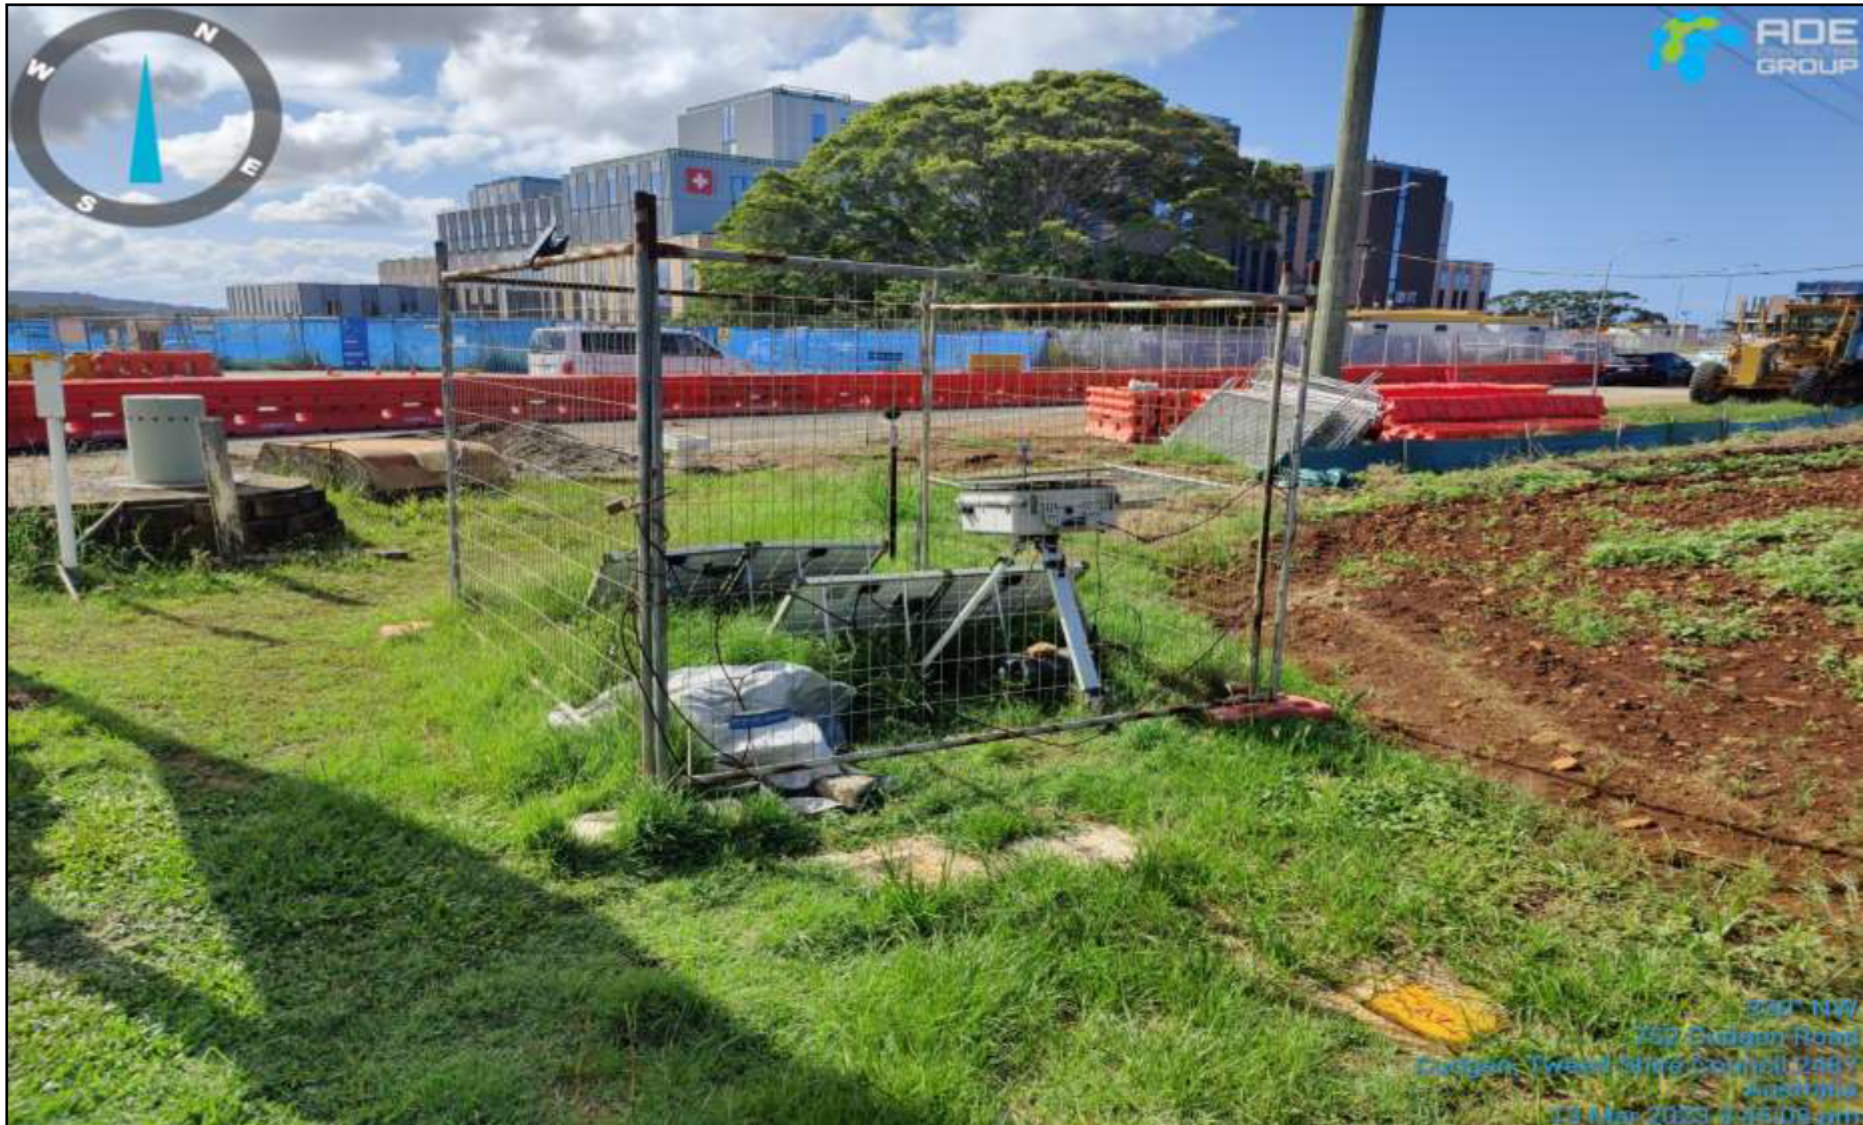
Photograph 3 Representative photograph of monitoring location 006 – Mate and Matts, as observed 13/03/2023
