Vibration Monitoring Assessment Report (January 2022)

Tweed Valley Hospital Project, Cudgen NSW

A101021.0286.00 | VIB30.Rev0 | Date: 8/02/2022

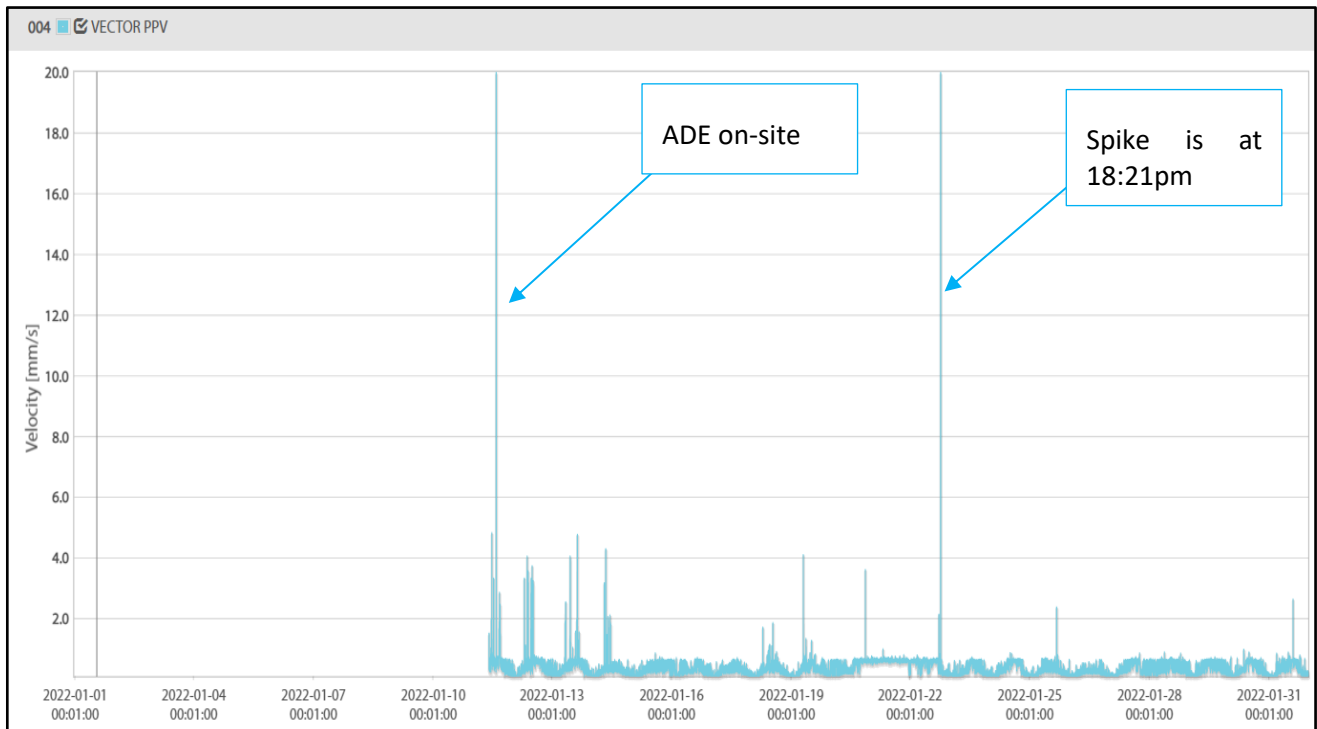
Data measured at location 004 is presented below in **Figure 1**.

Figure 1. Vibration data at location 004 | Mate and Matt’s | January 2022.

During the monitoring period (January 2022) no exceedance of DIN 4150 Line 1 or Line 2 PPV guideline values was observed. The results presented in Figure 1 – 3 do not include a distance correction.

Results from vibration monitoring undertaken during the monitoring period [January 2022] were **below** the threshold used to assess the effects of short-term vibration on structures according to DIN 4150-3 and DIN4150-1. Therefore, the Site works had no impact on any surrounding priorities.

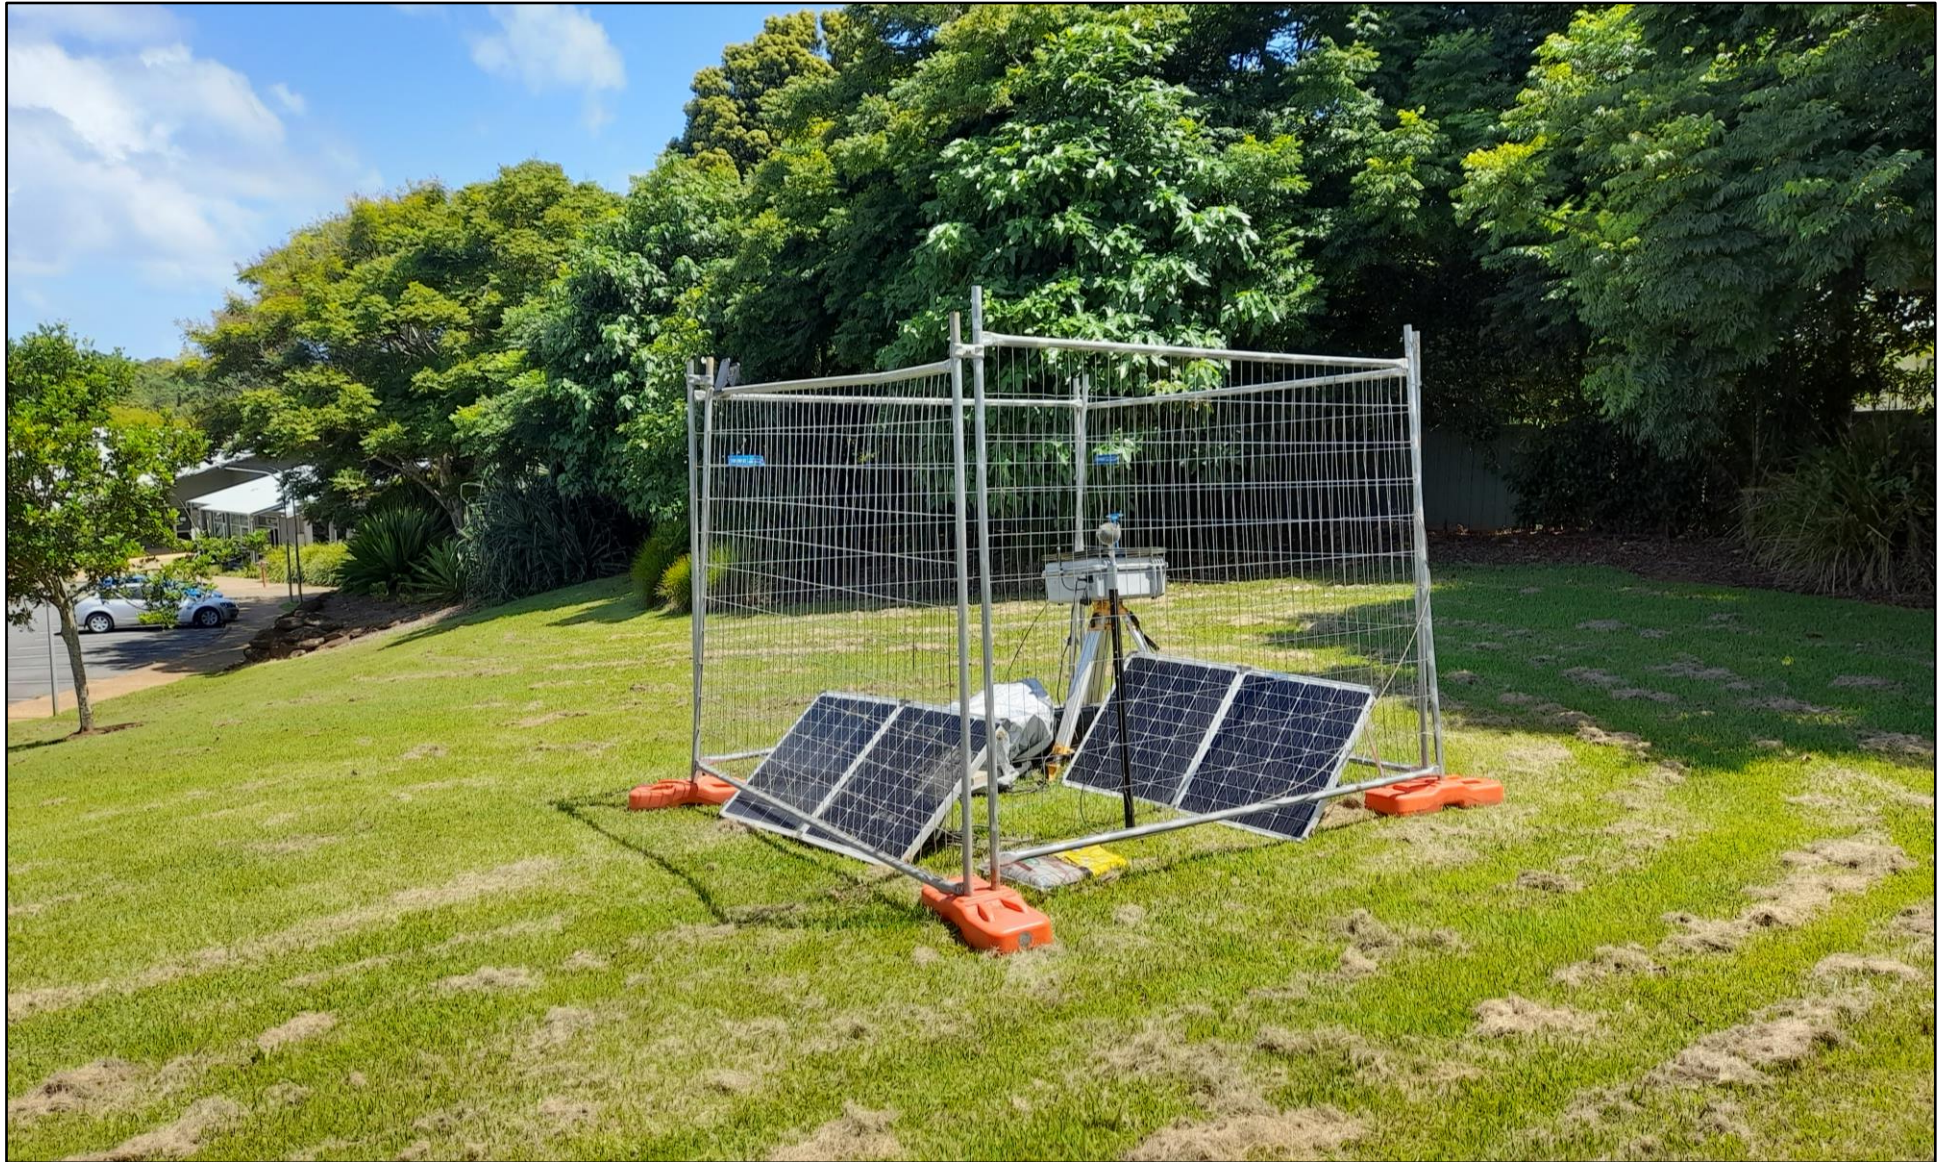
Photograph 1 Representative photograph of monitoring location 004 – TAFE East, as observed 11/01/2022

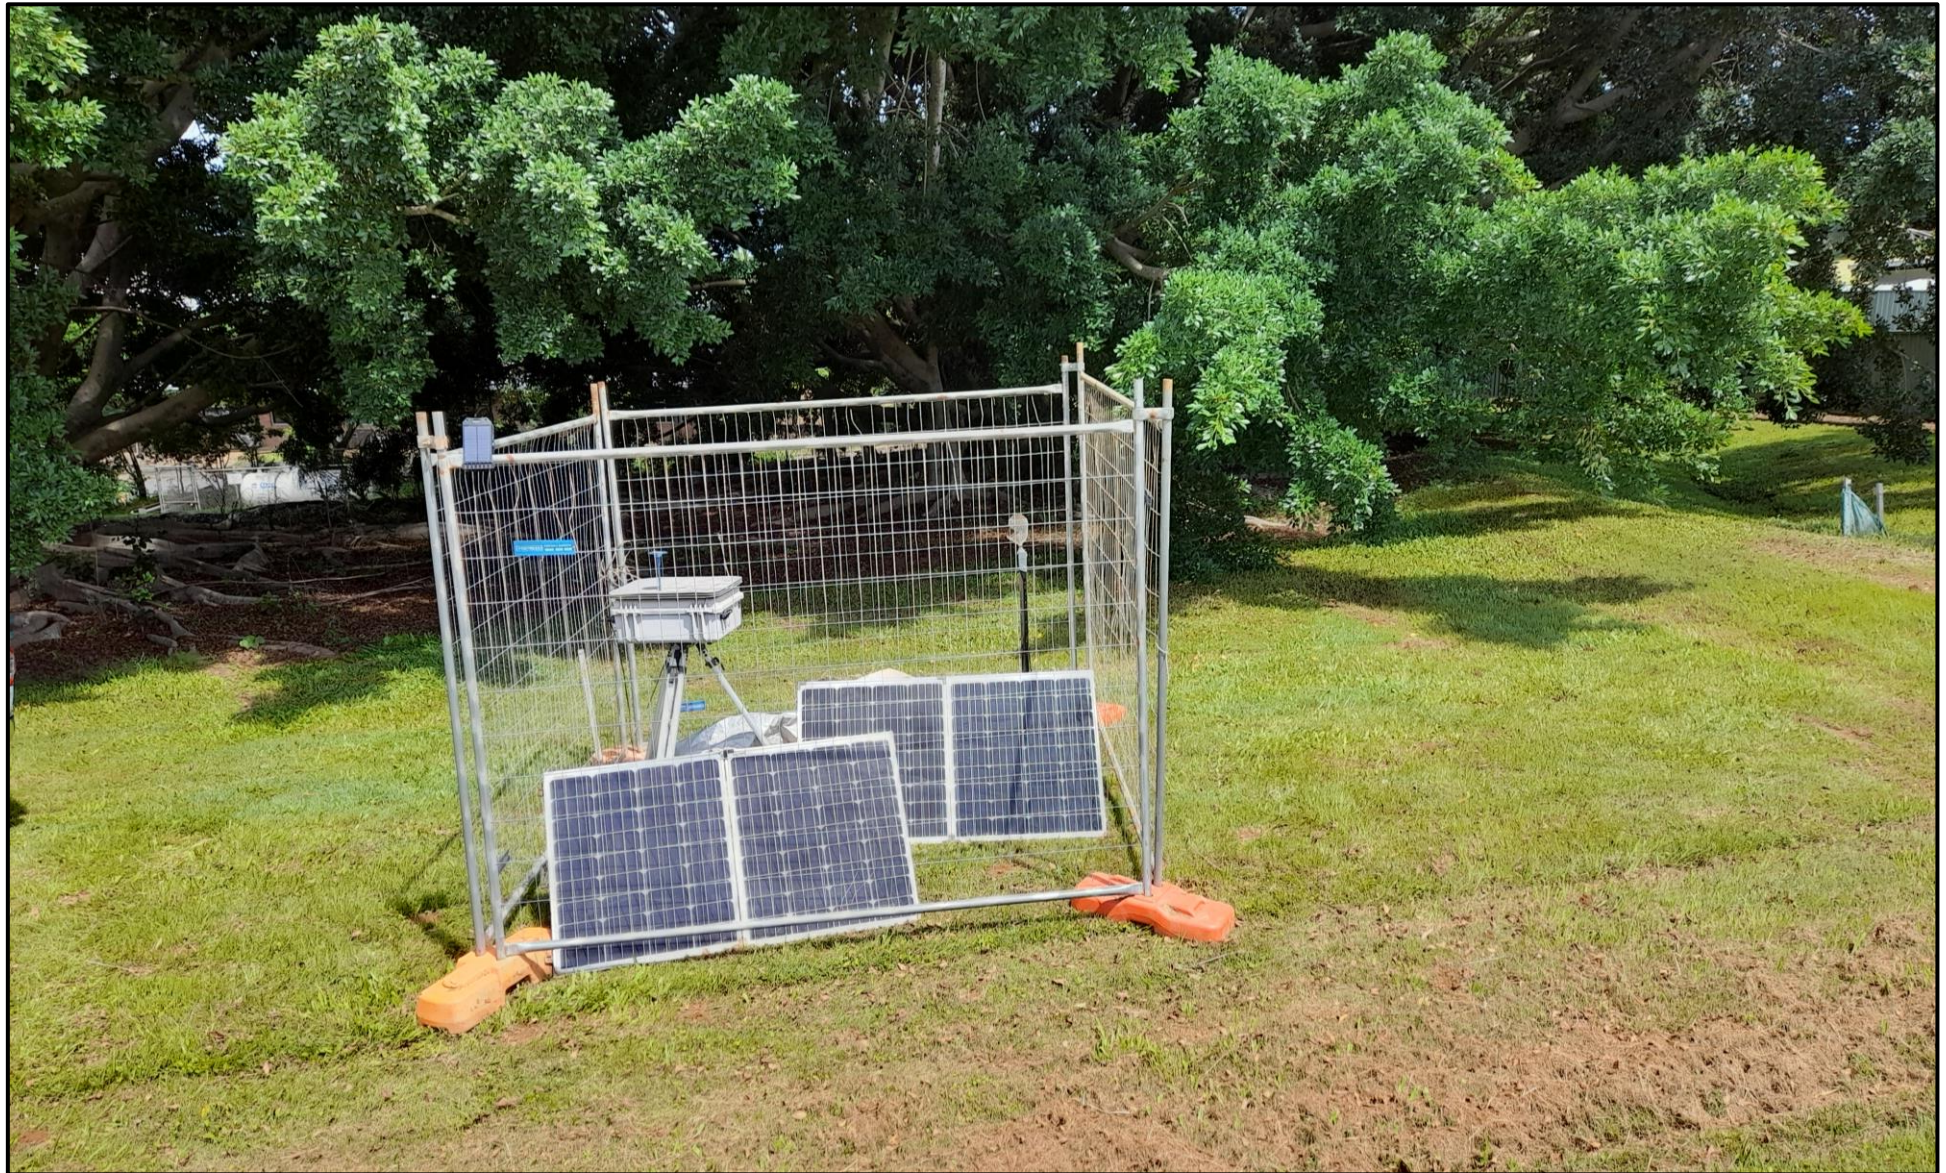
Photograph 2 Representative photograph of monitoring location 005 – TAFE West, as observed 11/01/2022

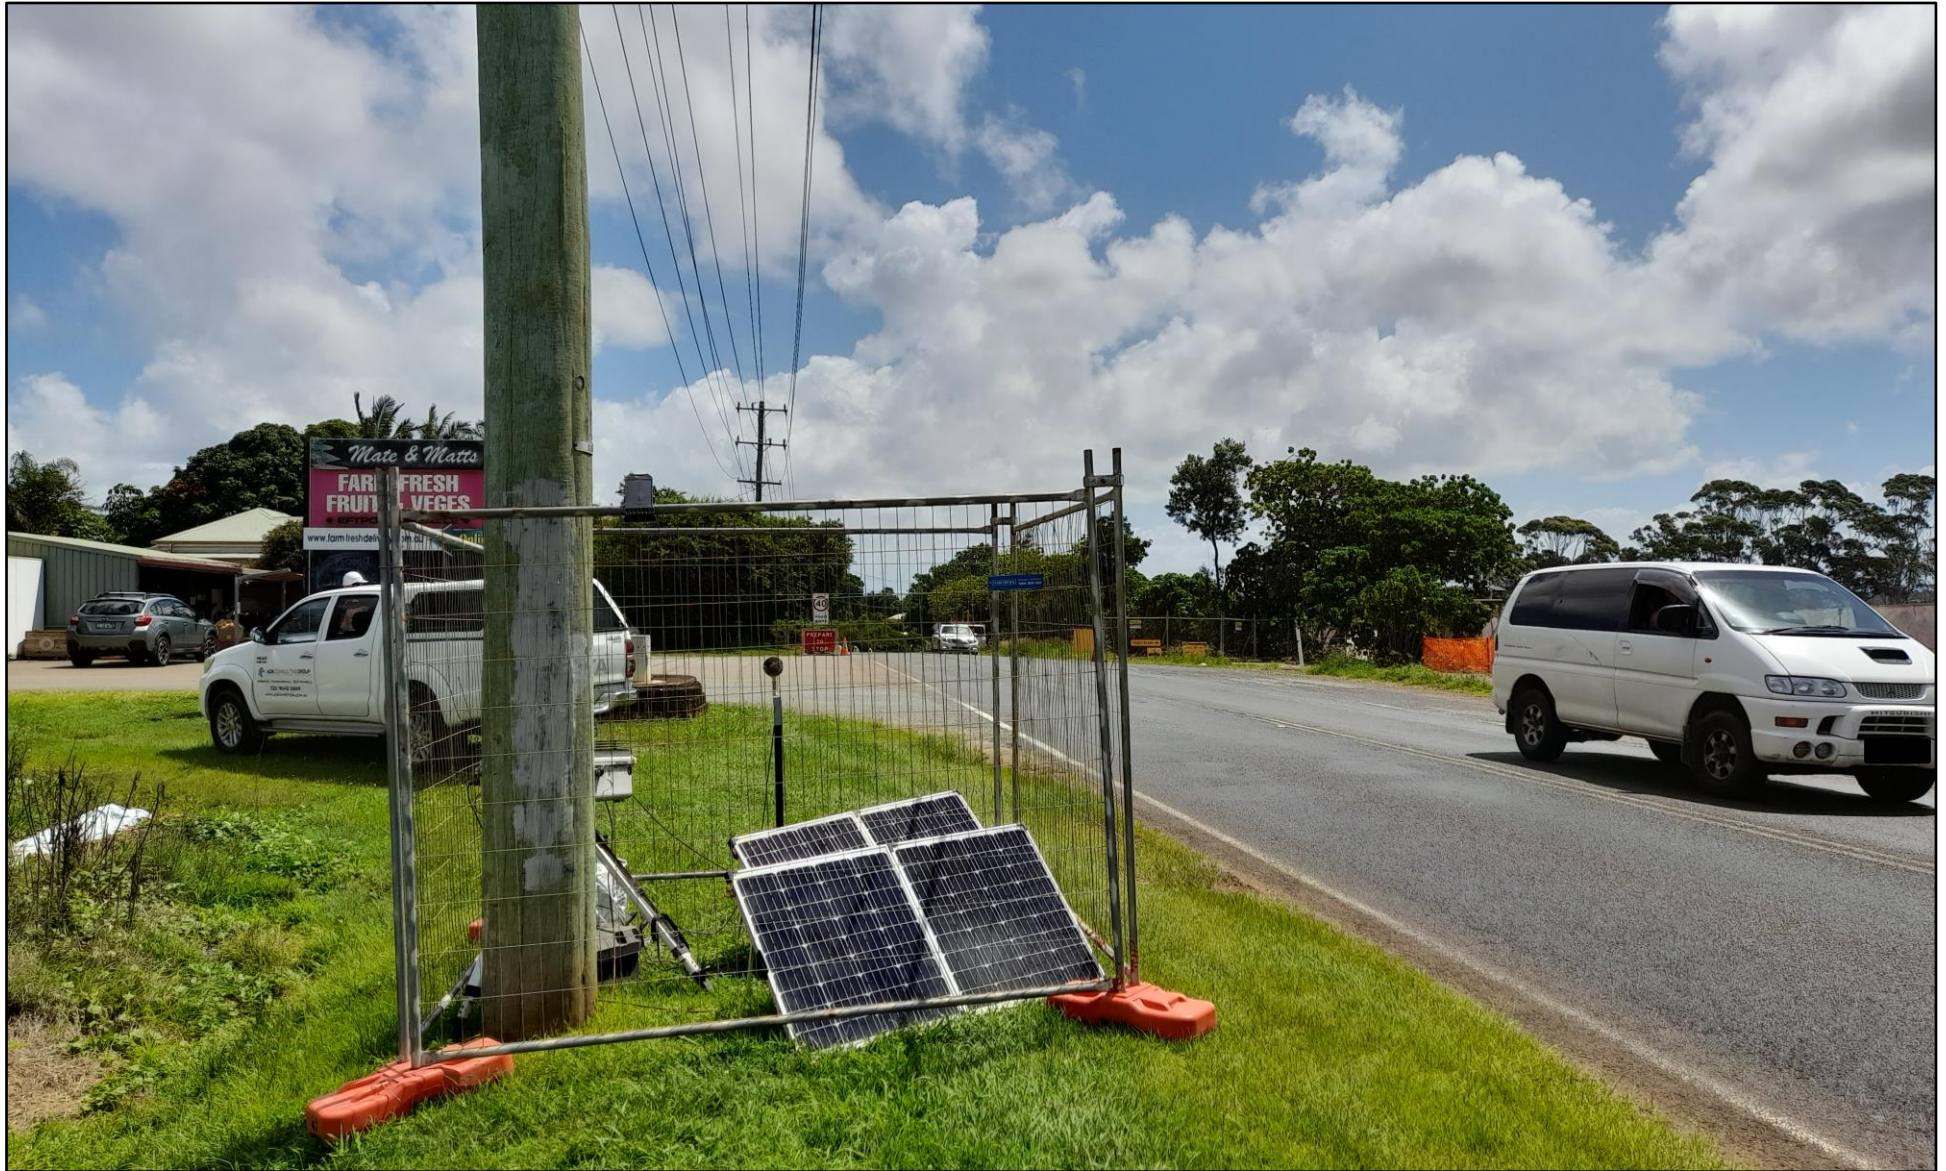
Photograph 3 Representative photograph of monitoring location 006 – Mate and Matts, as observed 11/01/2022
