# Vibration Monitoring Assessment Report (April 2022)

**Tweed Valley Hospital Project, Cudgen NSW**

A101021.0286.00 | VIB33.Rev0 | Date: 17/05/2022

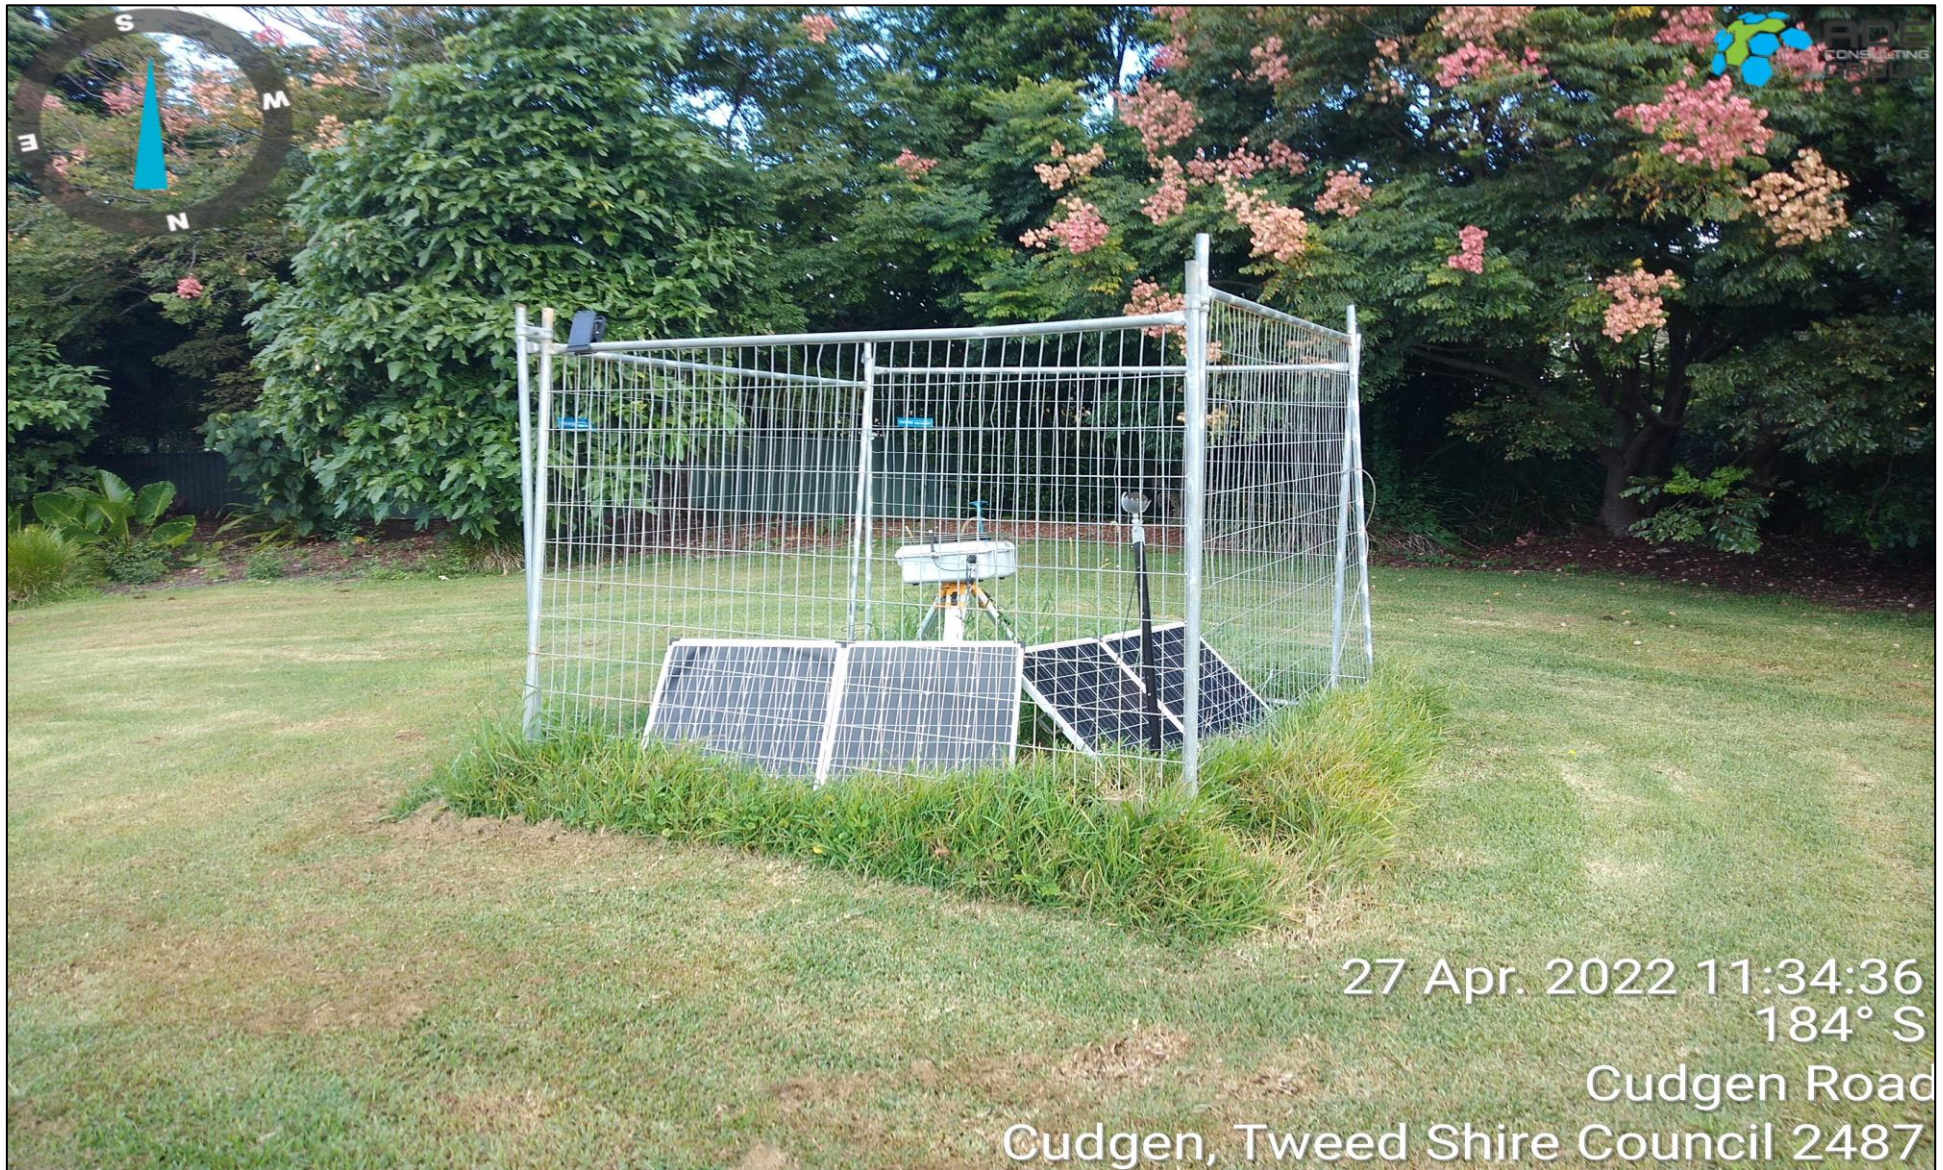
The vibration measurements were recorded using Profound Vibra+ vibration monitors. These vibration monitors are enclosed in a tough case which is placed on the ground and covered with a tarp to aid in keeping temperatures below 60°C, to ensure continuous monitoring. The accelerometer is placed firmly against the soil surface and covered with a sandbag to minimise external interference. The monitors are positioned along Cudgen Road.

Photograph 1 Representative photograph of monitoring location 004 – TAFE East, as observed 27/04/2022

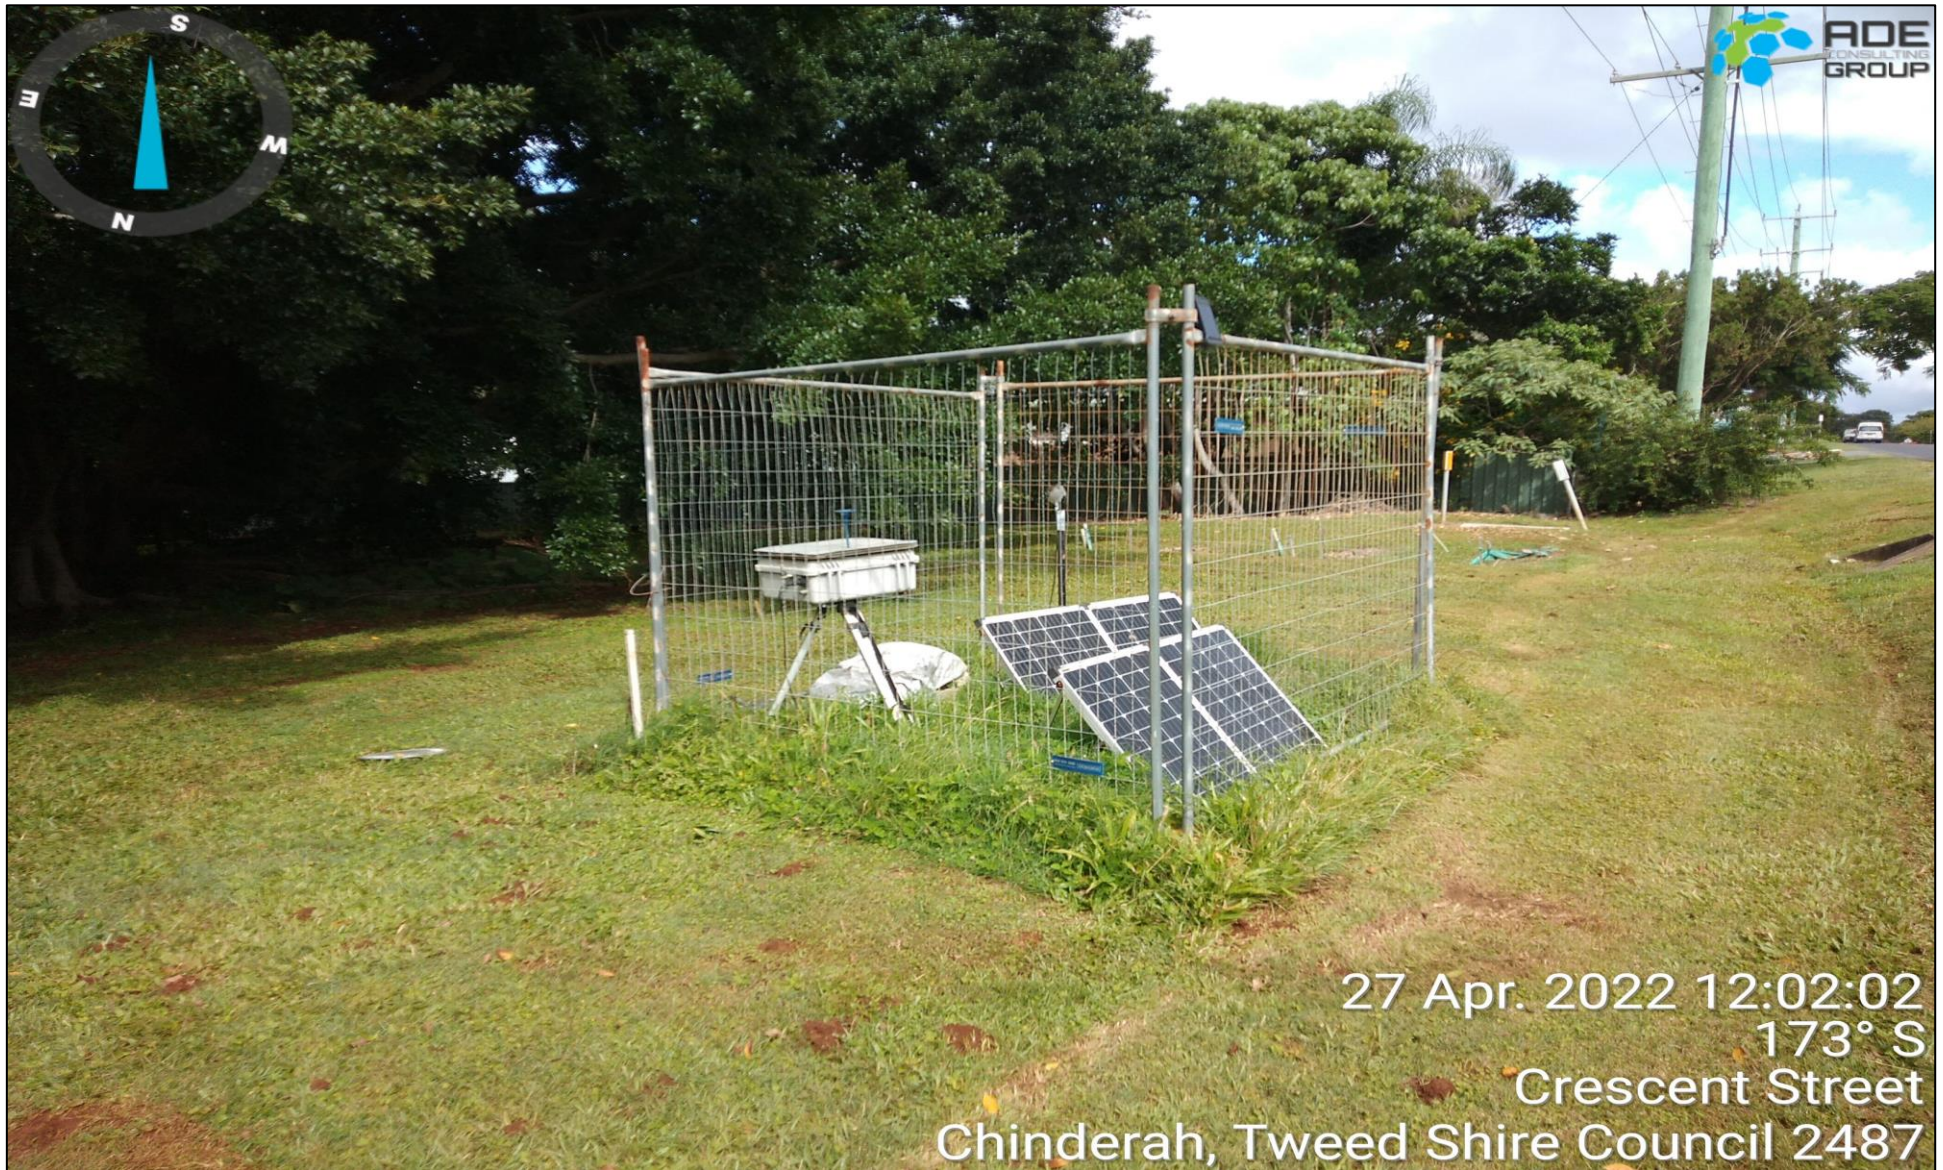
Photograph 2 Representative photograph of monitoring location 005 – TAFE West, as observed 27/04/2022

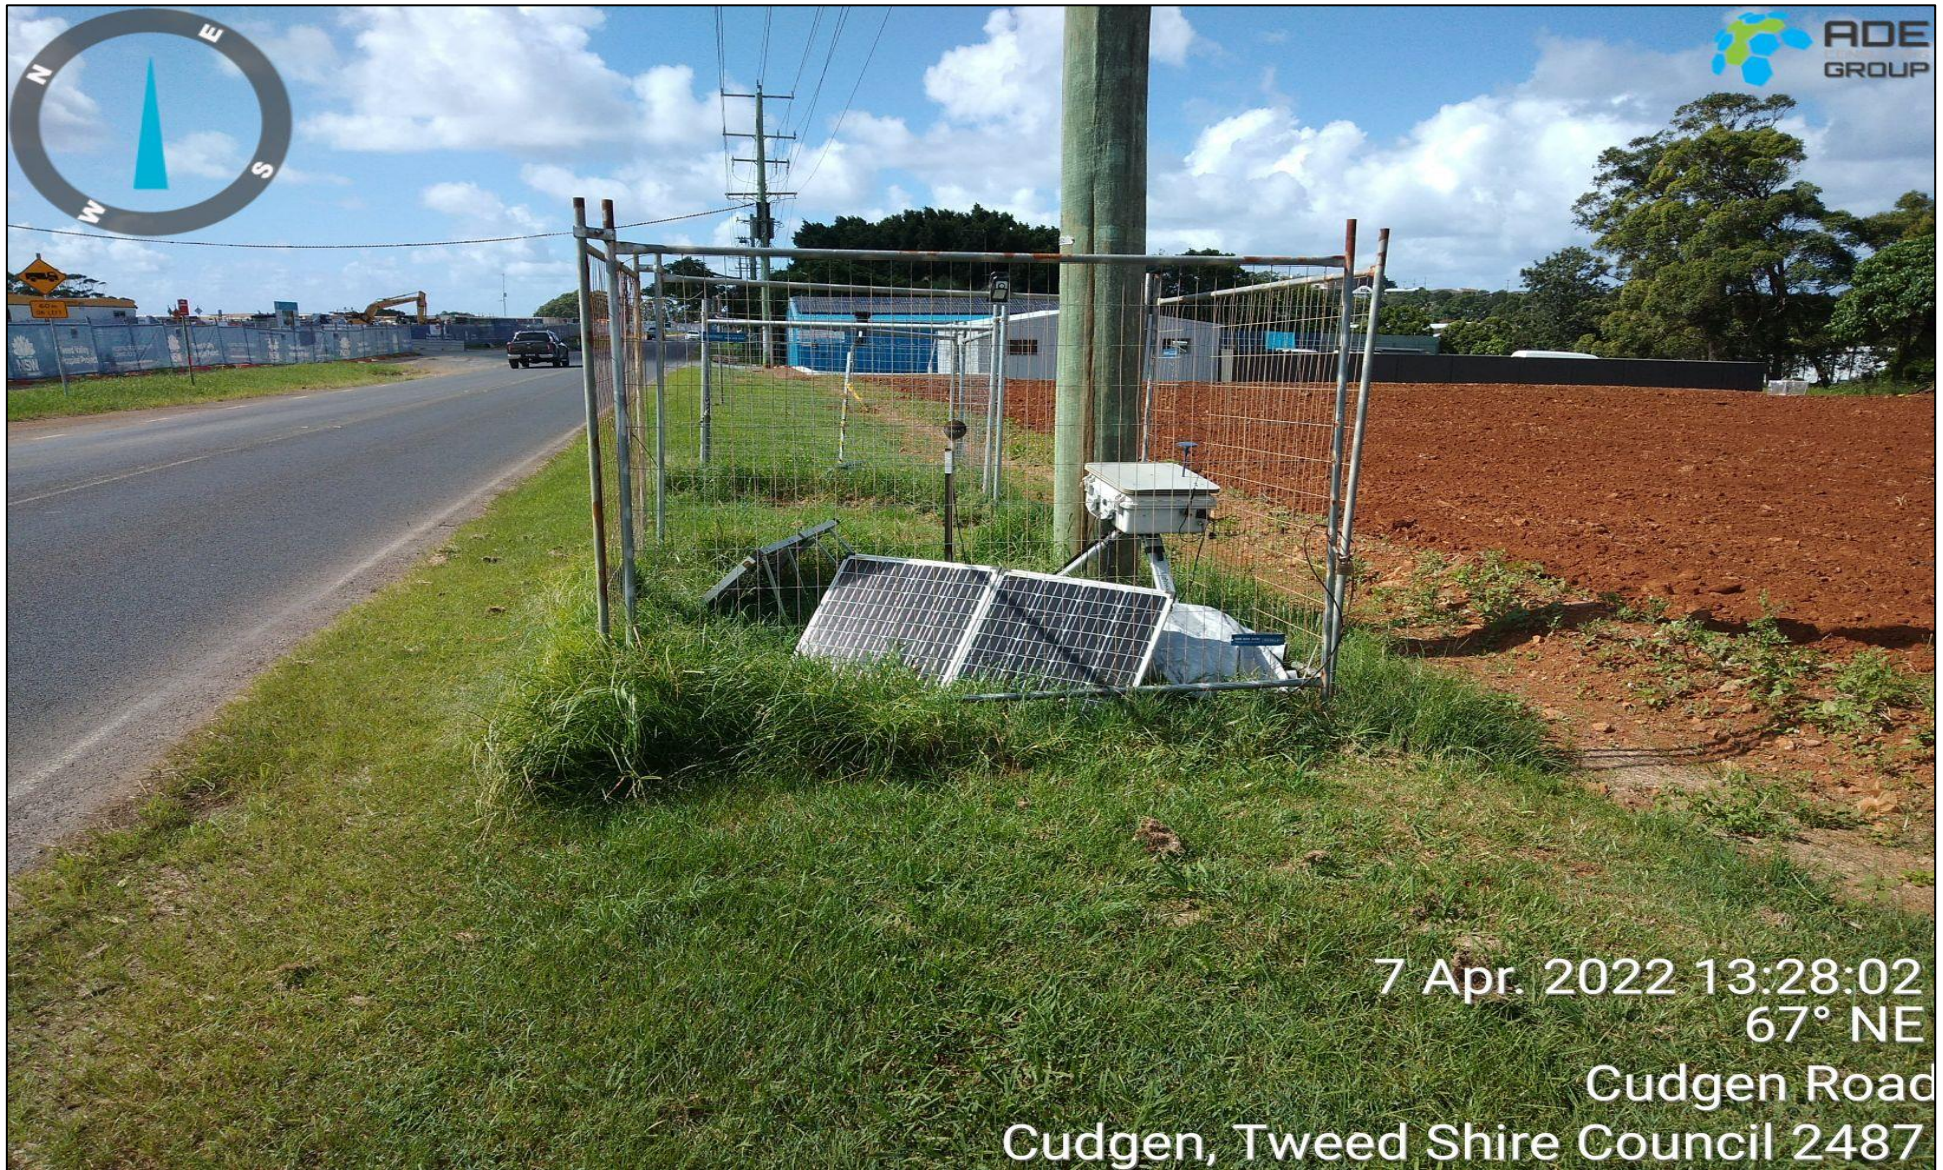
Photograph 3 Representative photograph of monitoring location 006 – Mate and Matts, as observed 07/04/2022
