Vibration Monitoring Assessment Report | October 2023

Tweed Valley Hospital 771 Cudgen Road, Cudgen NSW

Job Number: A101021.0286.00 VIB51 v1f | Date: 17/11/2023

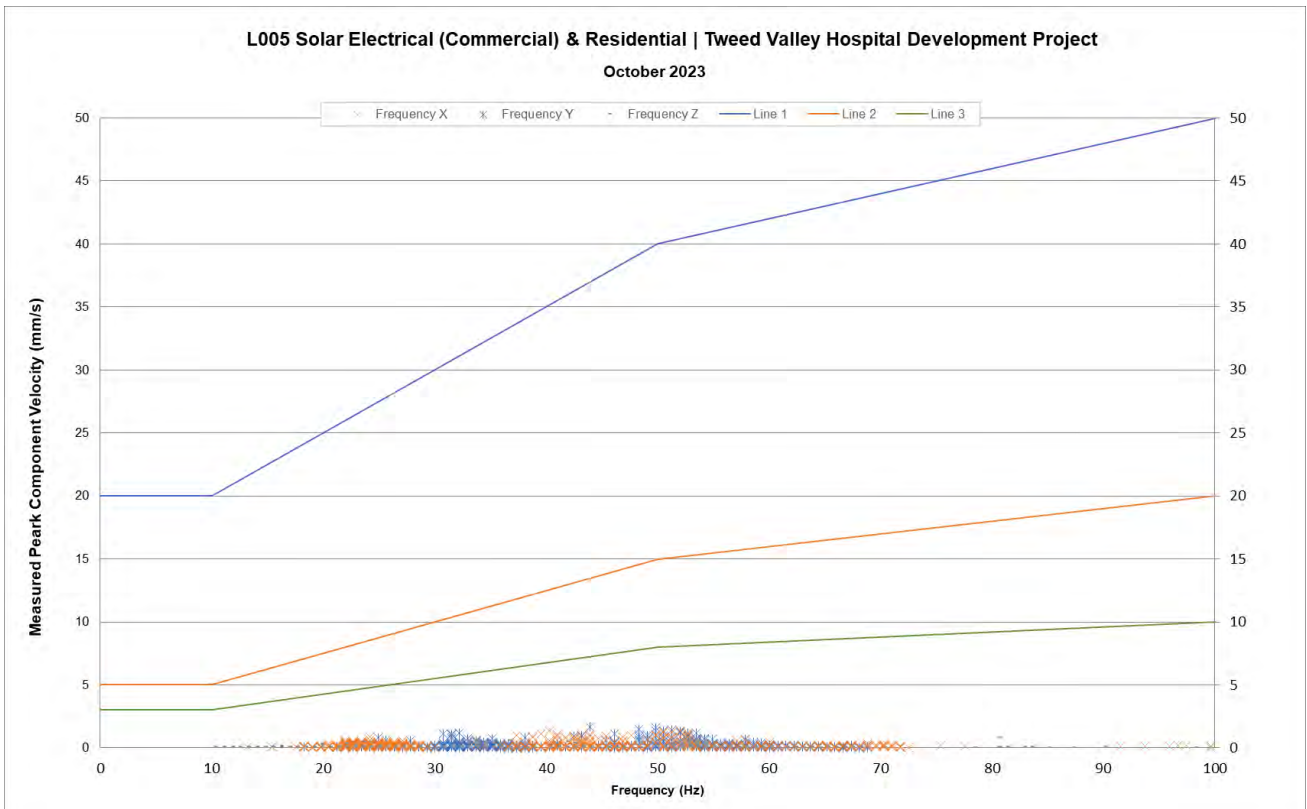
Figure 3 below presents frequency over velocity data for logger L.005.

Figure 3 Frequency over Velocity (Logger 005 – Residential/Commercial)

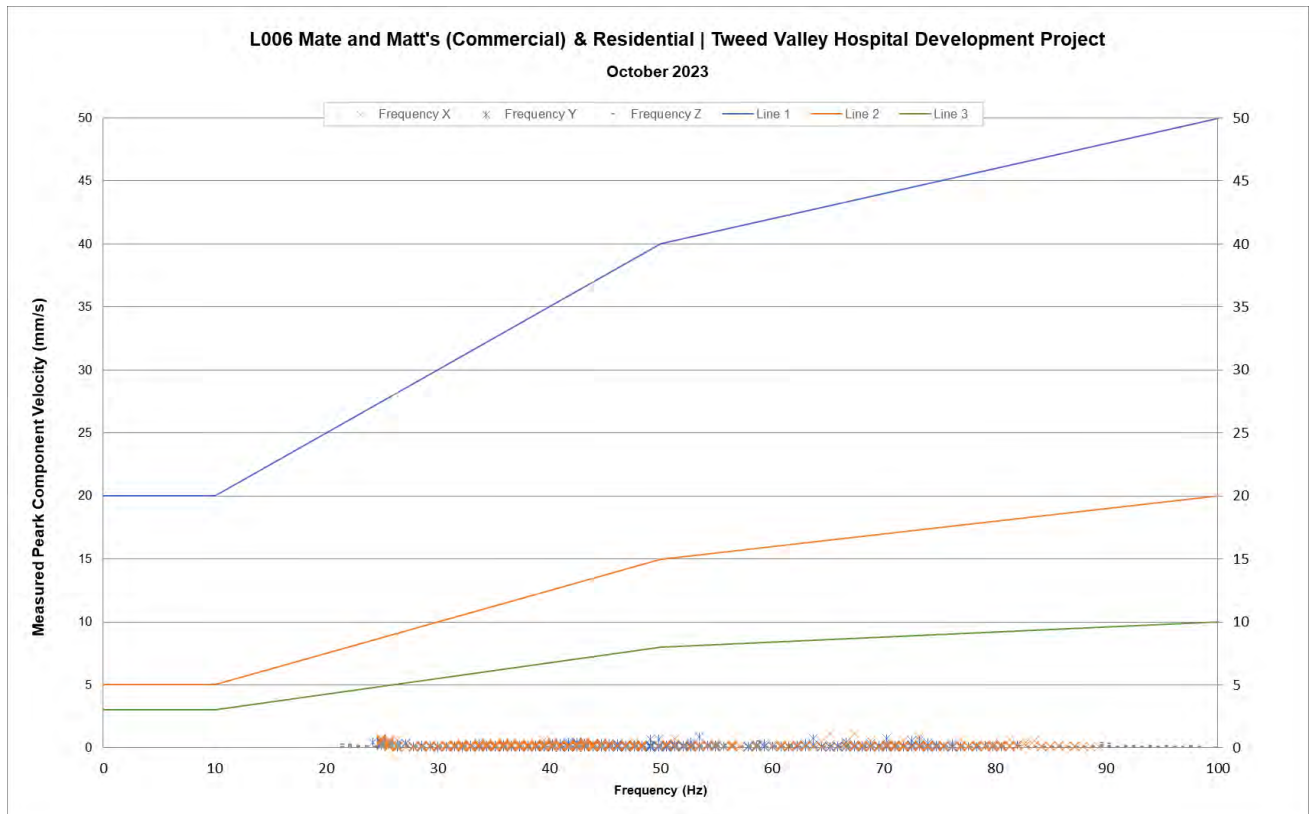
Figure 5 below illustrates the frequency over the velocity for each axis at Location L.006.

Figure 5 Frequency over Velocity (Logger 006 – Residential/Commercial)

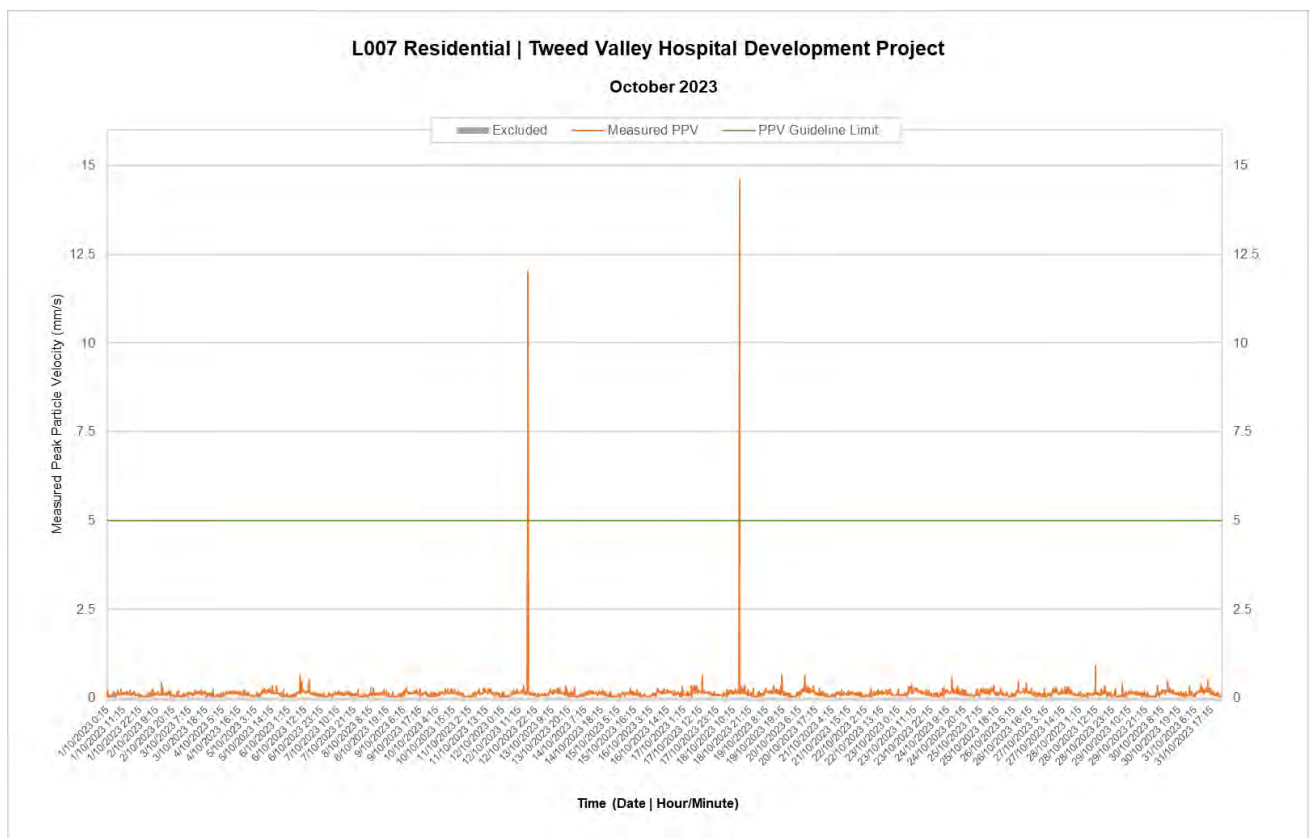
Figure 6 below presents velocity data for the logger located in close proximity to a residential premises, nominated as Location L.007.

Figure 6 Velocity over time (Logger 007 – Residential)

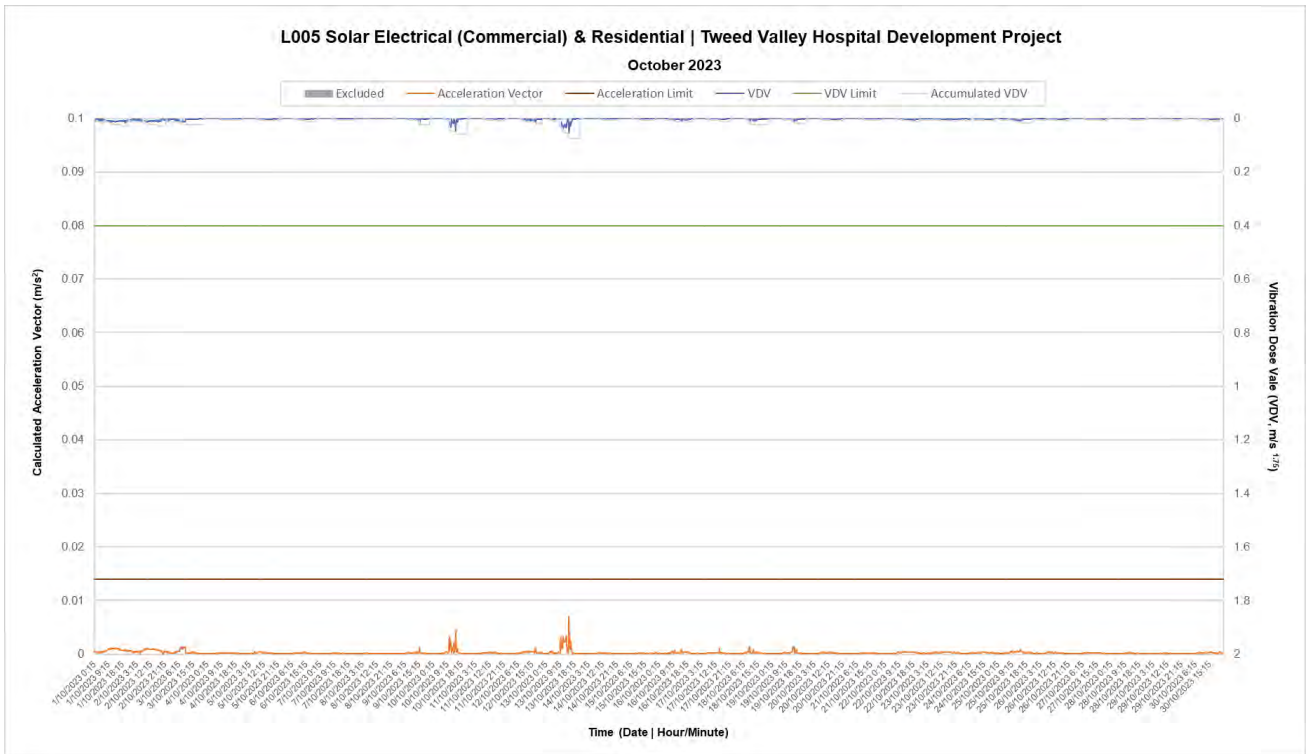
At each location, no reported acceleration or VDV levels of concern has been identified. The maximum VDV level measured across all locations is $0.083 \text{ m/s}^{1.75}$ and no impact is noted. This maximum level was measured at Location L007 on the 18 October 2023 for the 2:15PM 15-minute period.

Figure 8 overleaf presents iVDV, accumulated VDV (per period), and weighted RMS Acceleration (α_{rms}) data measured at L005.

Figure 8 Acceleration and Vibration Dose Value over time (Logger 005)

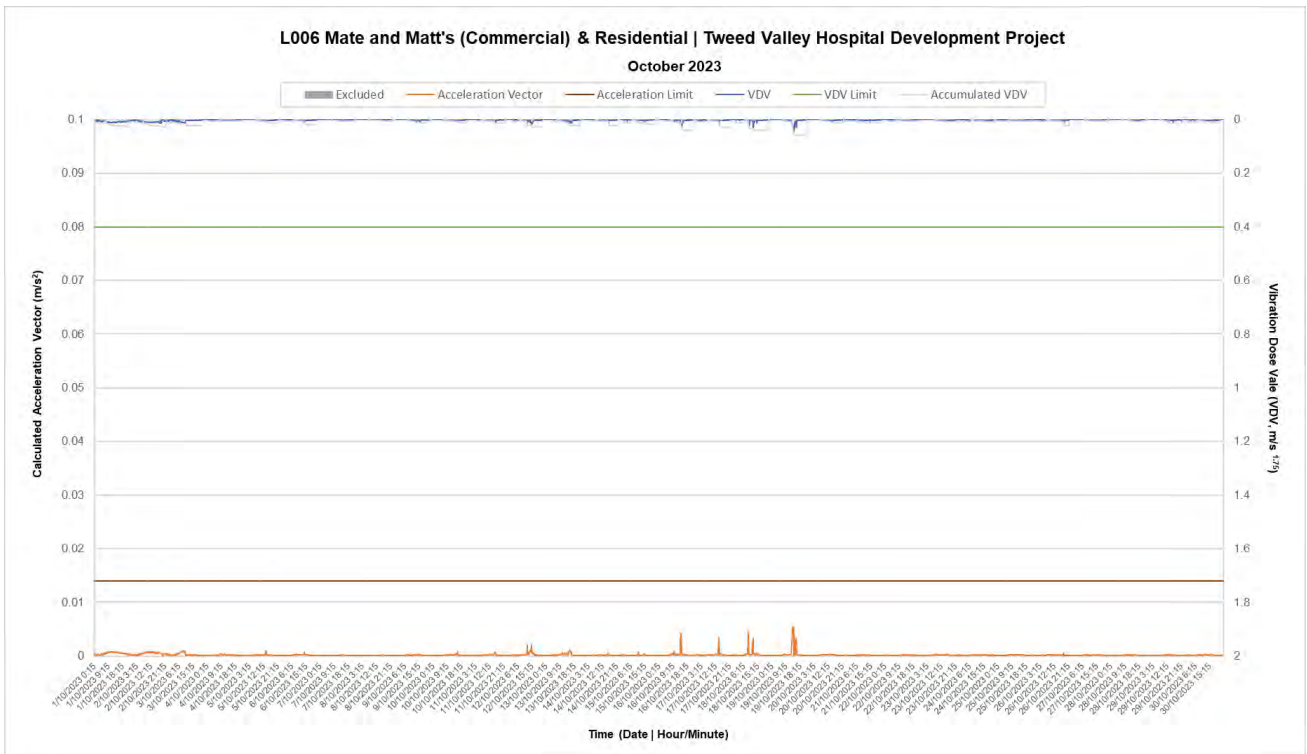
The vibration impact at the commercial and residential premises is presented below in **Figure 9**.

Figure 9 Acceleration and Vibration Dose Value over time (Logger 006 – Residential/Commercial)

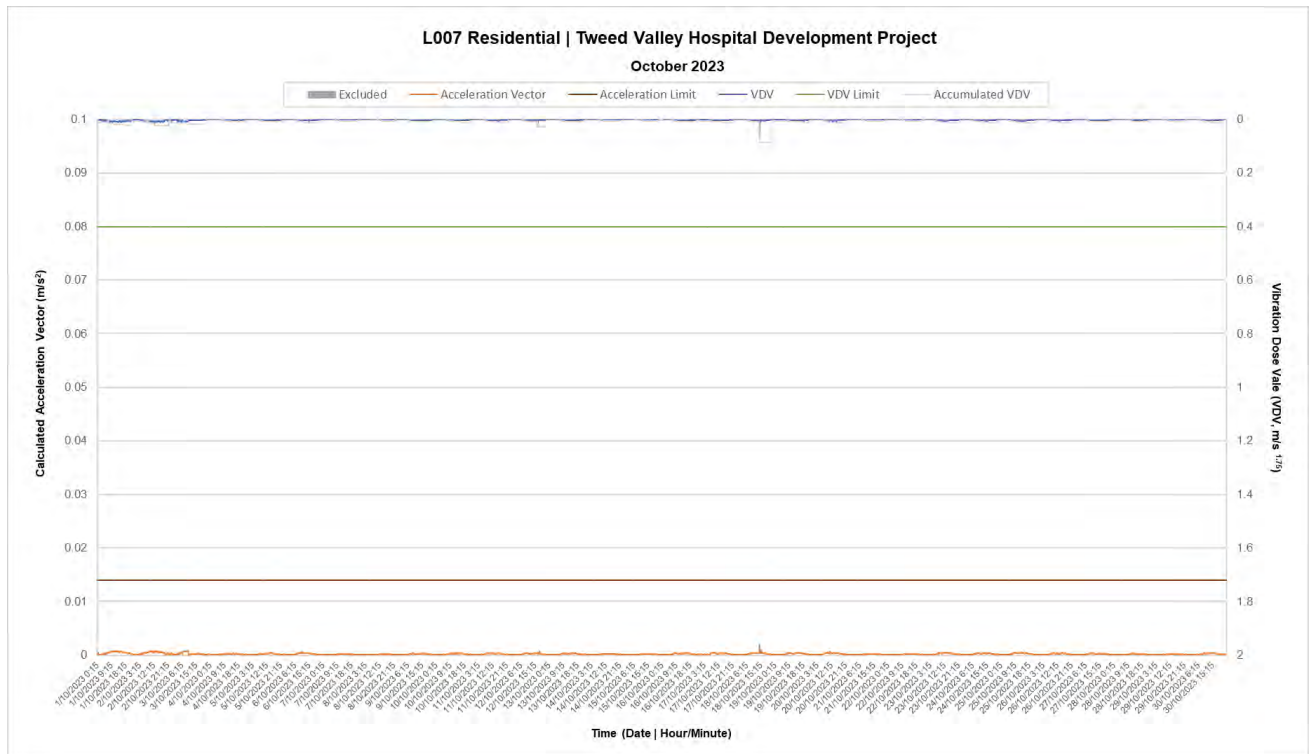
Figure 10 which follows presents vibration dose at the southwestern residential receiver at Location L.007.

Figure 10 Acceleration and Vibration Dose Value over time (Logger 007 – Residential)

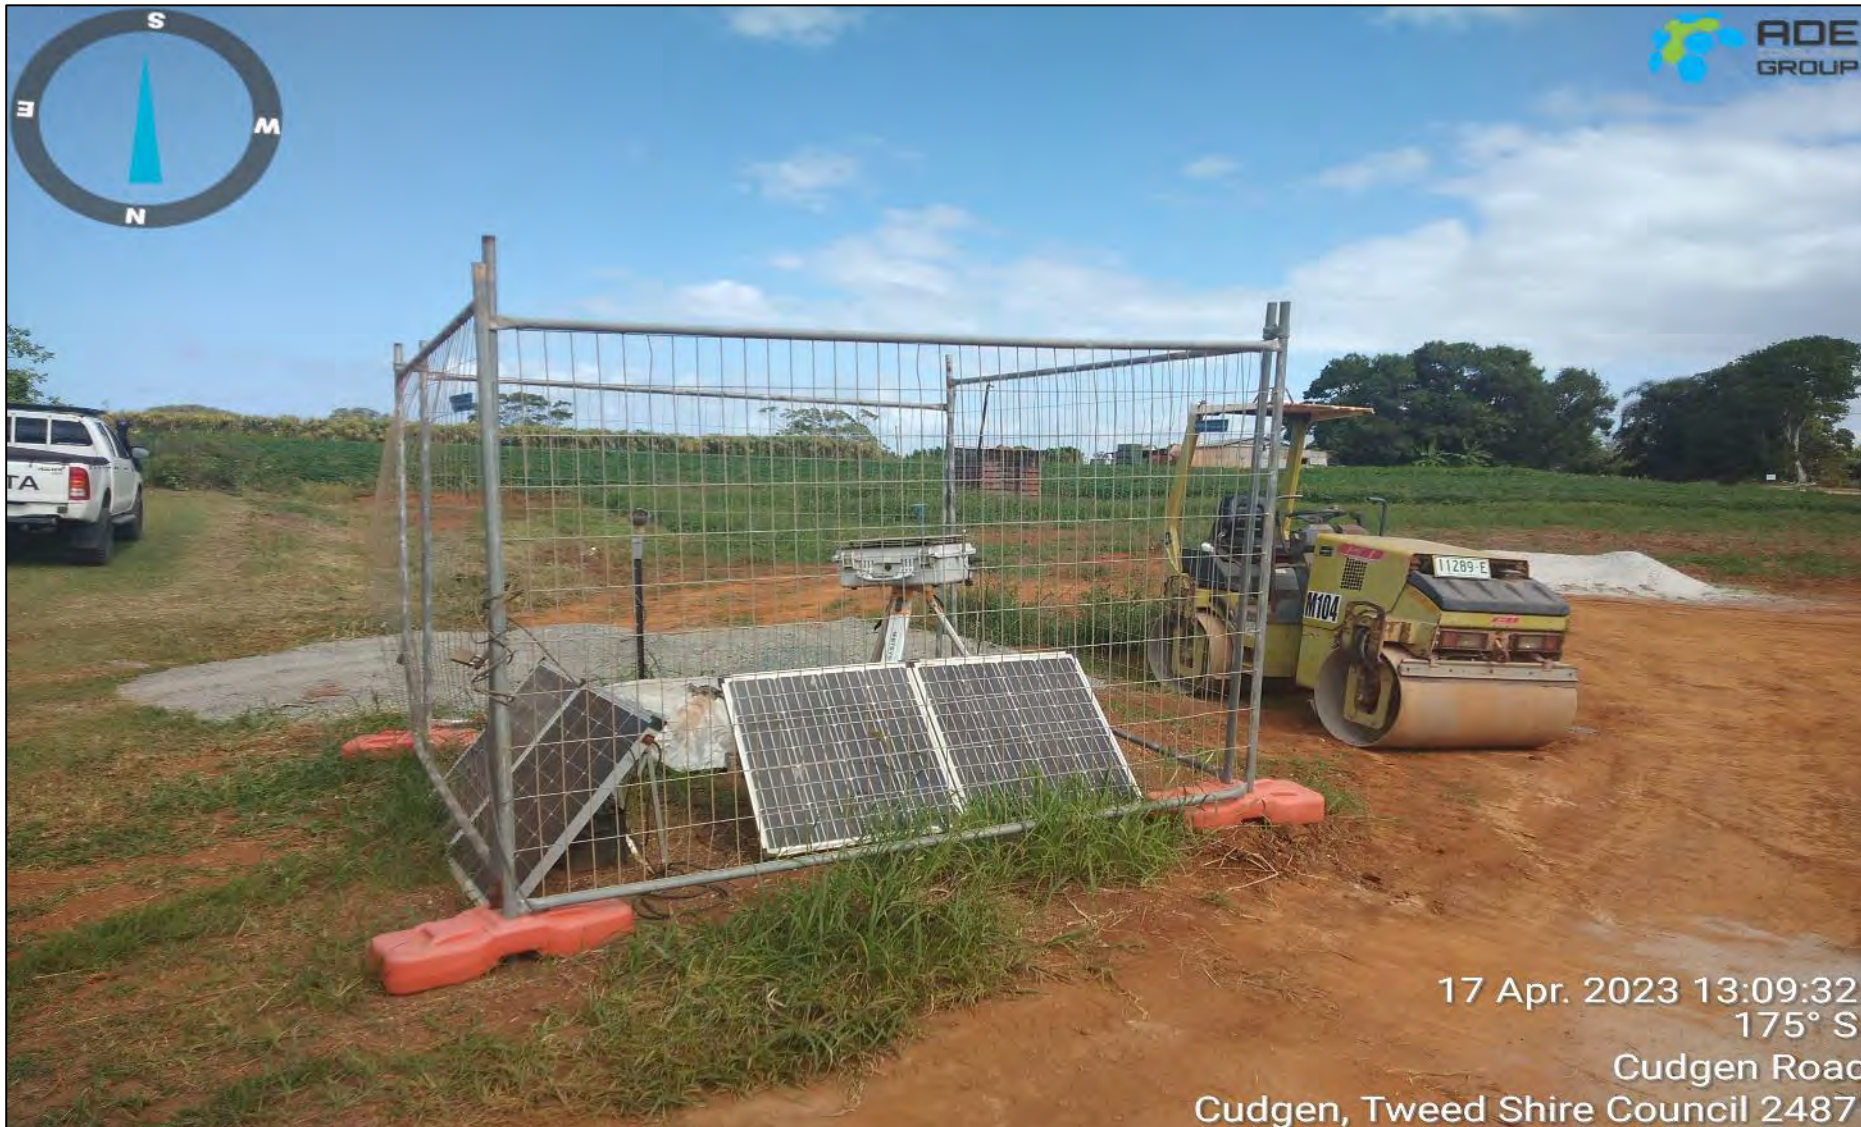
The tri-axial accelerometer is placed firmly against the soil surface and covered with a sandbag to minimise external interference. The monitors are positioned external to the Site along the boundary to sensitive receivers adjacent Cudgen Road to the south and southeast.

Photograph 1 Representative photograph of monitoring location 007 – Residential, as observed 17/04/2023

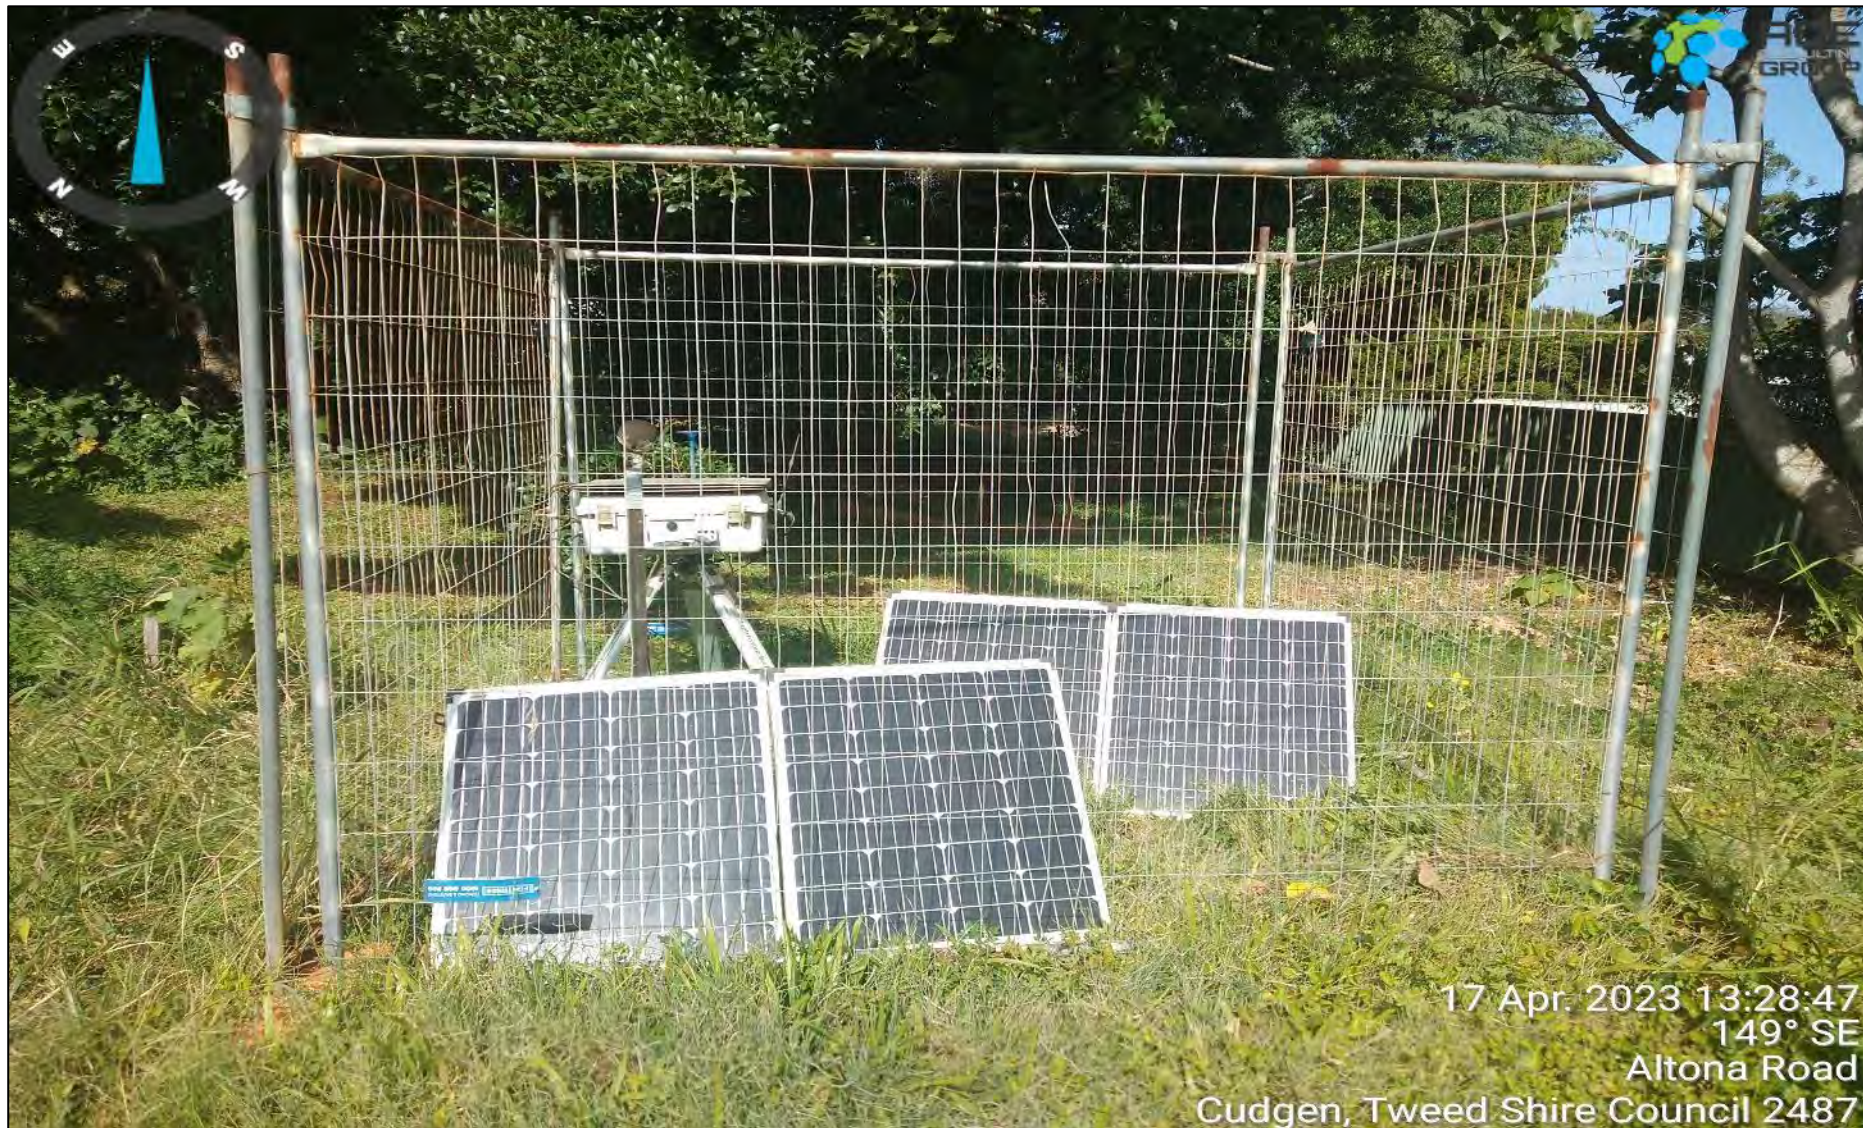
Photograph 2 Representative photograph of monitoring location 005 – Solar Industry, as observed 17/04/2023

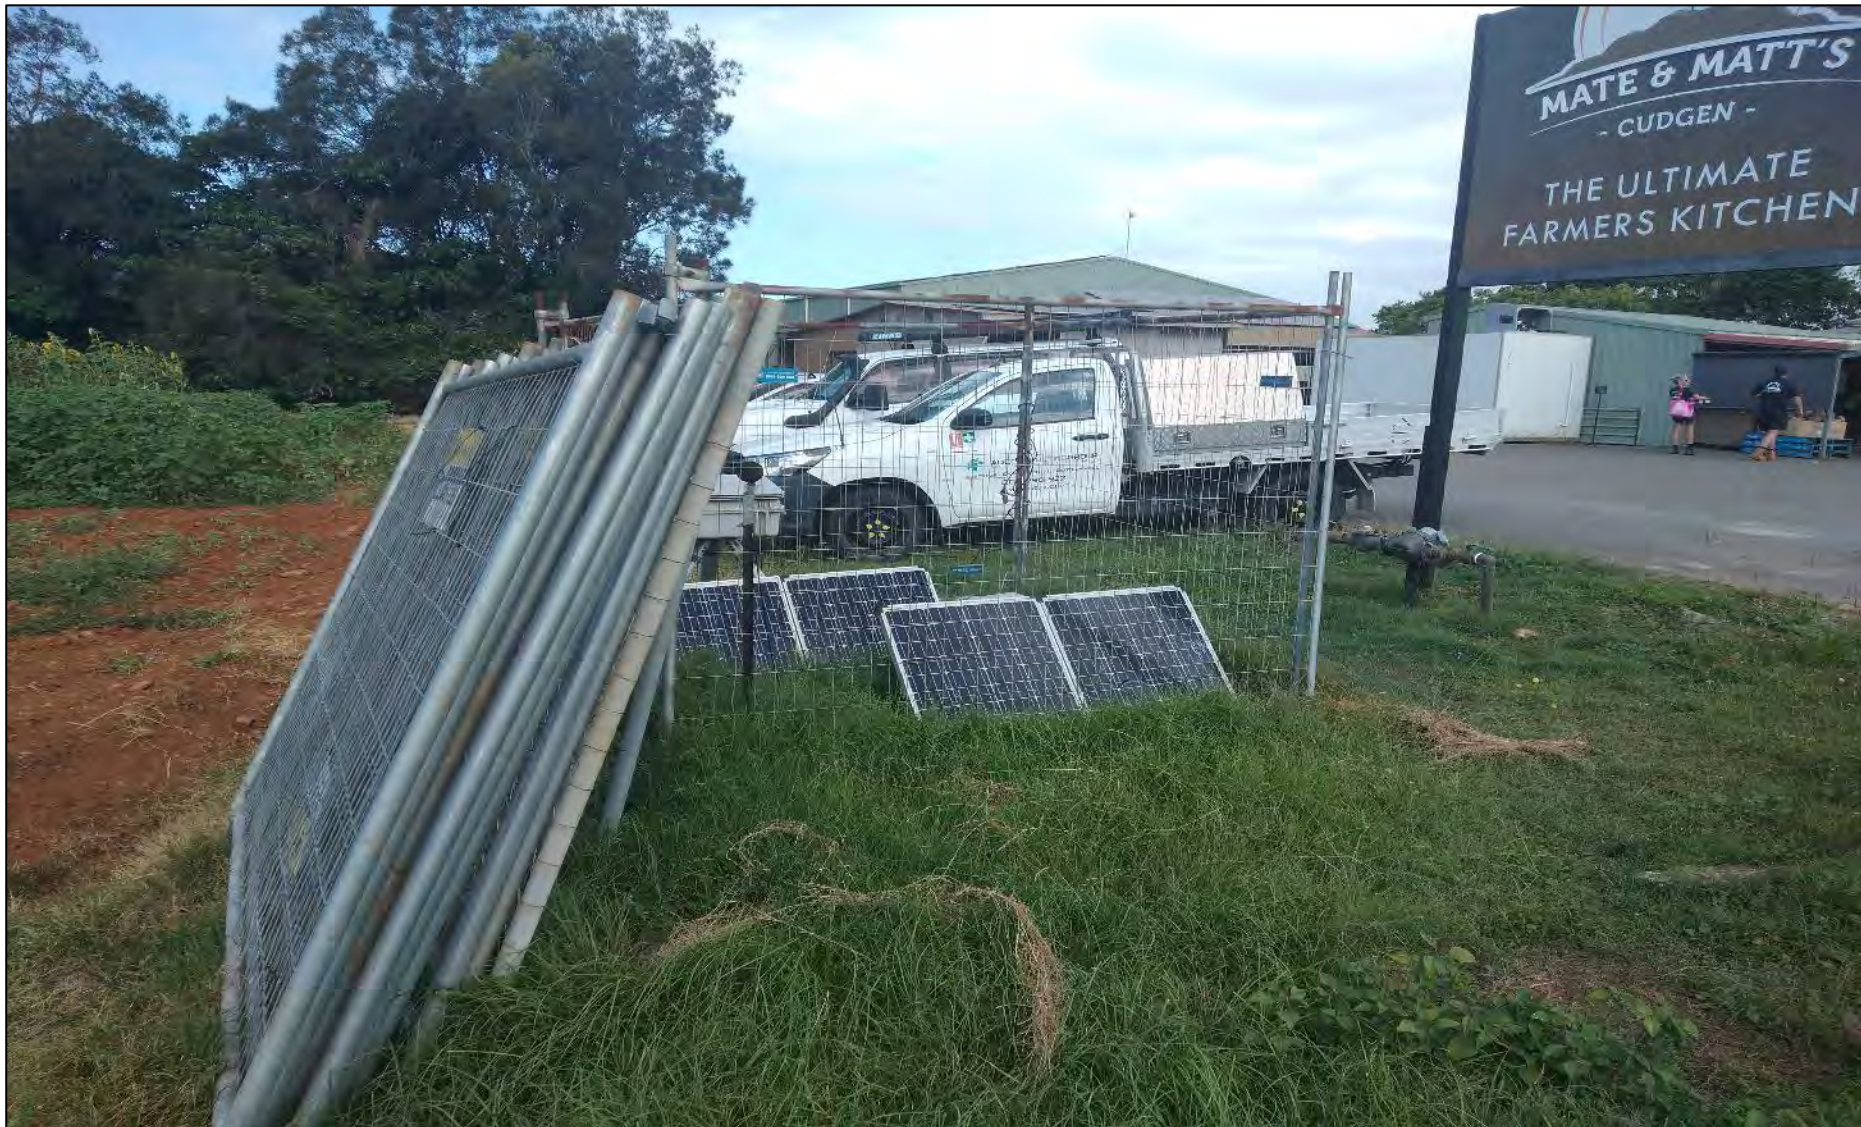
Site imaging demonstrate that the security cage in use around the logging devices has construction material resting against it, indicating that extraneous activity is present at times, and would contribute to higher readings not considered to be representative of construction activities.

Photograph 3 Representative photograph of monitoring location 006 – Mate and Matts, as observed 17/04/2023
