Vibration Monitoring Assessment Report | April 2023

771 Cudgen Road, Cudgen NSW

Prepared for: Lendlease Building Pty Ltd

Job Number: A101021.0286.00 VIB45.Rev0 | Date: 01/06/2023

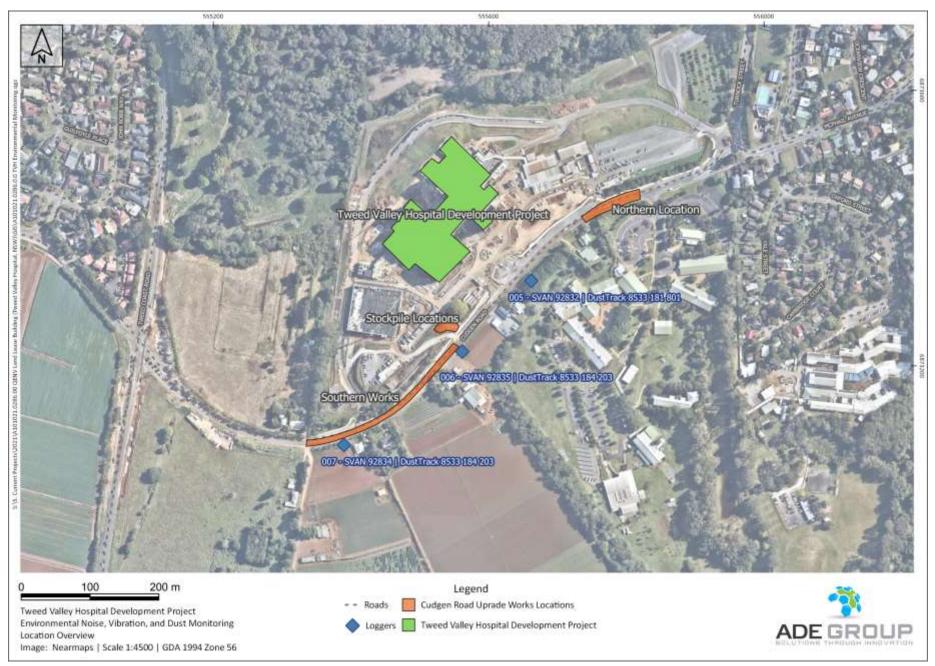
ADE Monitoring locations, site location (including CD Civil's Cudgen Road Upgrade works) are presented below.

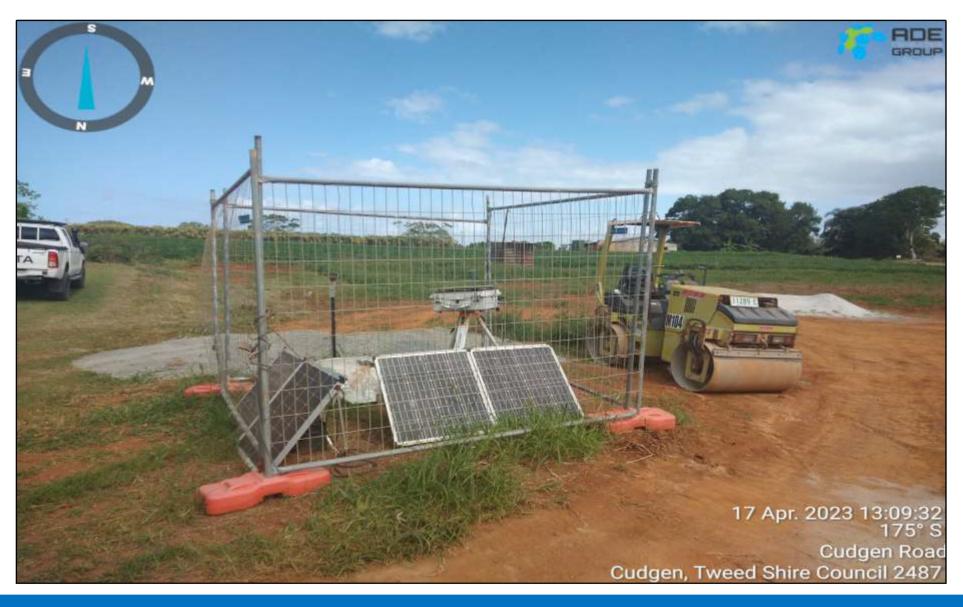
Photograph 1 Representative photograph of monitoring location 007 – Residential, as observed 17/04/2023

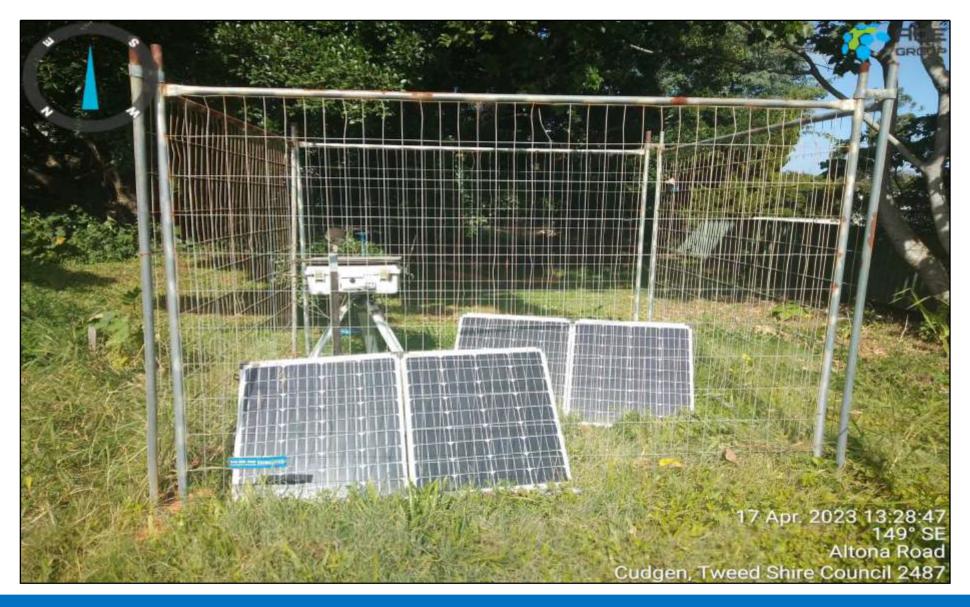
Photograph 2 Representative photograph of monitoring location 005 – Solar Industry, as observed 17/04/2023

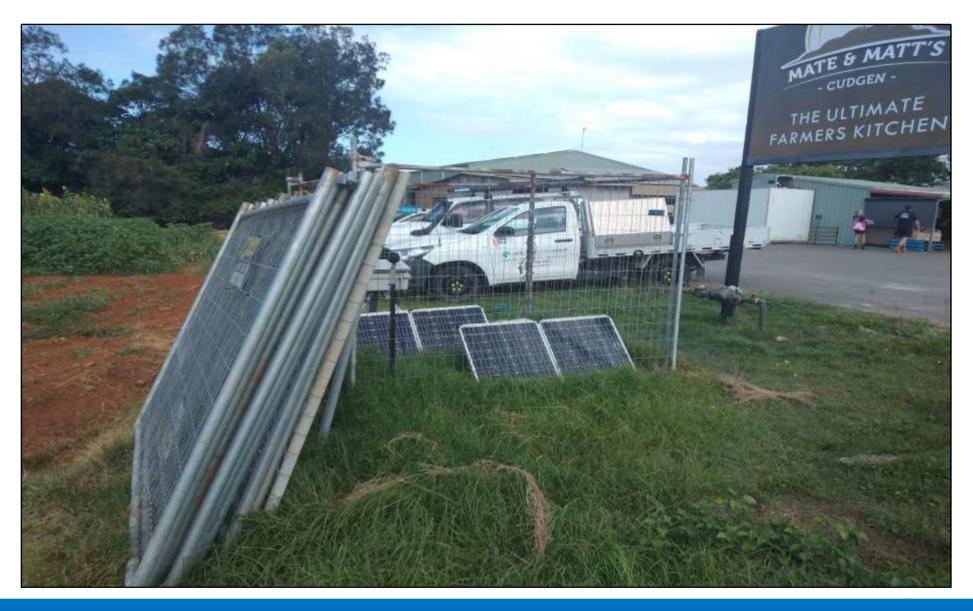
Photograph 3 Representative photograph of monitoring location 006 – Mate and Matts, as observed 17/04/2023
