Vibration Monitoring Assessment Report | September 2023

Tweed Valley Hospital 771 Cudgen Road, Cudgen NSW

Job Number: A101021.0286.00 VIB50 v1f | Date: 03/11/2023

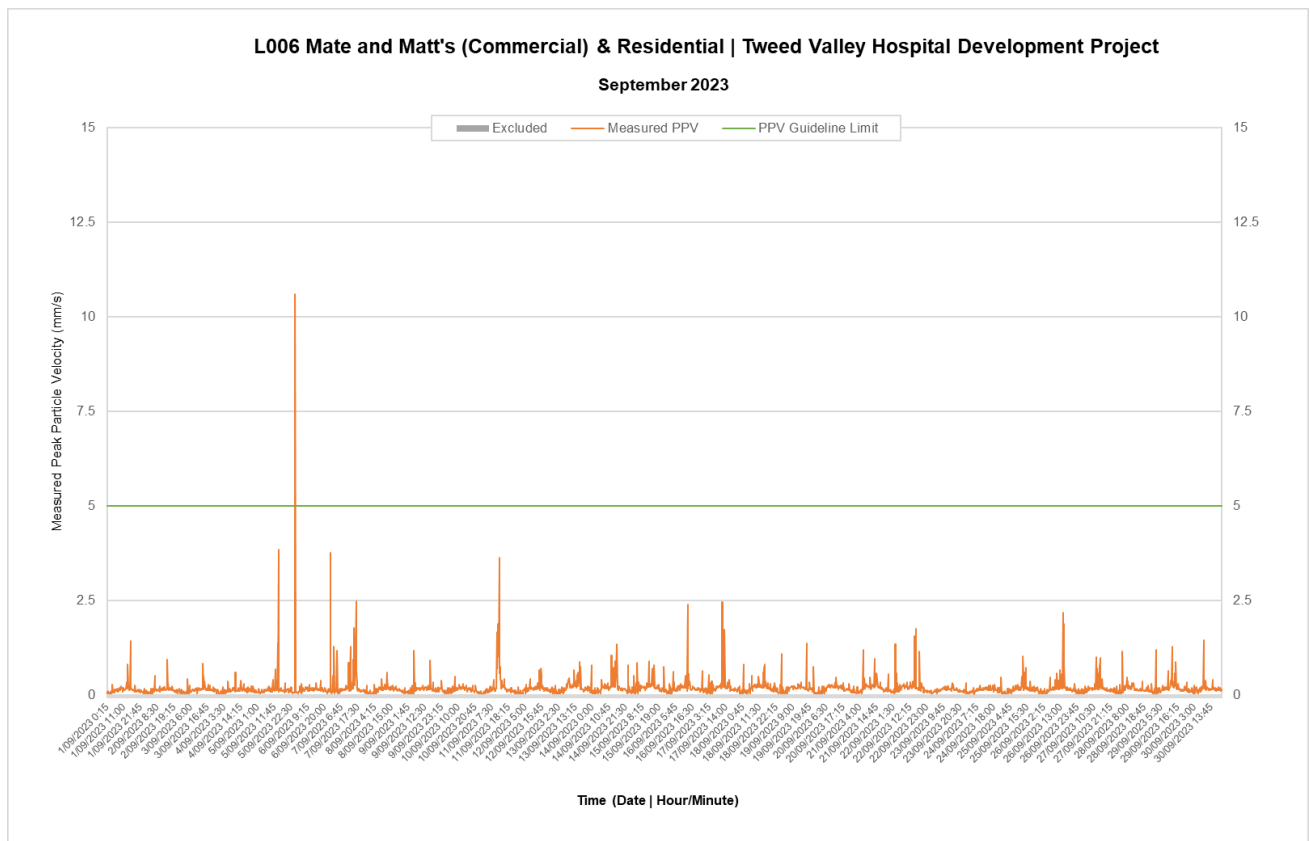
Figure 4 below presents velocity data for the logger located to a commercial and residential premises ('Mate and Matt's') nominated as Location L.006.

Figure 4 Velocity over time (Logger 006 – Residential/Commercial)

From **Figure 4** it can be seen a single exceedance of the velocity guideline was recorded (10.593 PPV) on 6 September 2023 during the 1:00AM 15-minute period and is attributed to extraneous activity near the device given the timeframe in which the measurement was recorded (i.e. outside of construction hours).

Regardless, frequency analysis of this demonstrates compliance with the DIN4150 frequency threshold guidelines, hence the measured spike exceeding 5 mm/s is not considered an 'exceedance'.

This location has measured higher vibration activity throughout the course of the loggers' deployment time, attributed to the operation of the business and the area in use by both the Sites contractor and the commercial premises itself.

Site imaging demonstrate that the security cage in use around the logging devices has construction material resting against it, indicating that extraneous activity is present at times, and would contribute to higher readings not considered to be representative of construction activities.

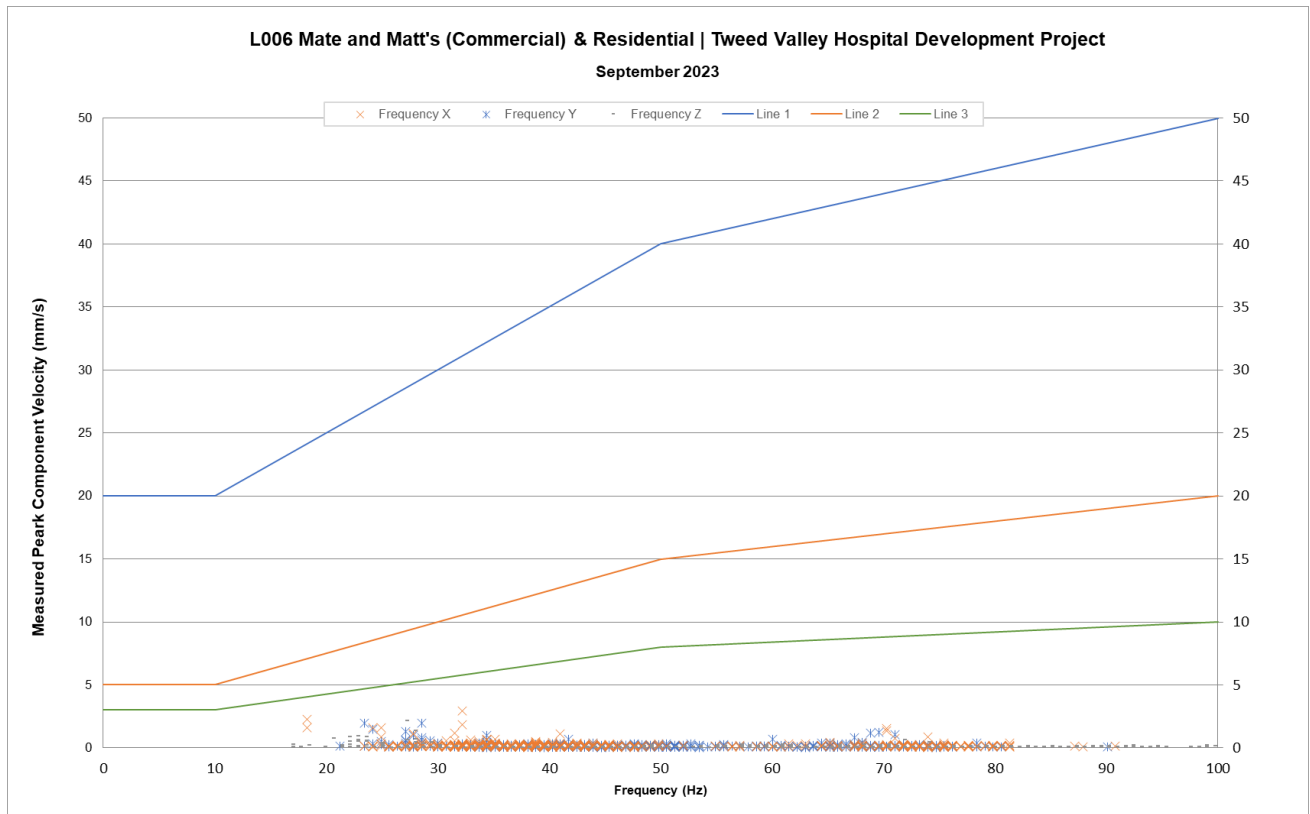
Figure 5 below illustrates the frequency over the velocity for each axis at Location L.006.

Figure 5 Frequency over Velocity (Logger 006 – Residential/Commercial)

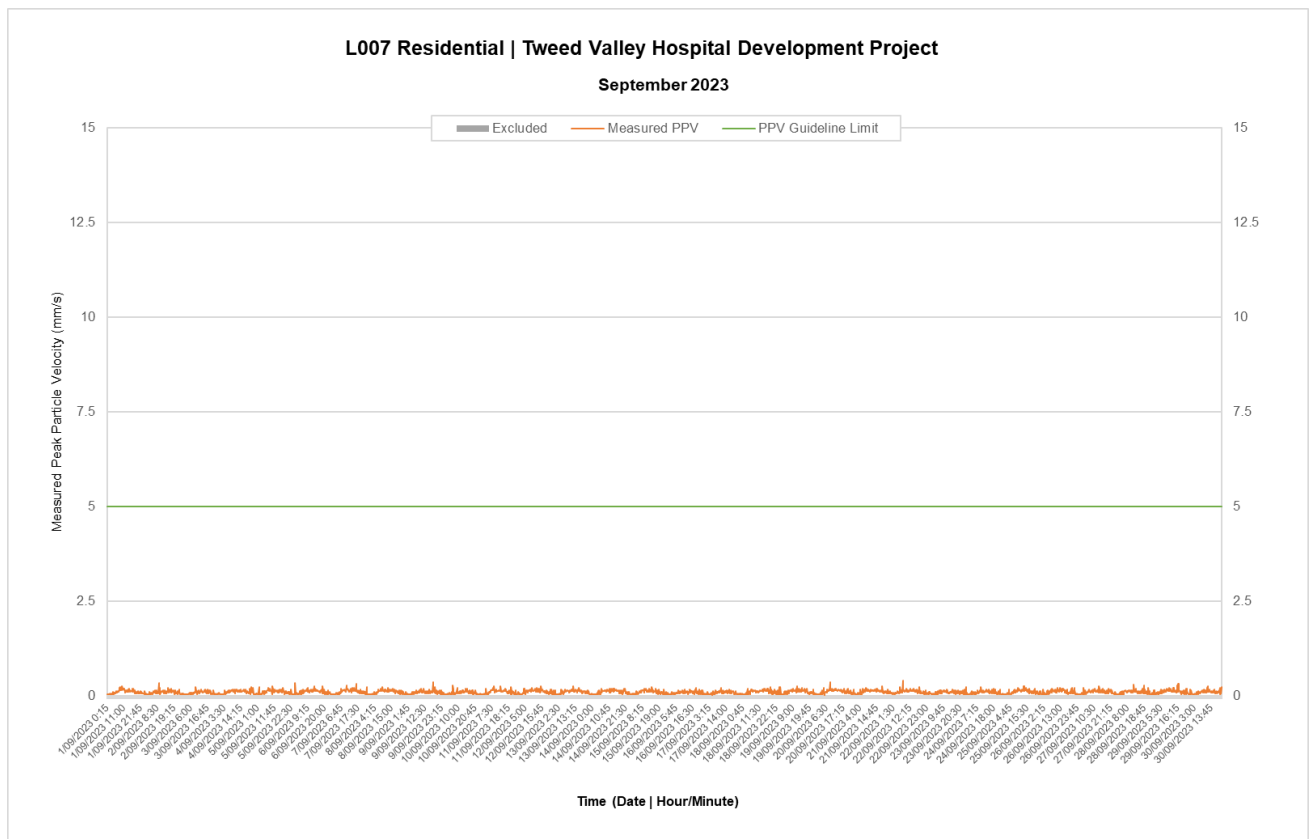
Figure 6 below presents velocity data for the logger located in close proximity to a residential premises, nominated as Location L.007.

Figure 6 Velocity over time (Logger 007 – Residential)

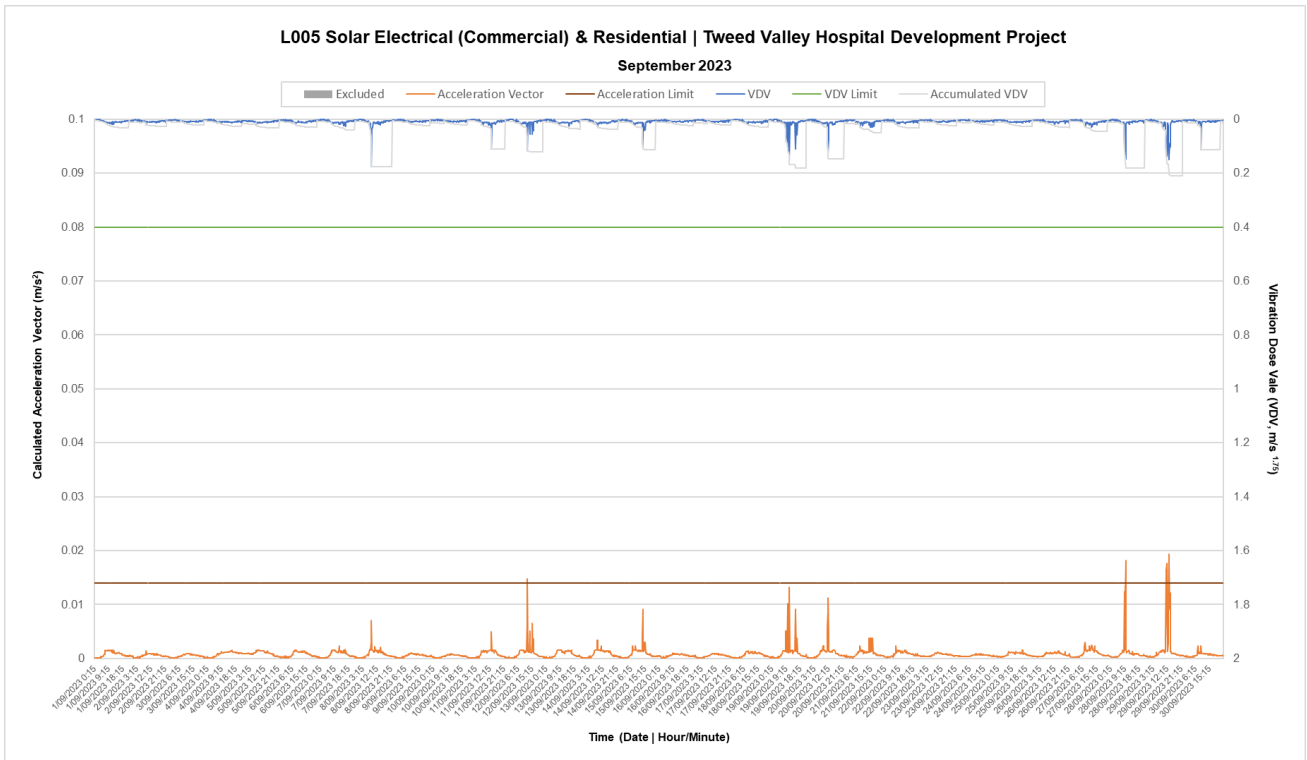
Figure 8 overleaf presents iVDV, accumulated VDV (per period), and weighted RMS Acceleration (α_{rms}) data measured at L005. Review of Figure 8 below and underlying data shows weighted RMS acceleration measurements exceeding the adopted worst case maximum vibration criteria (0.014 m/s^2 – threshold of perception applicable to residences during the night) on six (6) separate occasions:

- 0.0193 m/s^2 on 12 September 2023 for the 12:15PM 15-minute period.
- 0.0182 m/s^2 on 28 September 2023 for the 9:45 AM 15-minute period.
- 0.0176 m/s^2 on 29 September 2023 for the 11:45 AM 15-minute period.
- 0.0170 m/s^2 on 29 September 2023 for the 1:30 PM 15-minute period.
- 0.0164 m/s^2 on 29 September 2023 for the 11:30 AM 15-minute period.
- 0.0147 m/s^2 on 12 September 2023 for the 12:15 PM 15-minute period.

It should be noted that all the above exceedances of the adopted criteria occurred during the day and are below the maximum corresponding day time criteria of 0.020 m/s^2 for residences, and therefore are not considered 'exceedances'.

Figure 8 Acceleration and Vibration Dose Value over time (Logger 005)

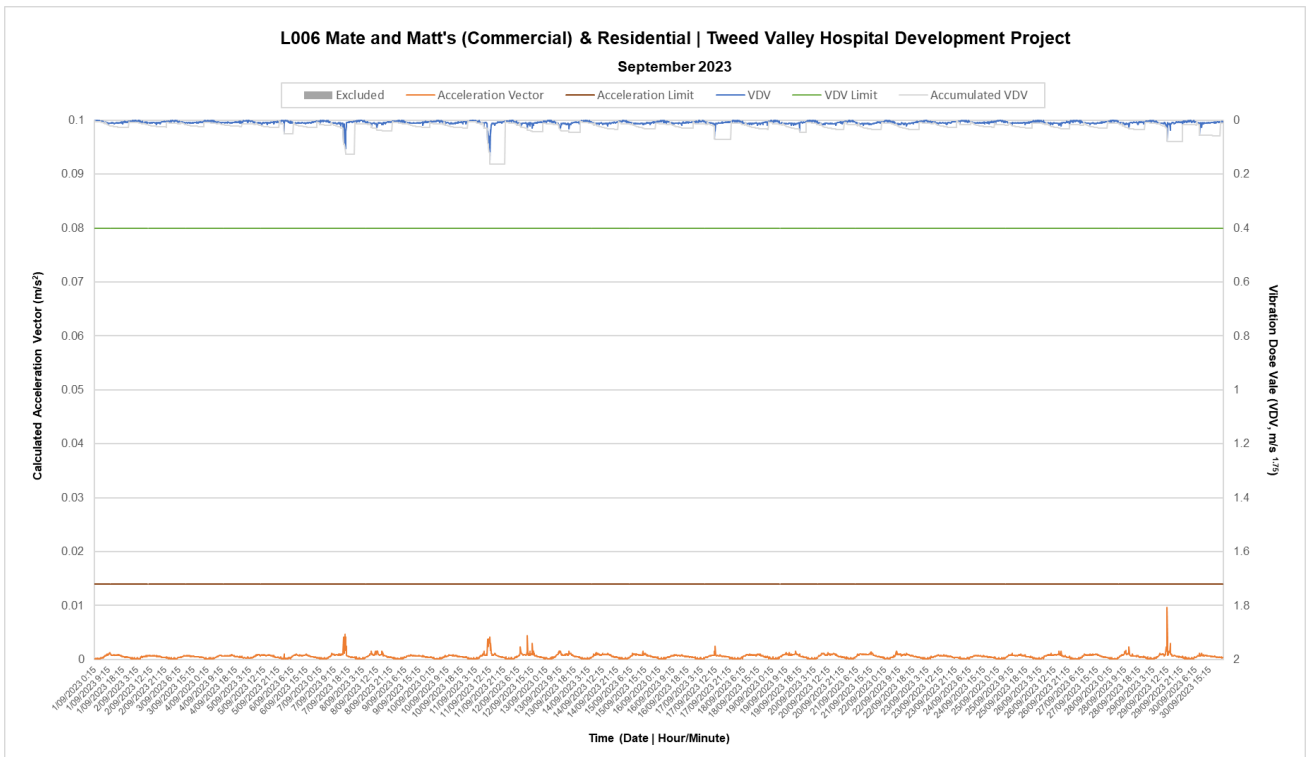
The vibration impact at the commercial and residential premises is presented below in **Figure 9**.

Figure 9 Acceleration and Vibration Dose Value over time (Logger 006 – Residential/Commercial)

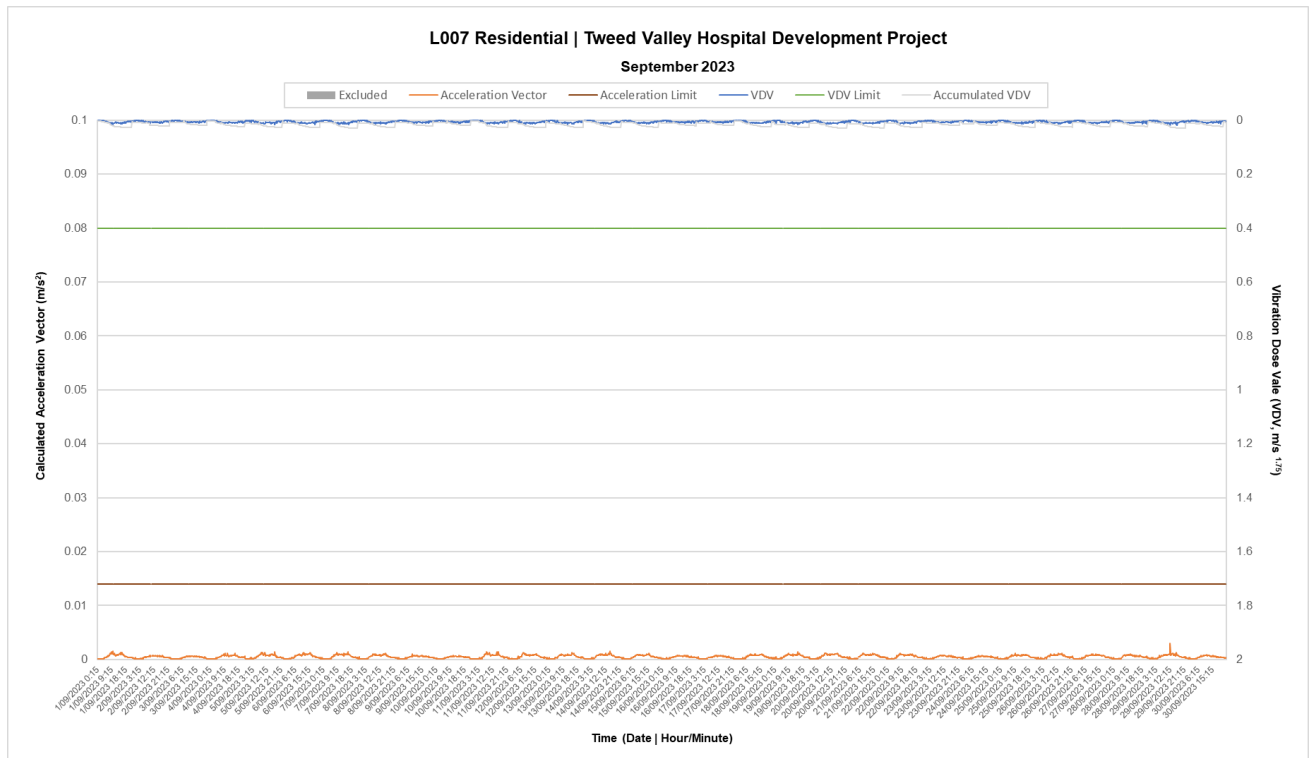
Figure 10 which follows presents vibration dose at the southwestern residential receiver at Location L.007.

Figure 10 Acceleration and Vibration Dose Value over time (Logger 007 – Residential)

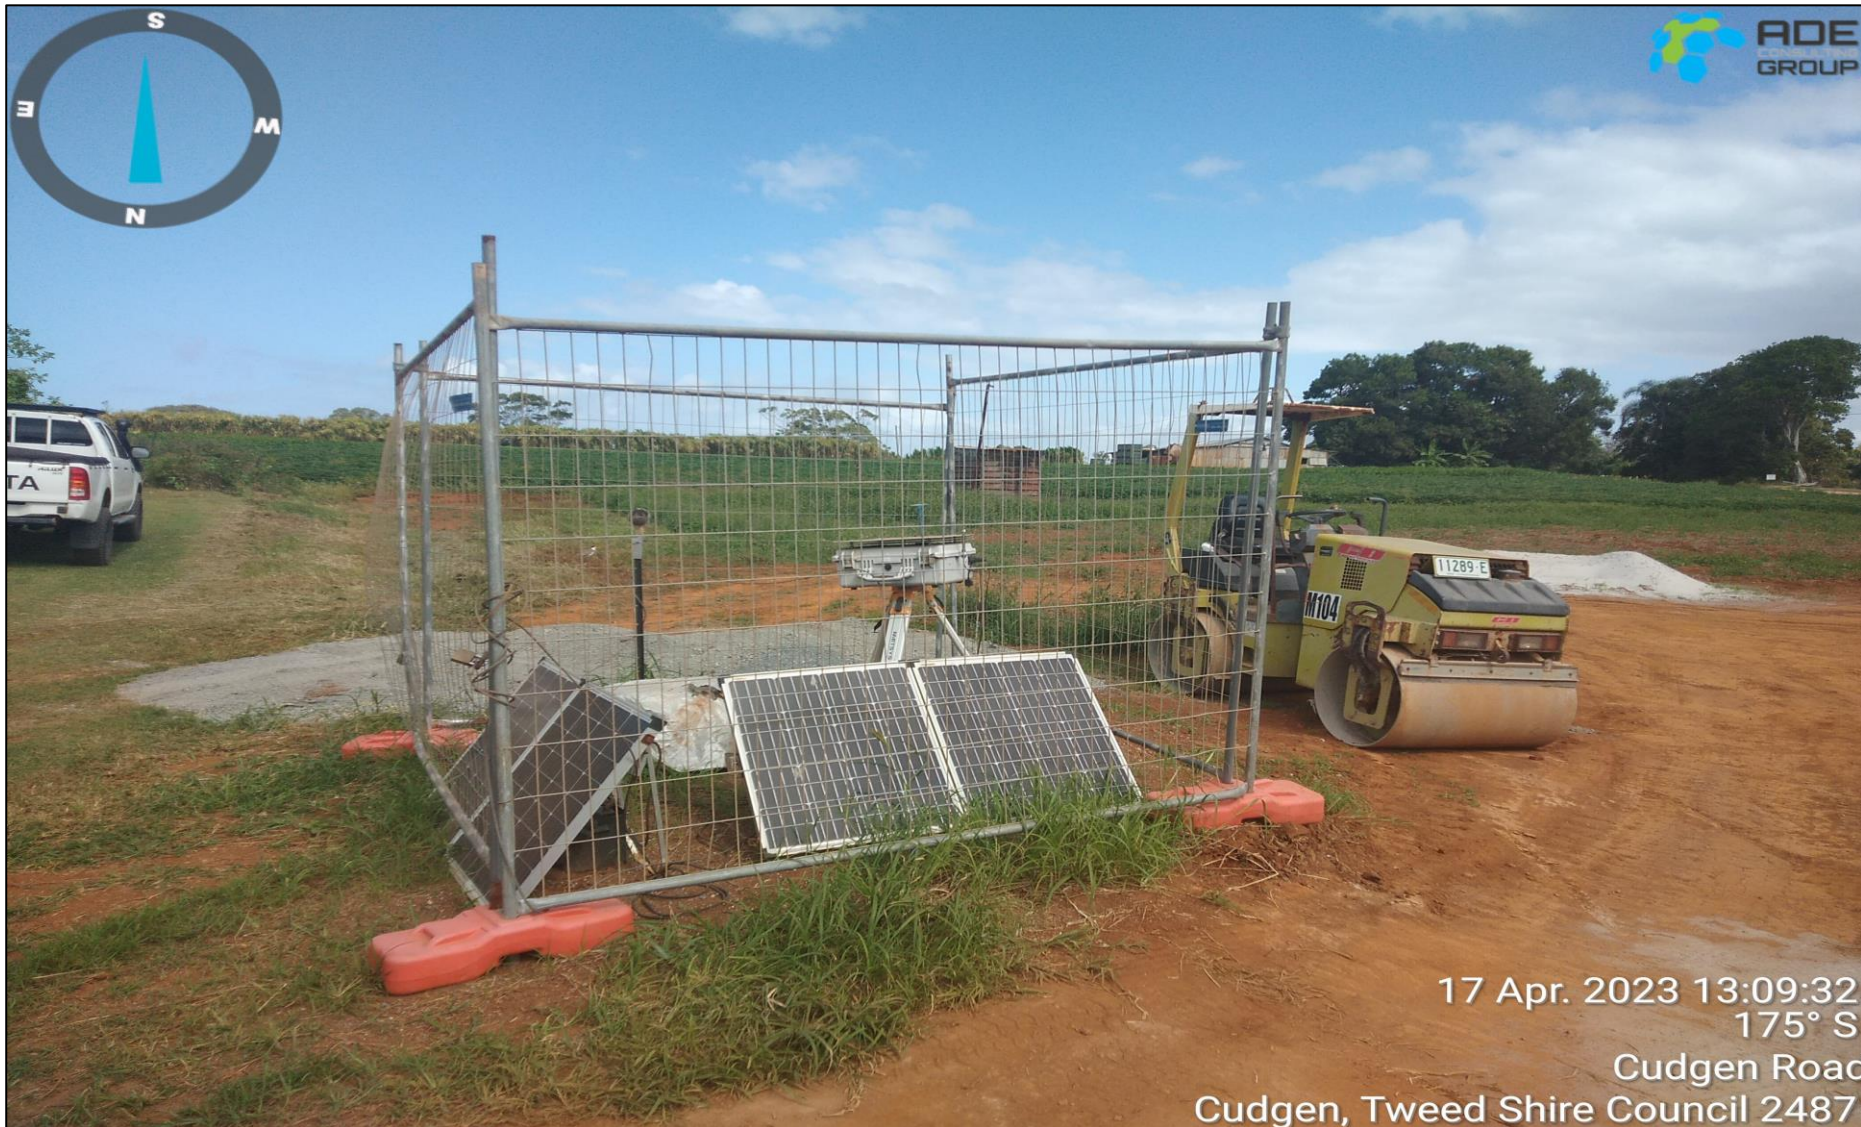
Photograph 1 Representative photograph of monitoring location 007 – Residential, as observed 17/04/2023

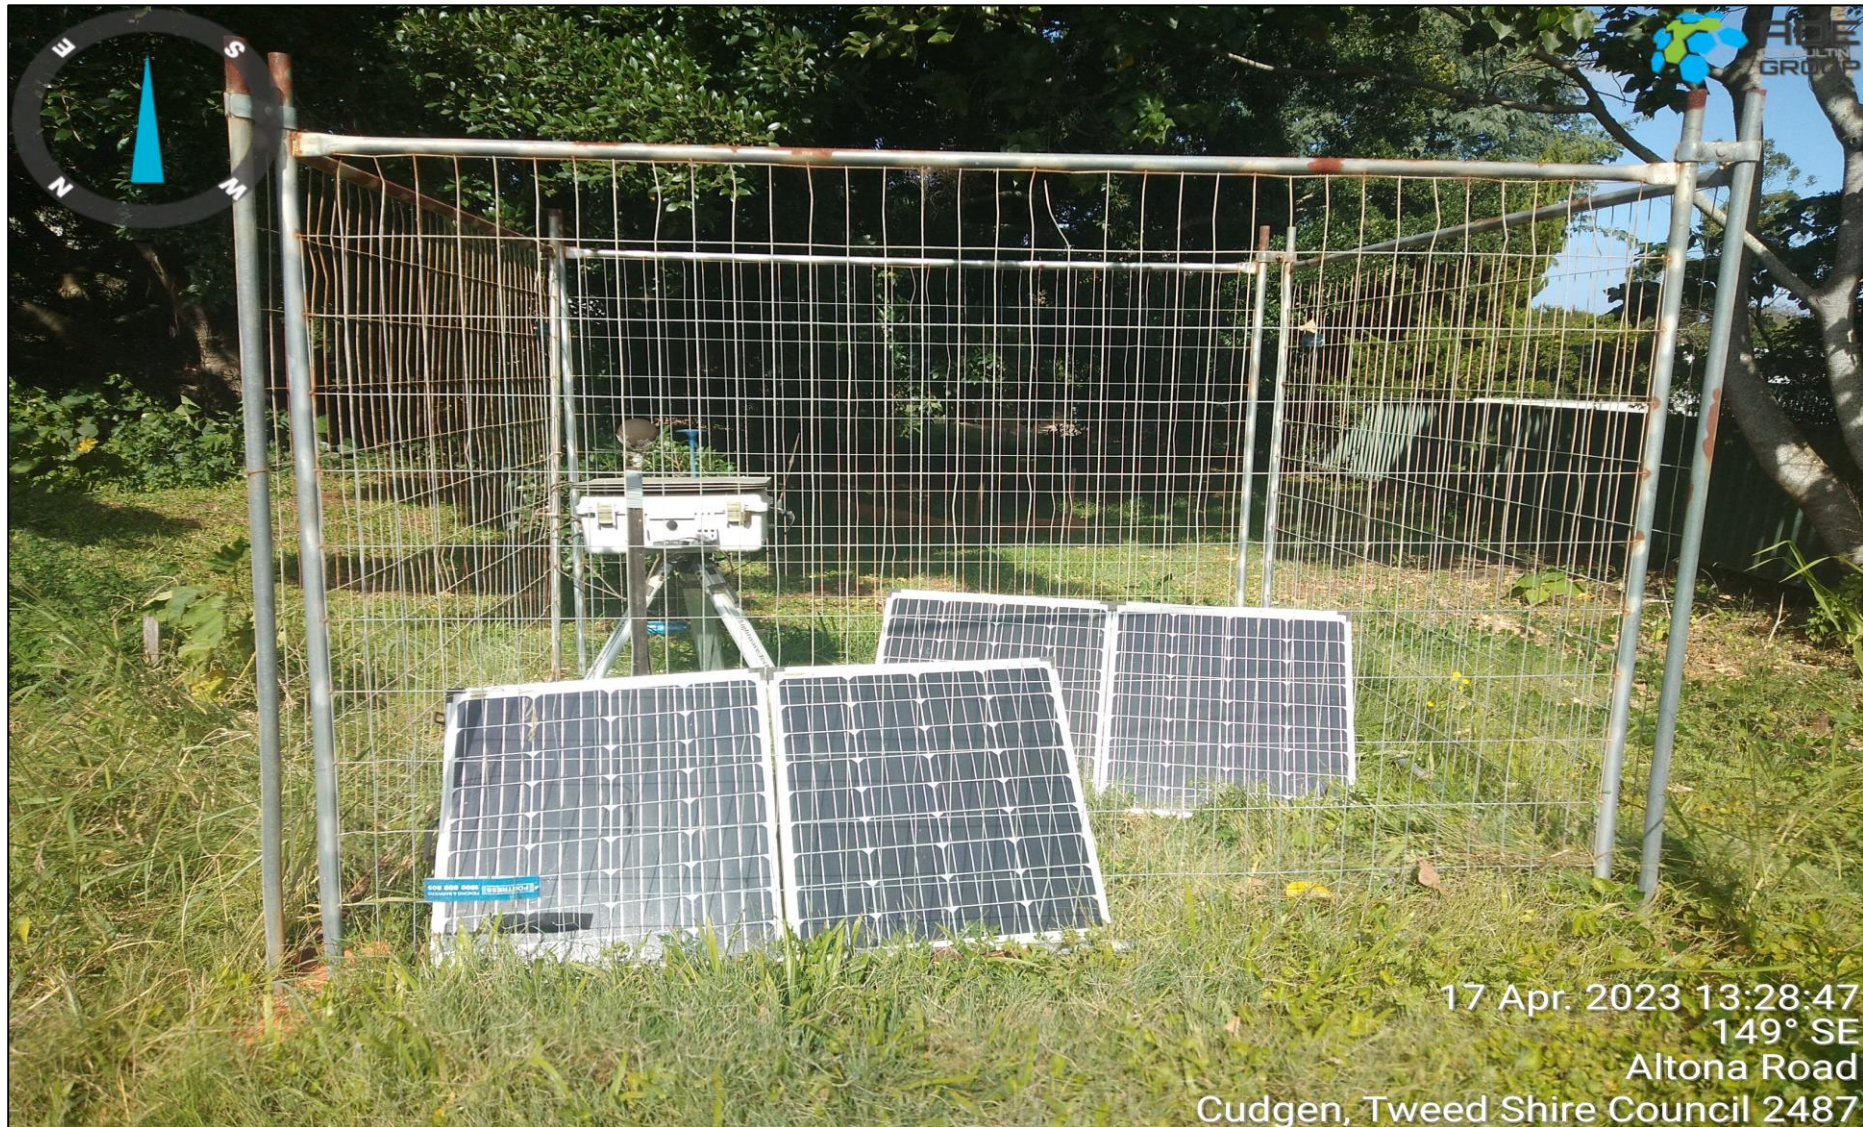
Photograph 2 Representative photograph of monitoring location 005 – Solar Industry, as observed 17/04/2023

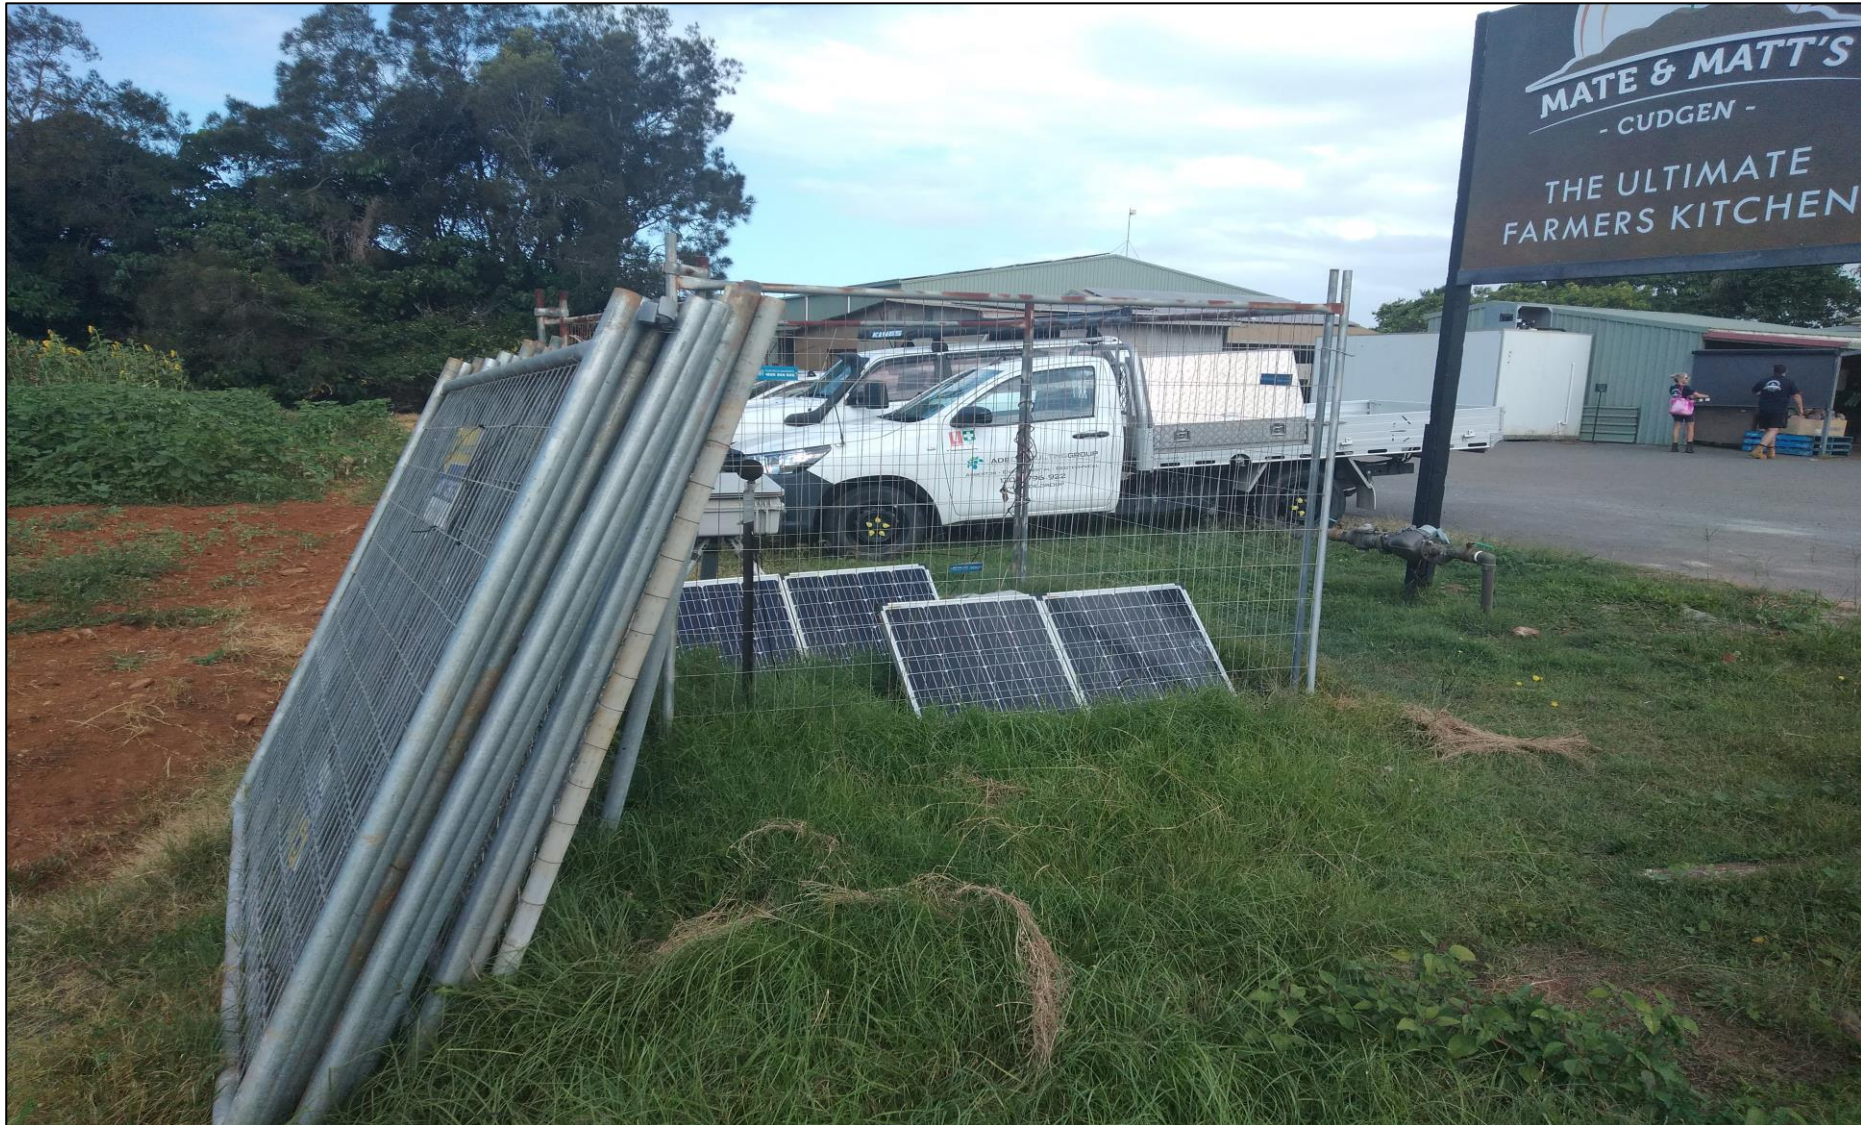
Photograph 3 Representative photograph of monitoring location 006 – Mate and Matts, as observed 17/04/2023
