# Vibration Monitoring Assessment Report (July 2022)

**Tweed Valley Hospital Project, Cudgen NSW**

Prepared for: Lendlease Building Pty Ltd

A101021.0286.00 | VIB36.Rev0 | Date: 18/08/2022

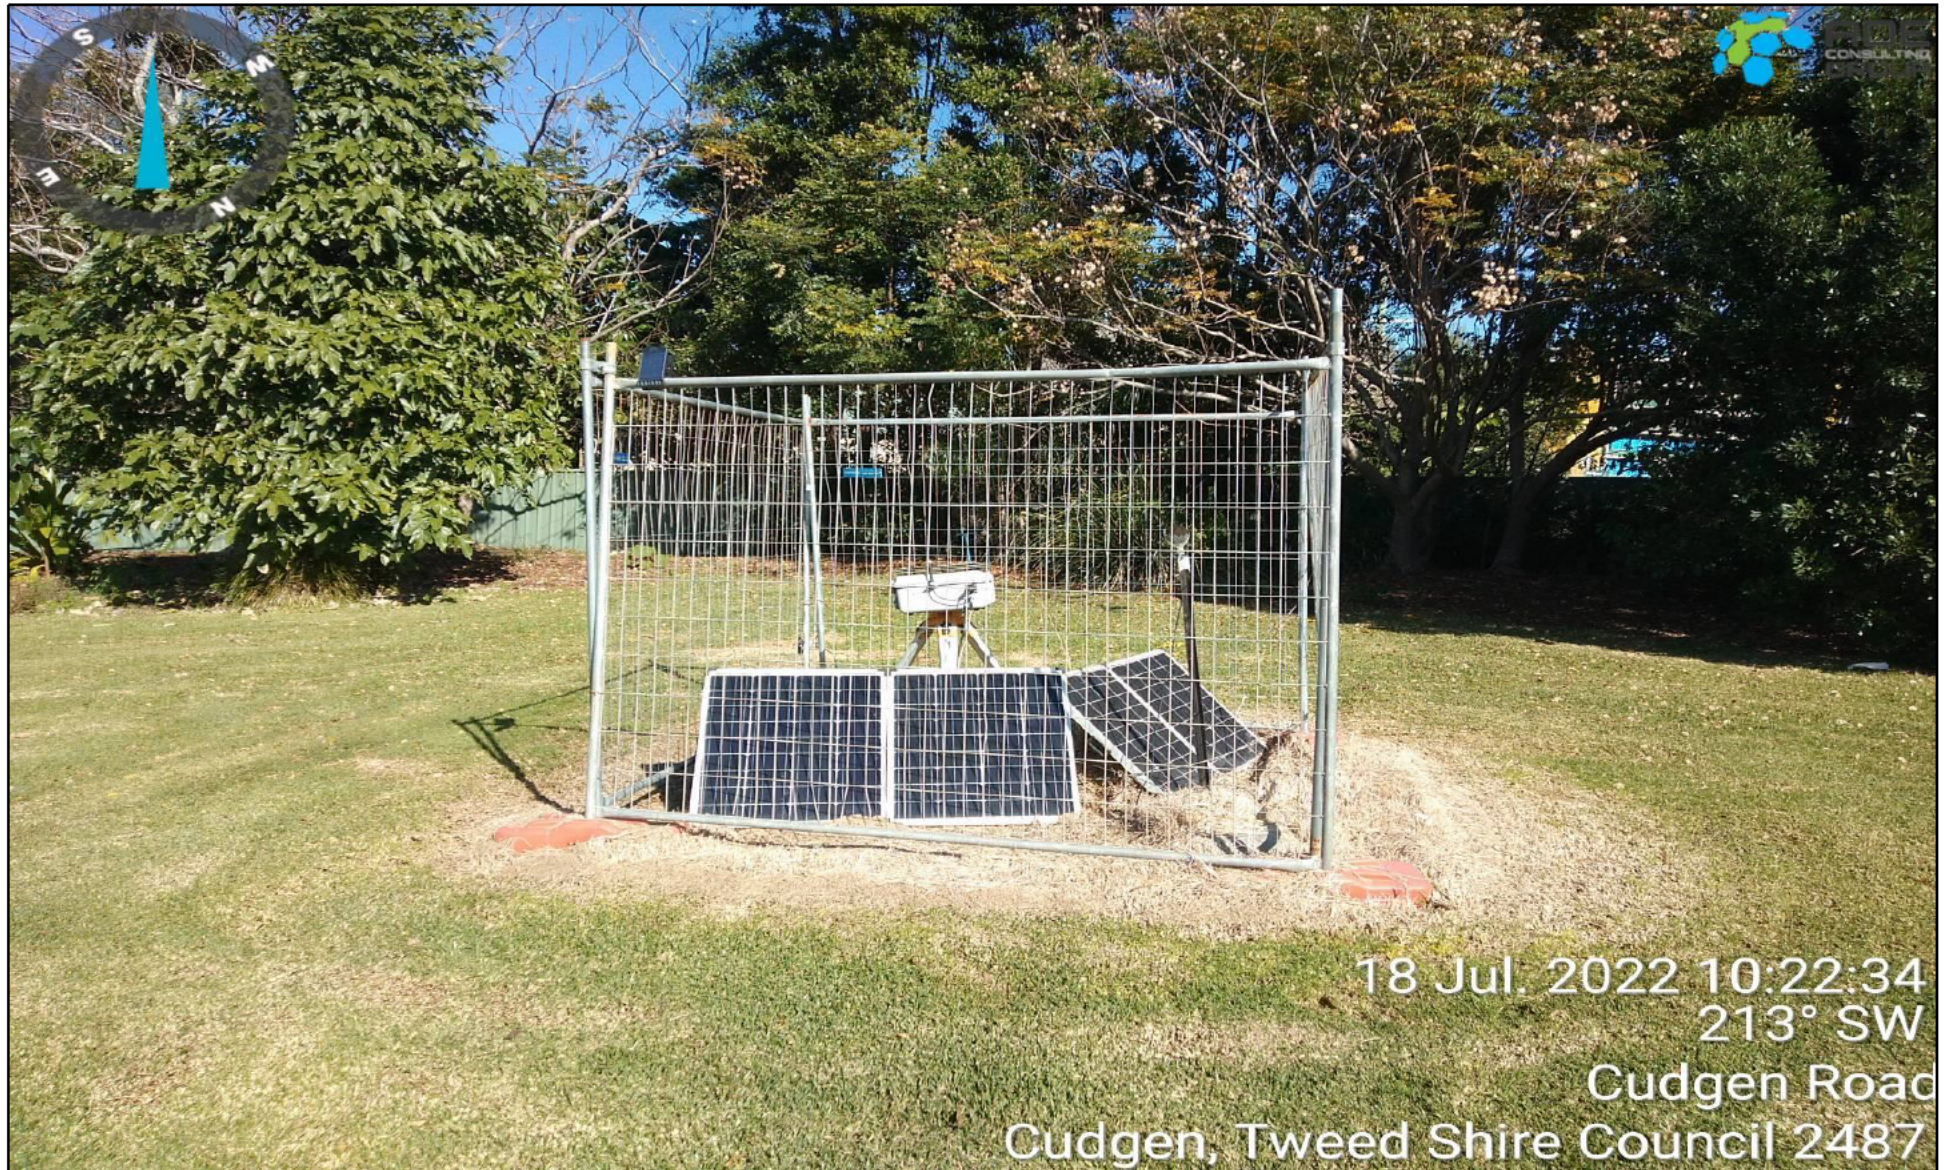
Photograph 1 Representative photograph of monitoring location 004 – TAFE East, as observed 18/07/2022

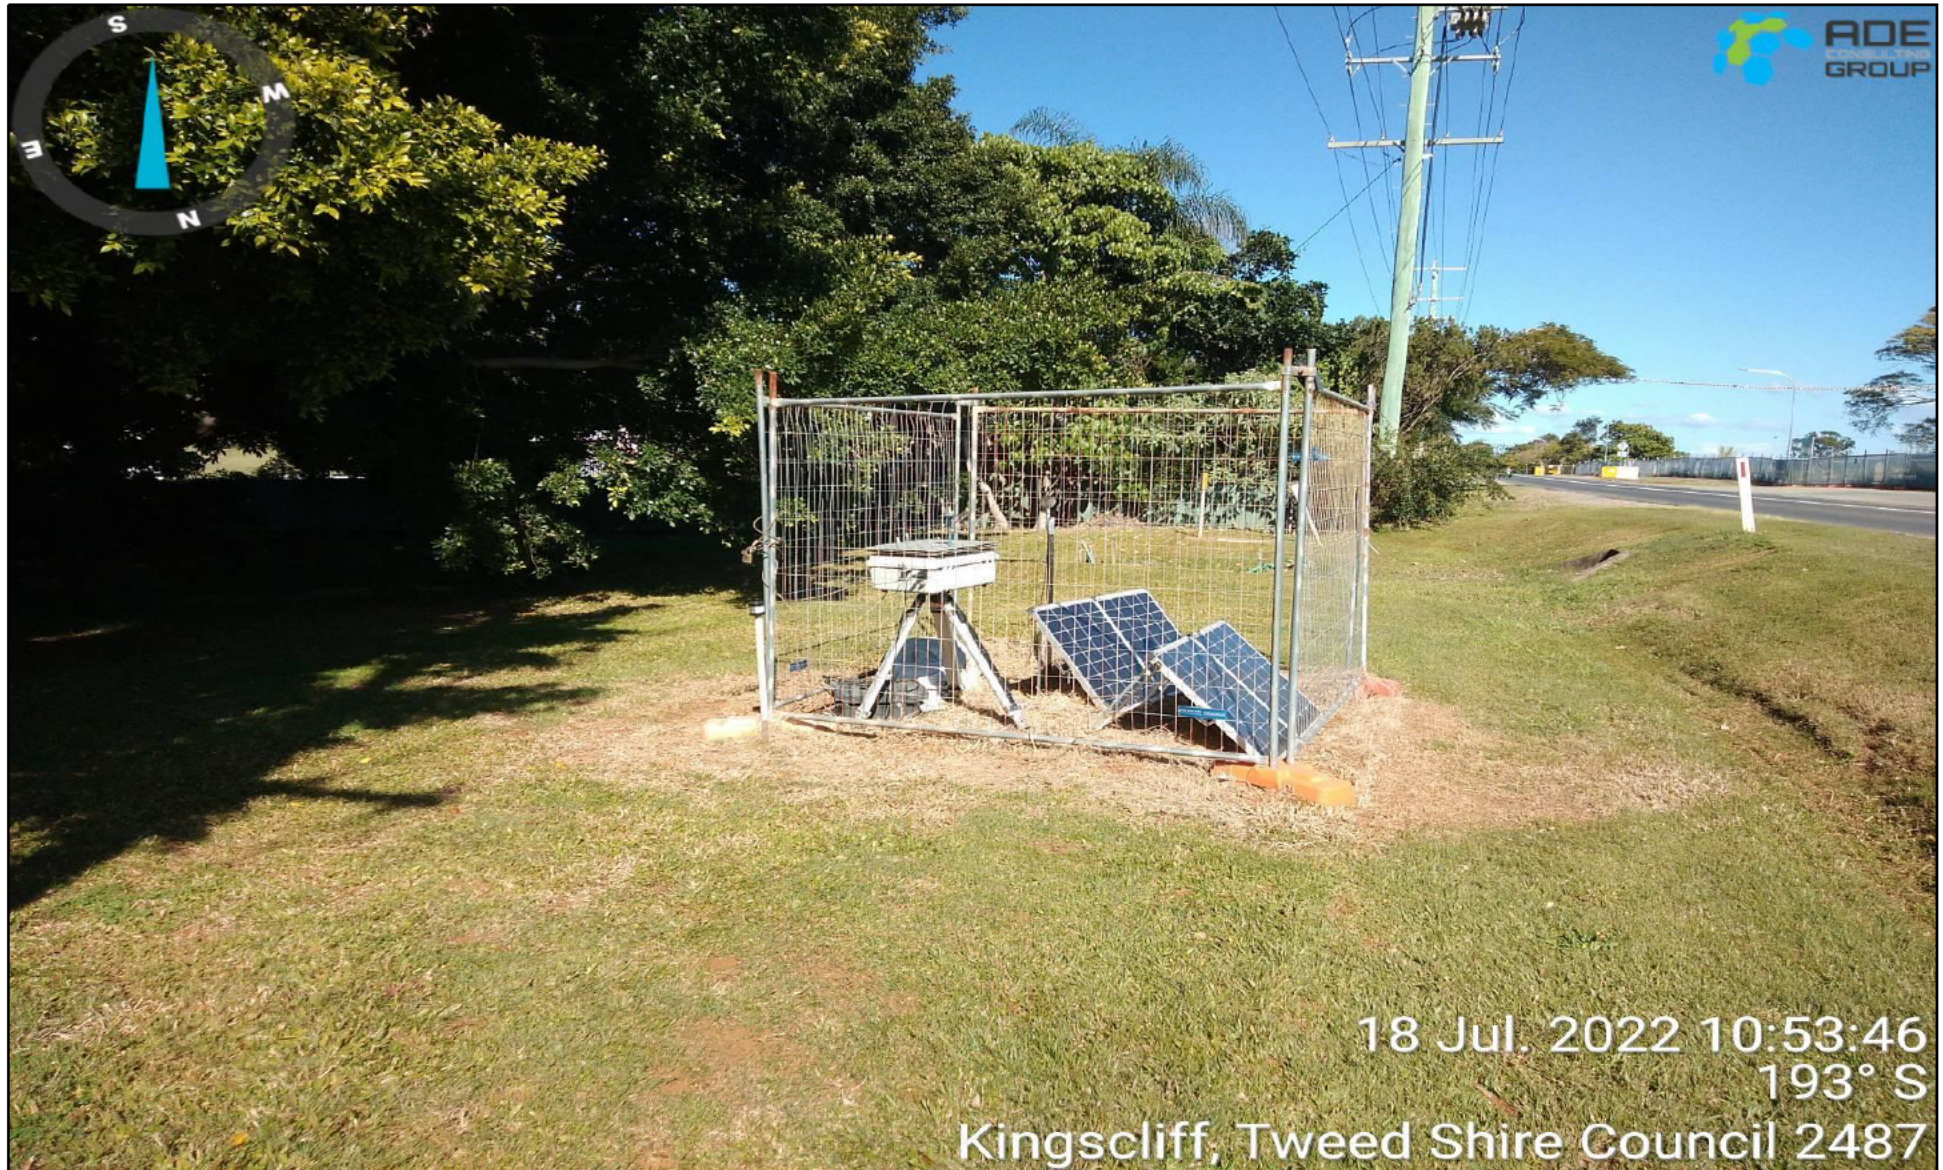
Photograph 2 Representative photograph of monitoring location 005 – TAFE West, as observed 18/07/2022

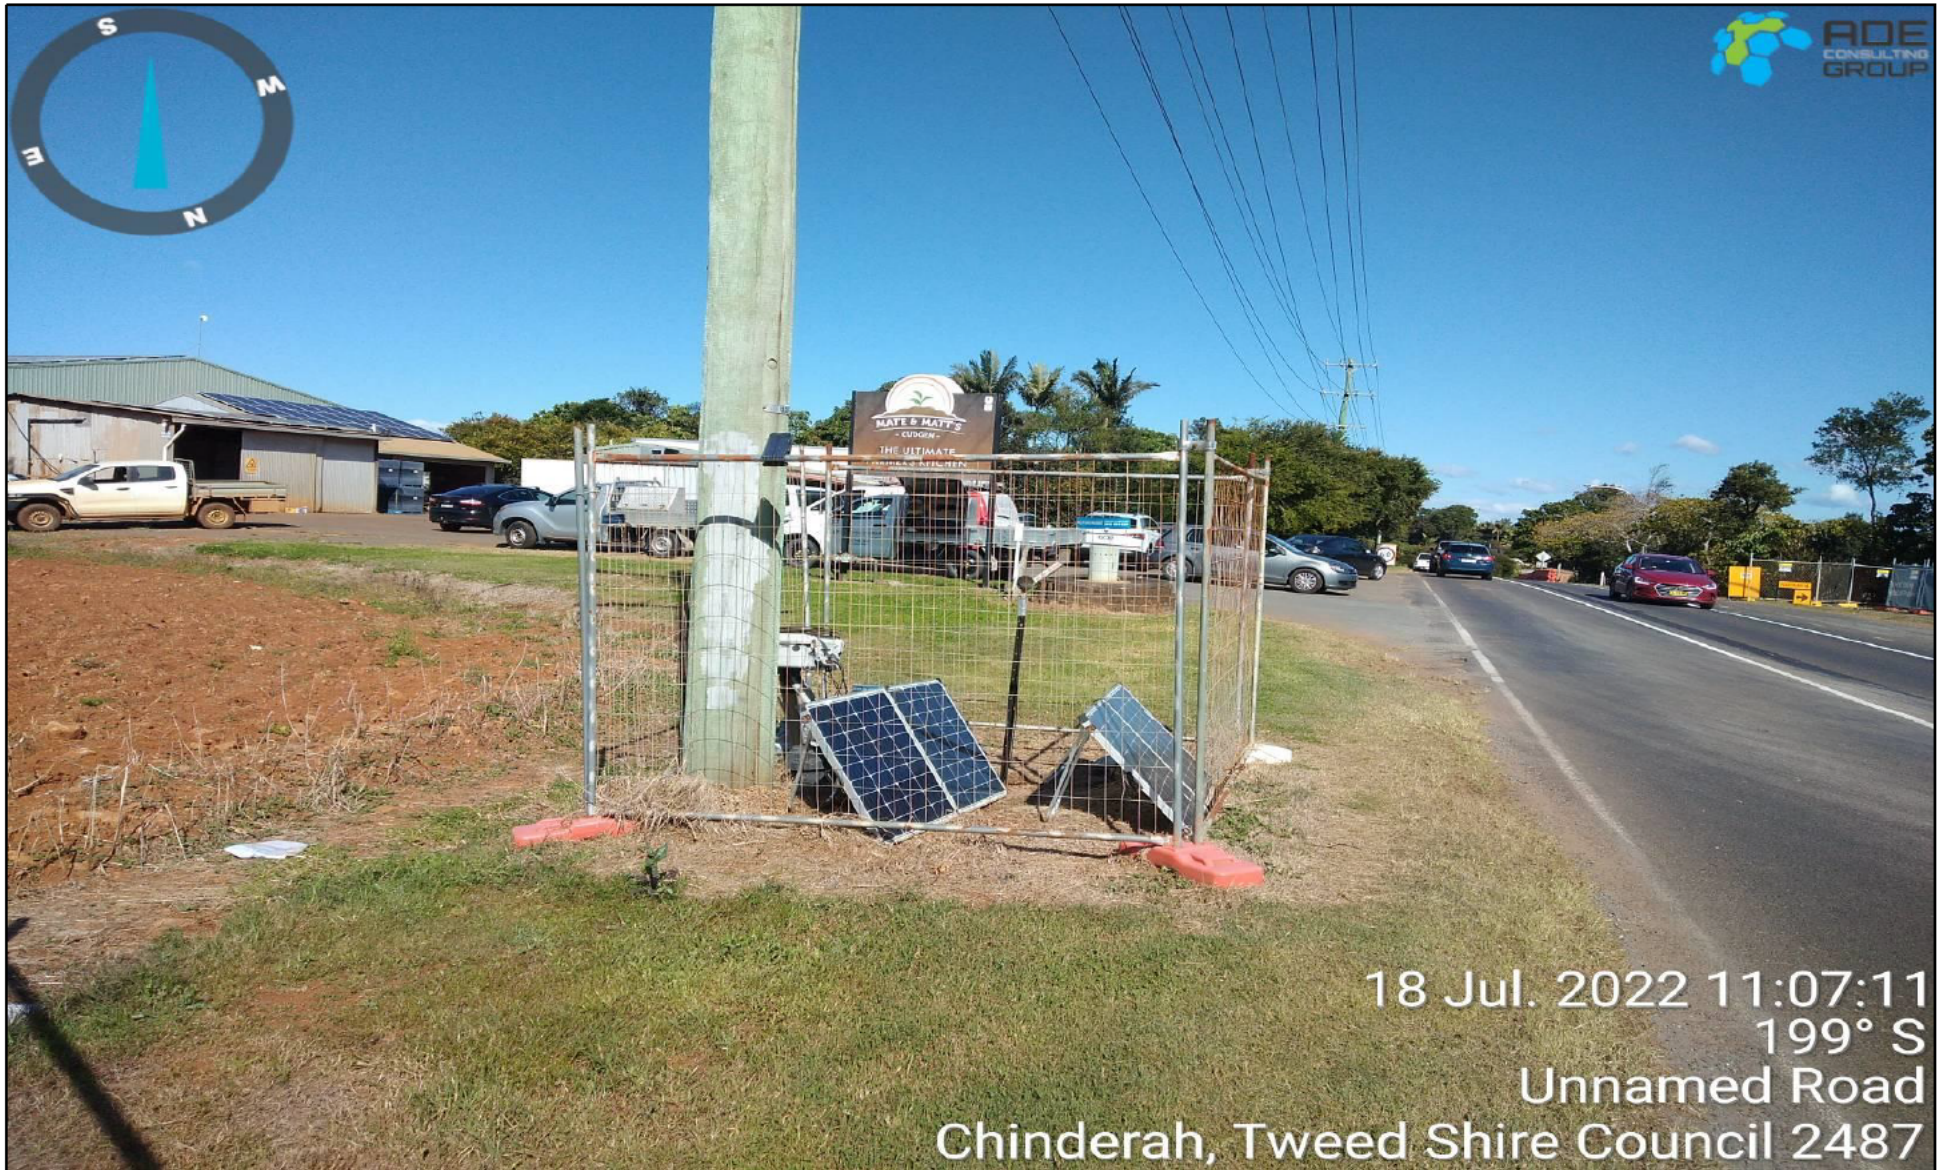
Photograph 3 Representative photograph of monitoring location 006 – Mate and Matts, as observed 18/07/2022
