# Vibration Monitoring Assessment Report (May 2022)

**Tweed Valley Hospital Project, Cudgen NSW**

Prepared for: Lendlease Building Pty Ltd

A101021.0286.00 | VIB34.Rev0 | Date: 7/06/2022

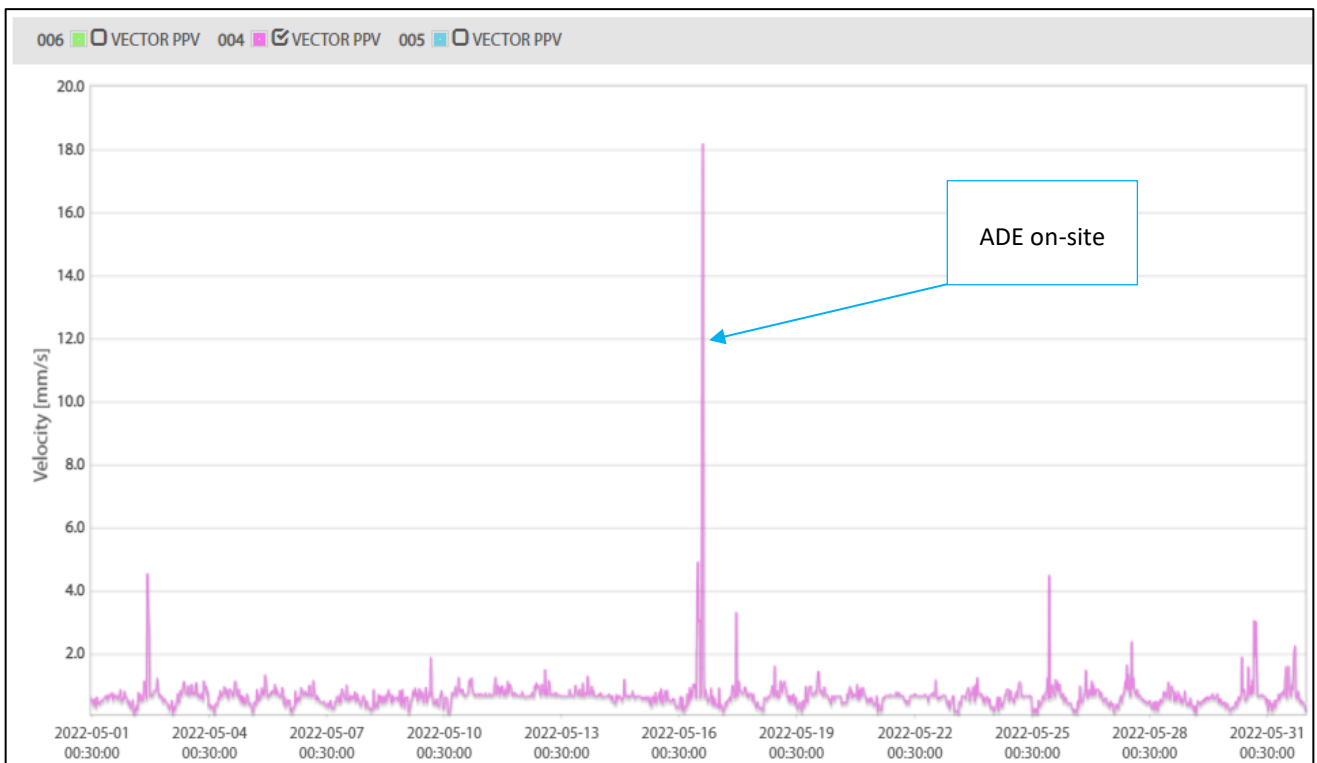
Data measured at location 004 is presented below in **Figure 1**.

**Figure 1.** Vibration data at location 004 | TAFE East | May 2022

During the monitoring period (May 2022) no exceedance of DIN 4150 Line 1 or Line 2 PPV guideline values was observed. The results presented in Figures 1 – 3 do not include a distance correction.

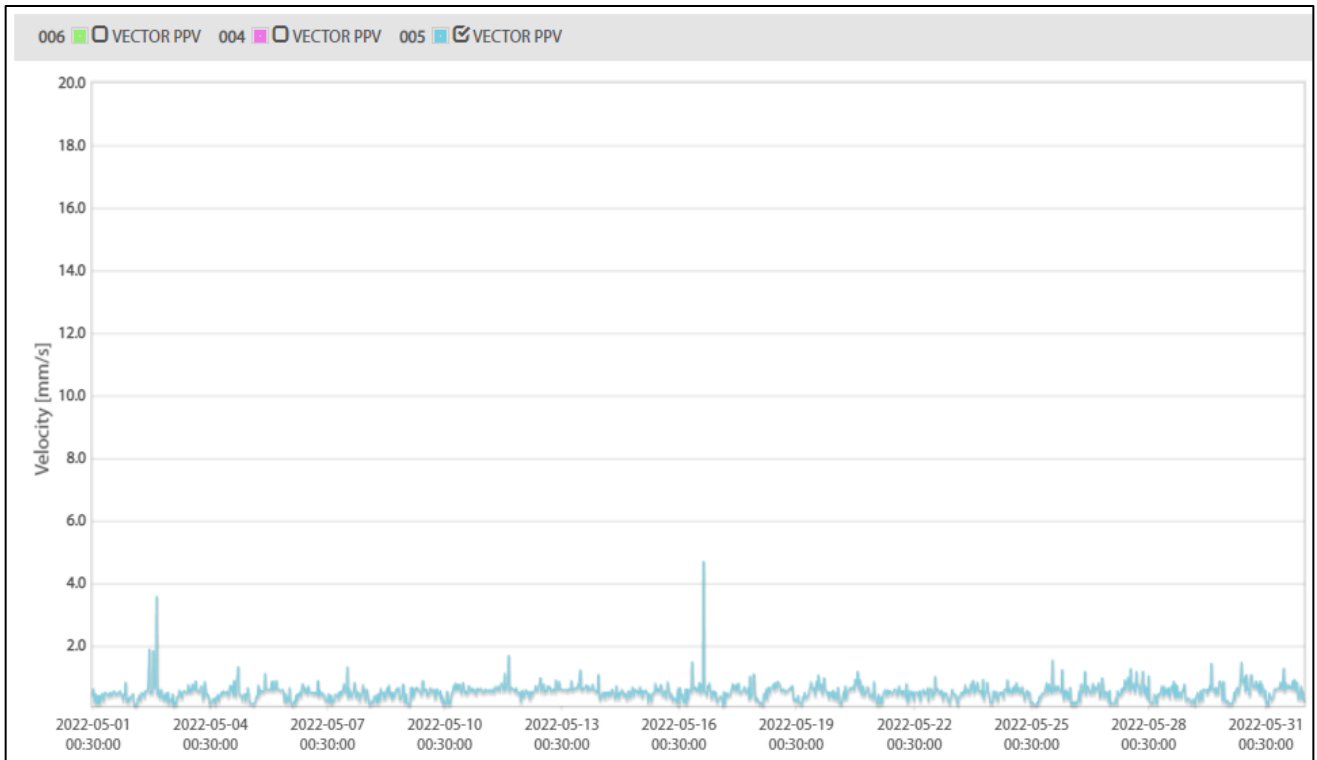
Data measured at location 005 is presented below in **Figure 2**.

**Figure 2.** Vibration data at location 005 | TAFE West | **May 2022**

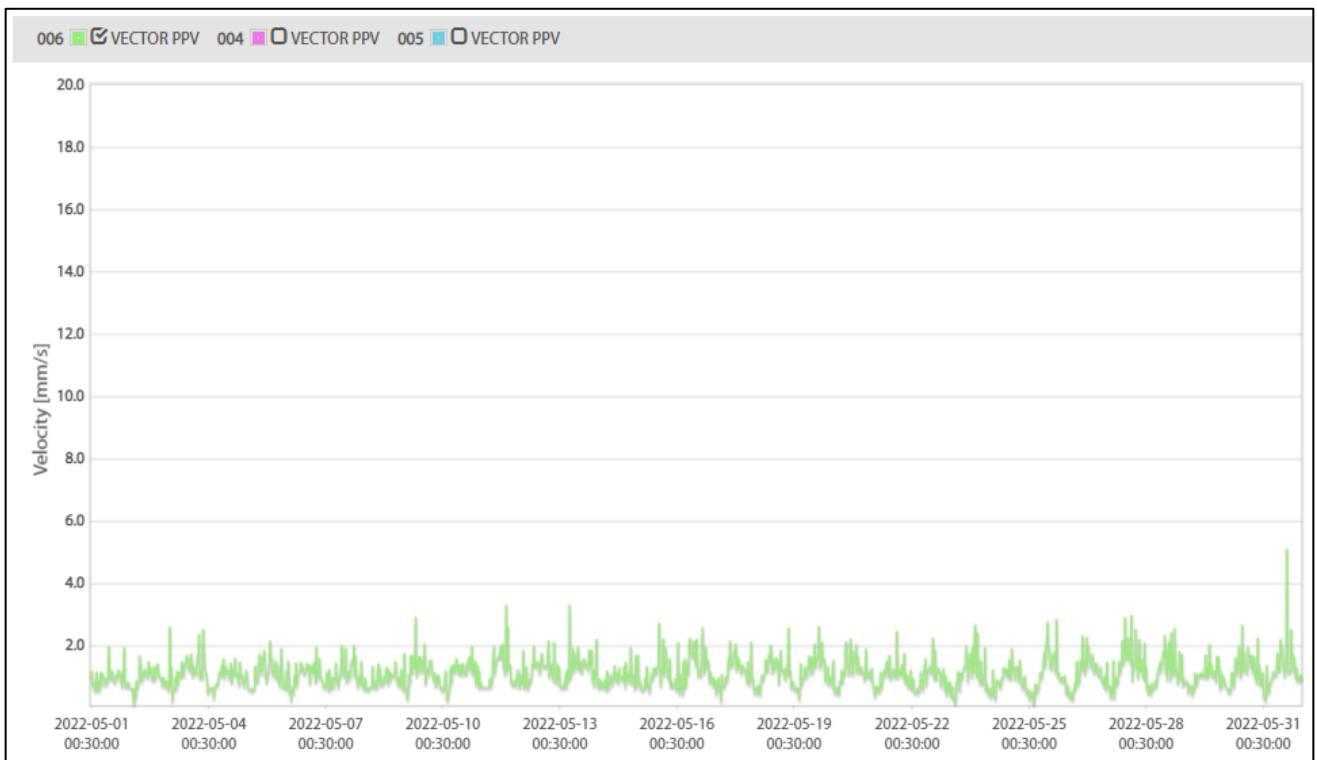
Data measured at location 006 is presented below in **Figure 3**.

**Figure 3.** Vibration data at location 006 | Mate and Matt's | **May 2022**

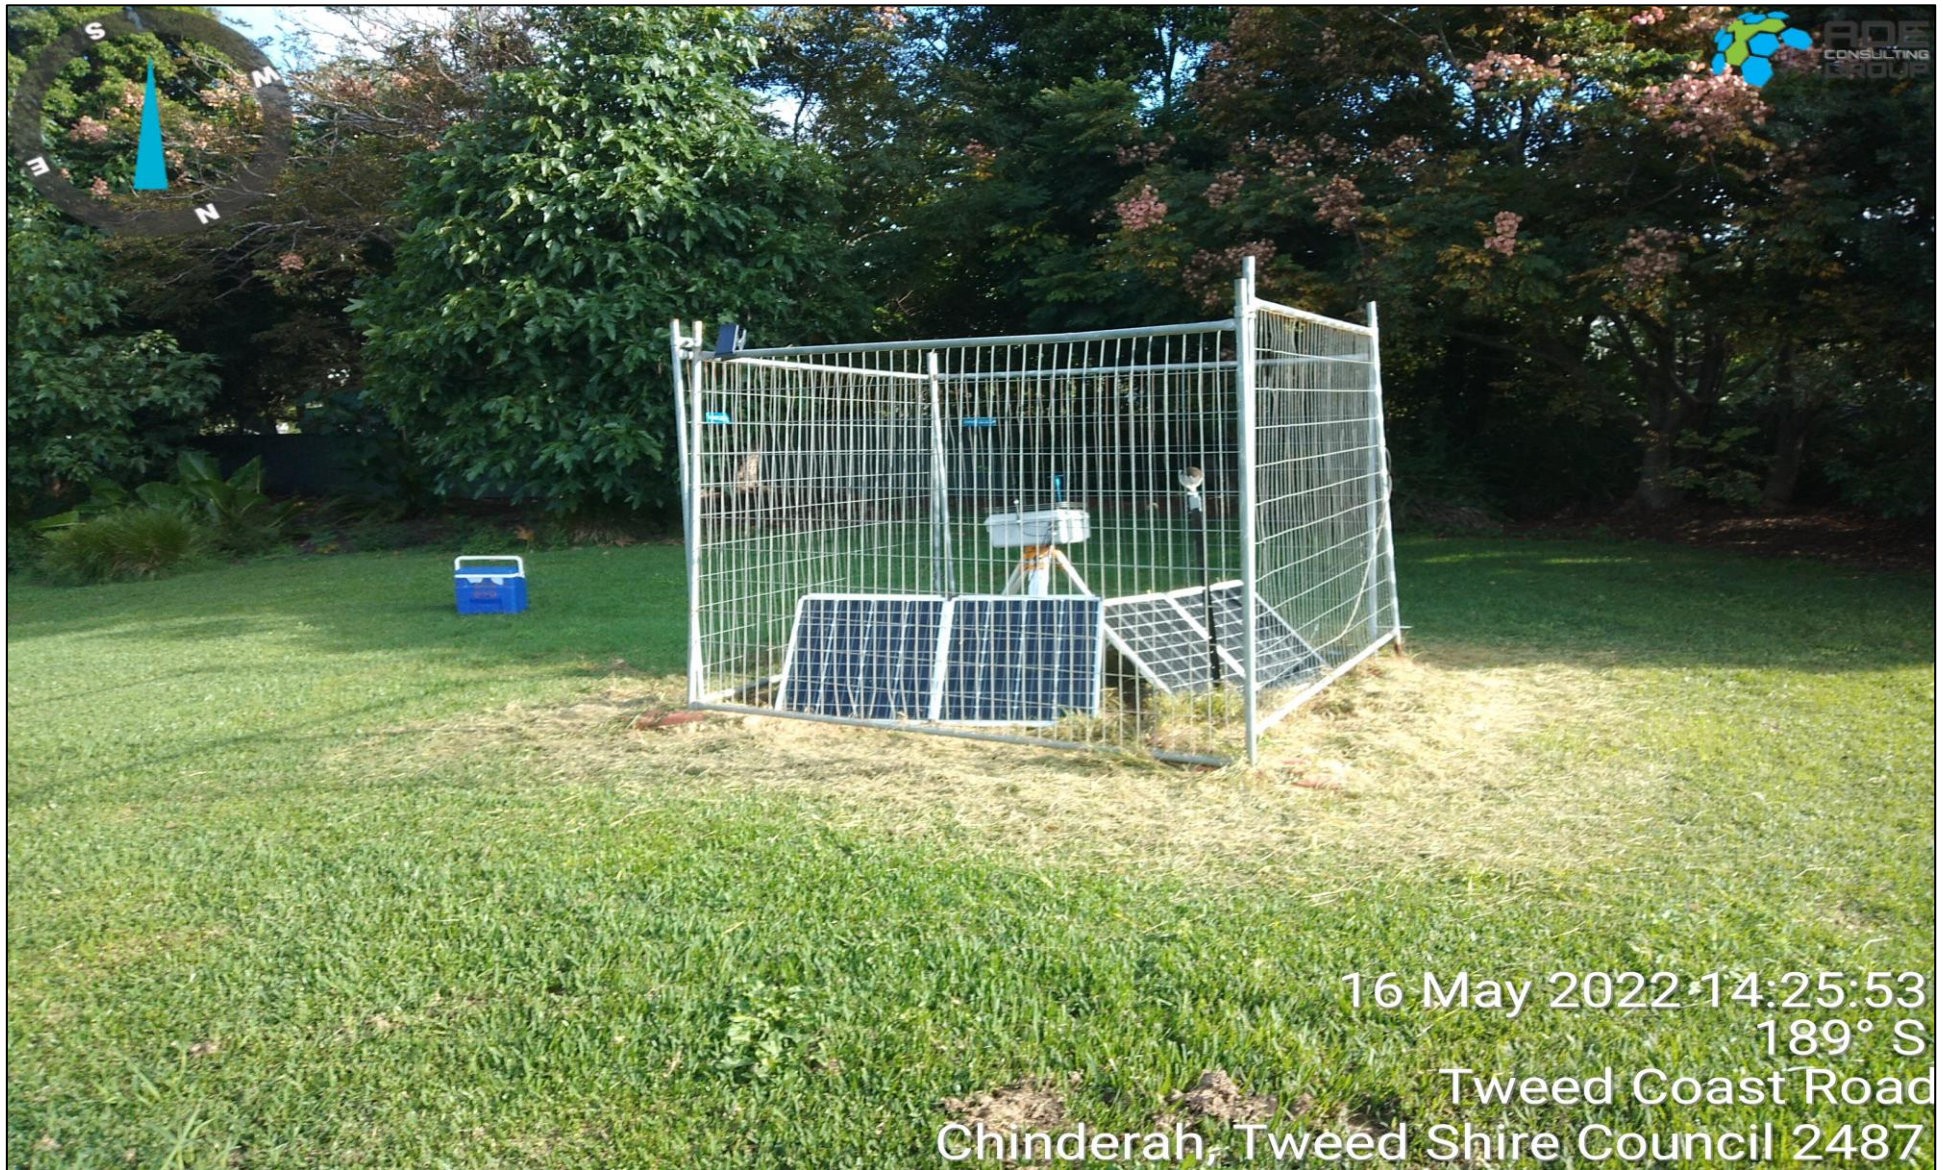
Photograph 1 Representative photograph of monitoring location 004 – TAFE East, as observed 16/05/2022

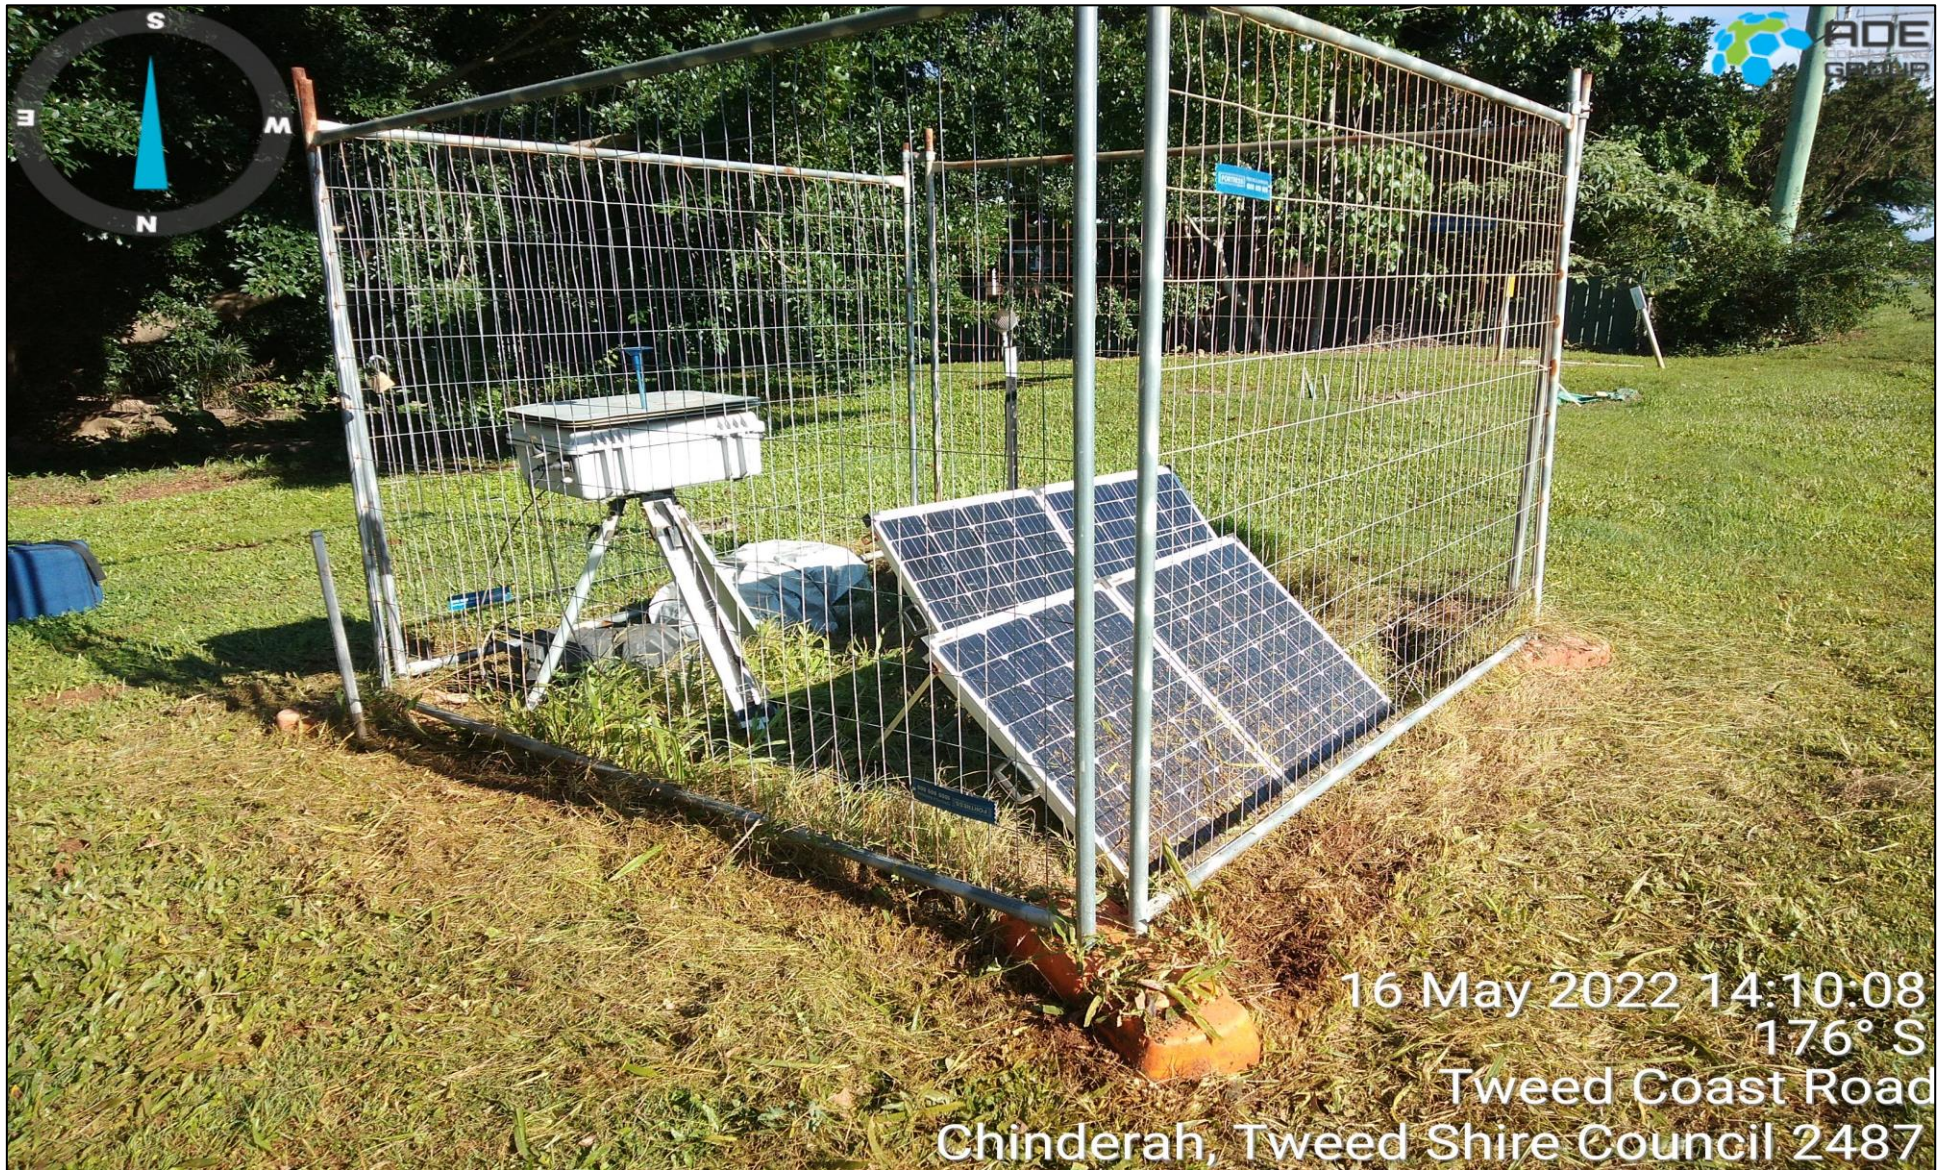
Photograph 2 Representative photograph of monitoring location 005 – TAFE West, as observed 16/05/2022

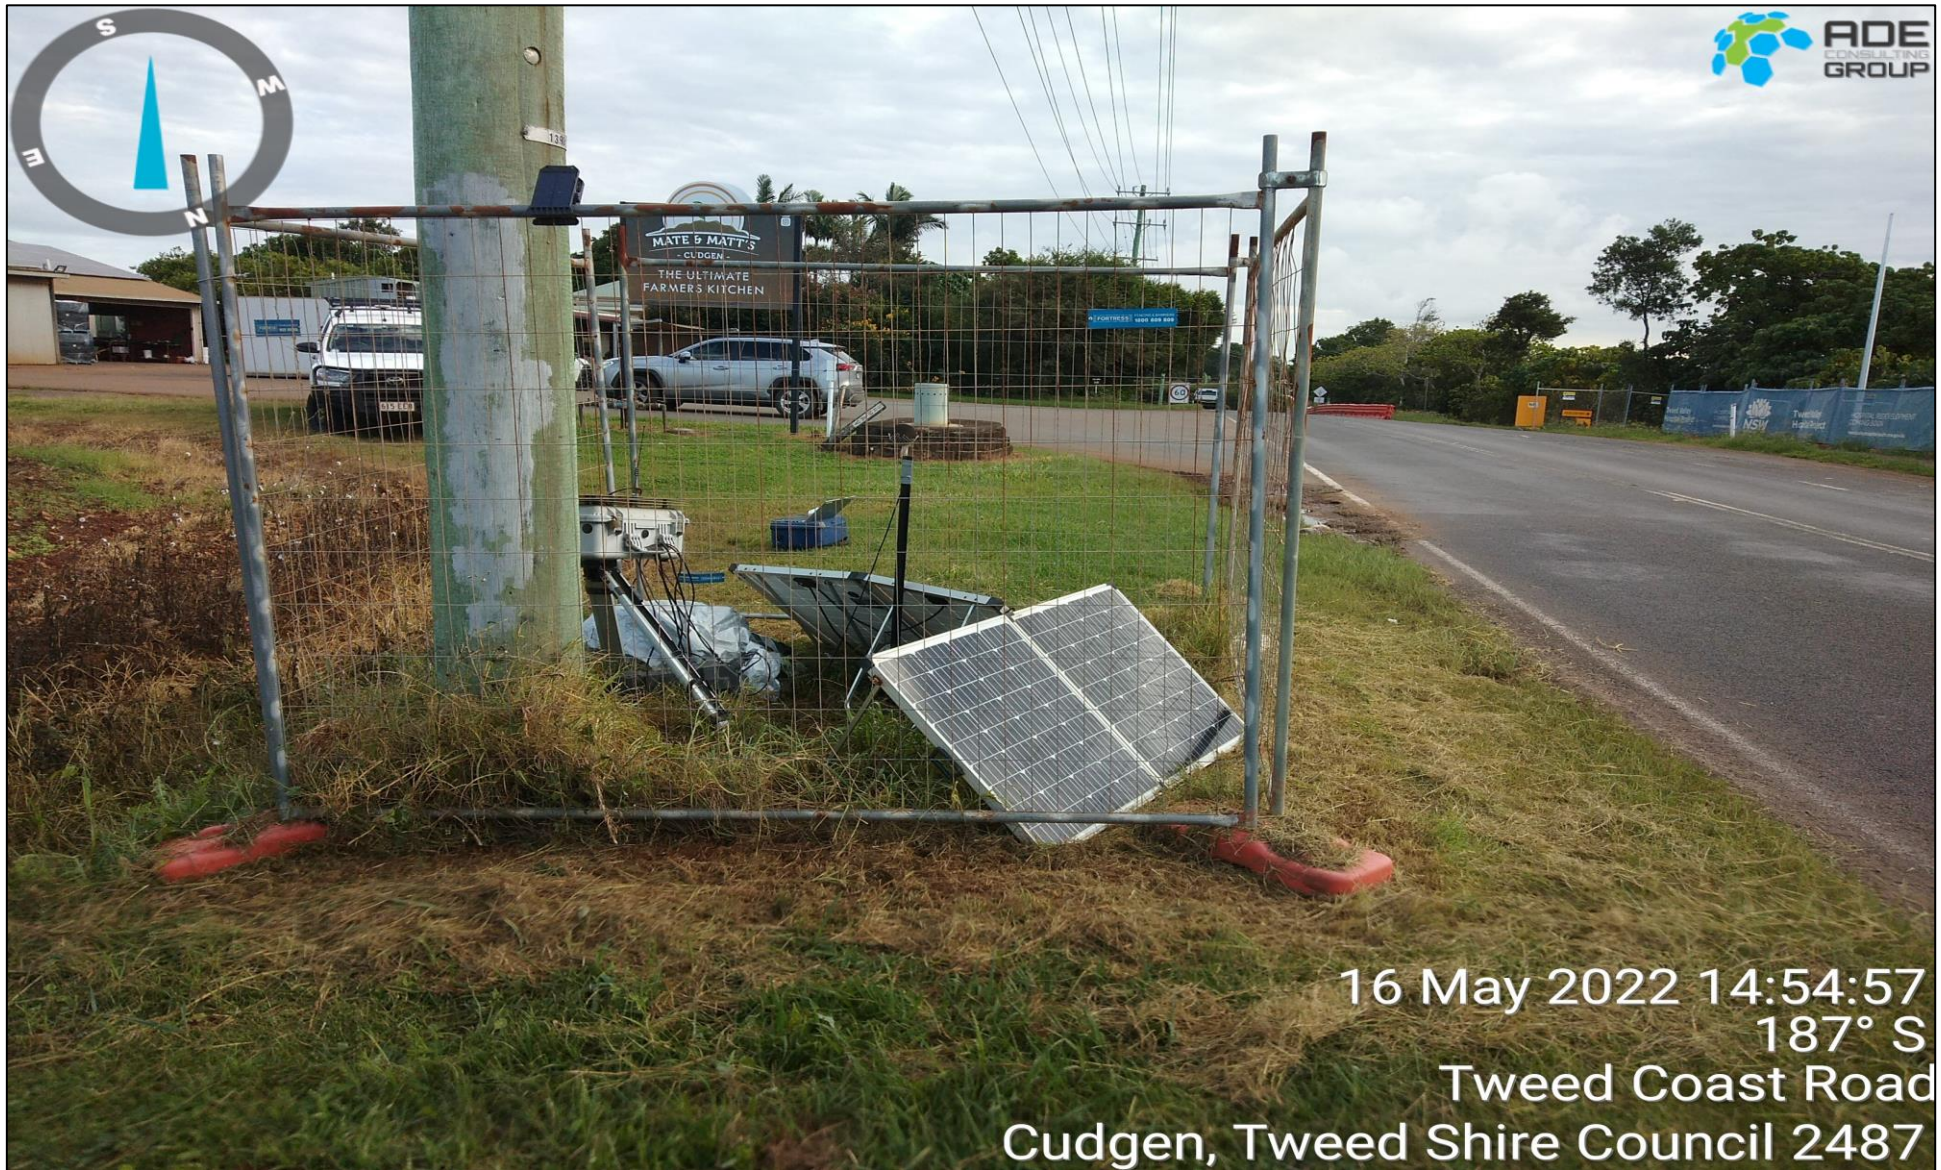
Photograph 3 Representative photograph of monitoring location 006 – Mate and Matts, as observed 16/05/2022
