Vibration Monitoring Assessment Report (March 2022)

Tweed Valley Hospital Project, Cudgen NSW

Prepared for: Lendlease Building Pty Ltd

A101021.0286.00 | VIB32.Rev0 | Date: 19/04/2022

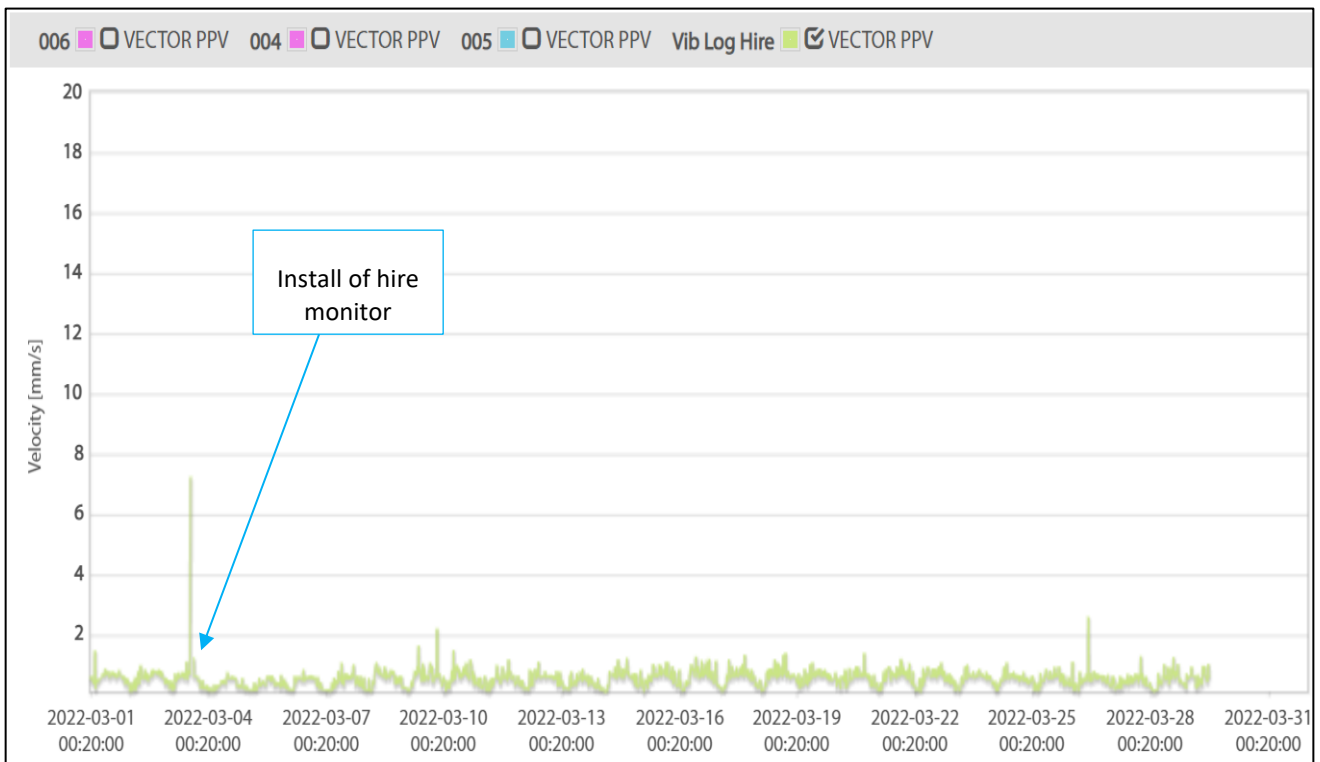
Figure 1. Vibration data at location 004 | TAFE West | 3 – 29 March 2022

Data measured at location 004 is presented below in **Figures 1 and 2**. The top graph represents data recorded on a hire logger from 03.03.2022 – 29.03.2022 while the ADE logger was sent for calibration. The ADE logger was reinstalled on site on 29.02.2022 and the results from 01.03.2022 – 03.03.2022 and from 29.03.2022 – 31.03.2022 can be seen in the bottom graph.

During the monitoring period (March 2022) no exceedance of DIN 4150 Line 1 or Line 2 PPV guideline values was observed. The results presented in Figures 1 – 5 do not include a distance correction.

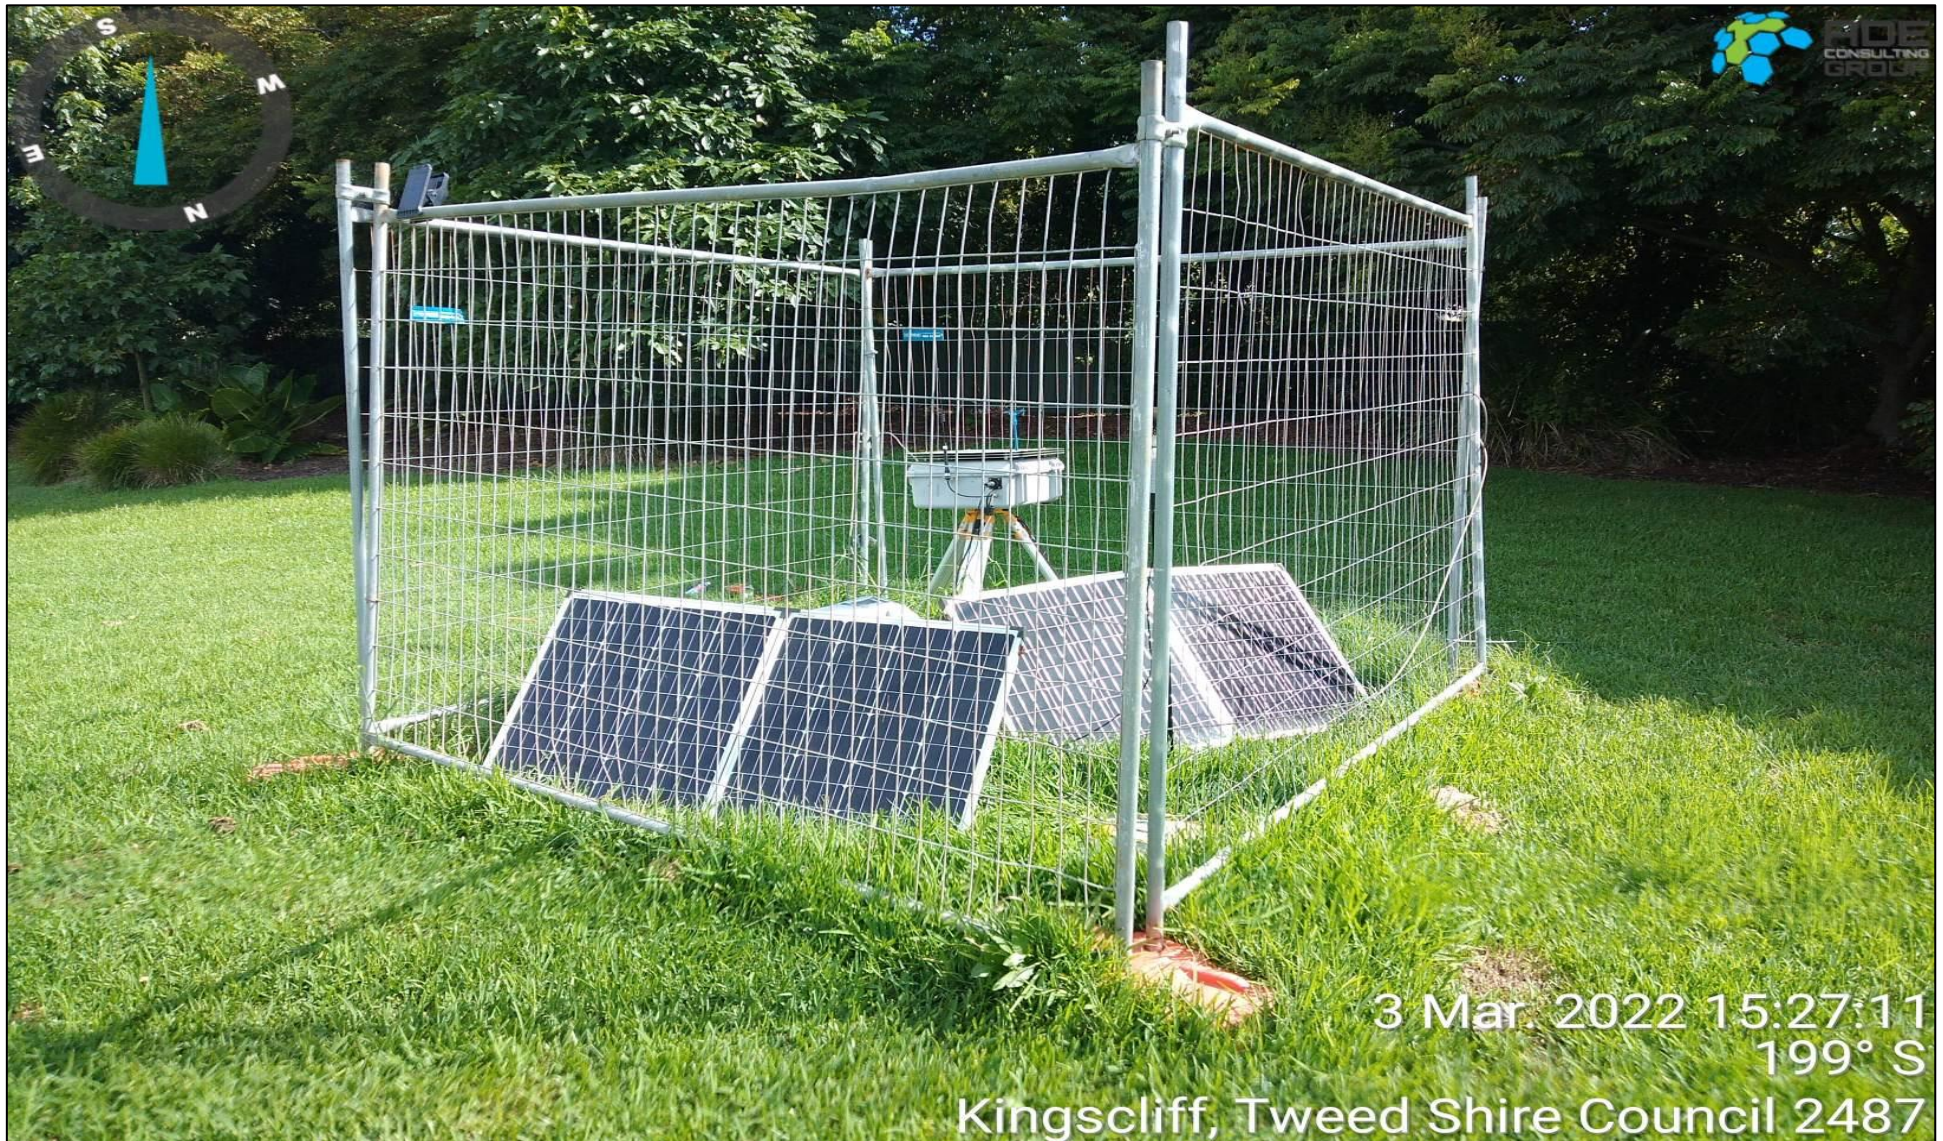
Photograph 1 Representative photograph of monitoring location 004 – TAFE East, as observed 03/03/2022

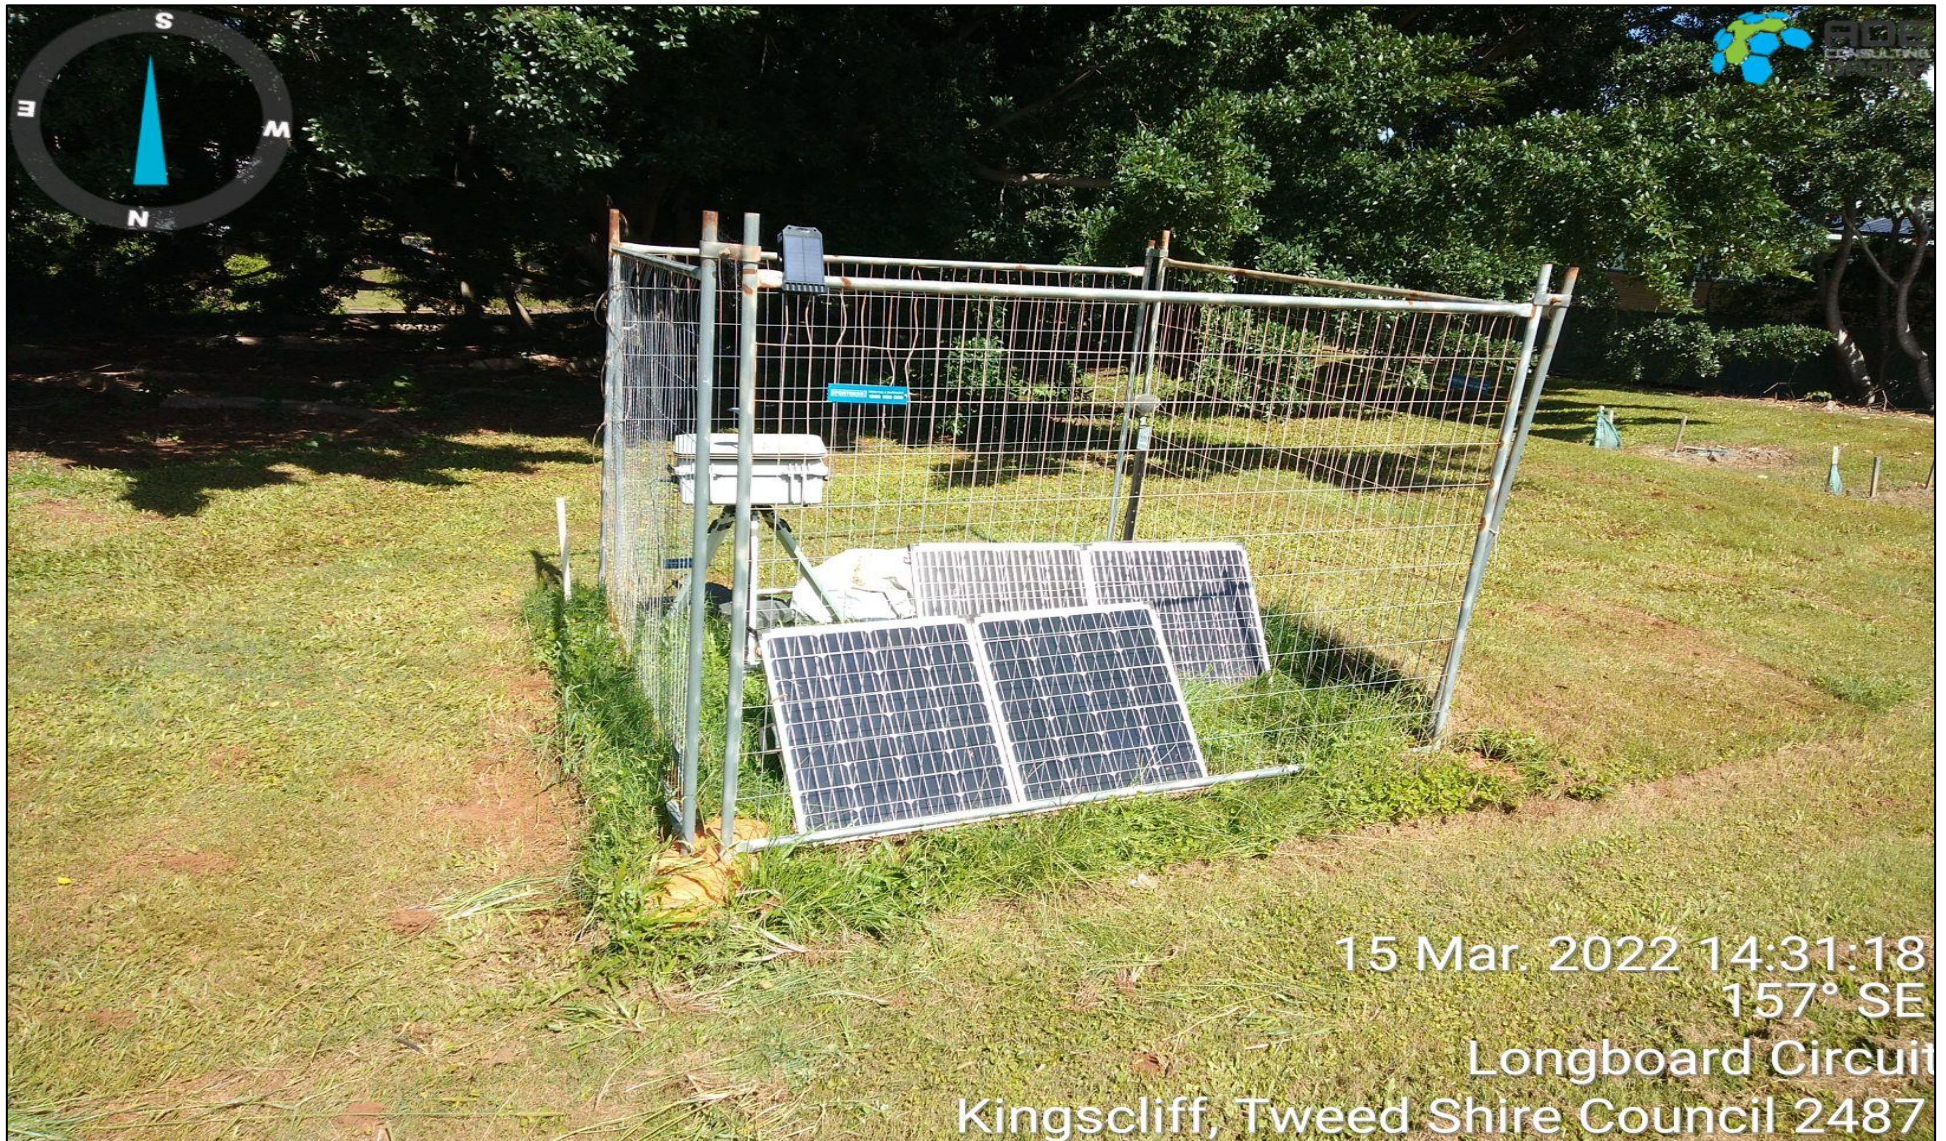
Photograph 2 Representative photograph of monitoring location 005 – TAFE West, as observed 15/03/2022

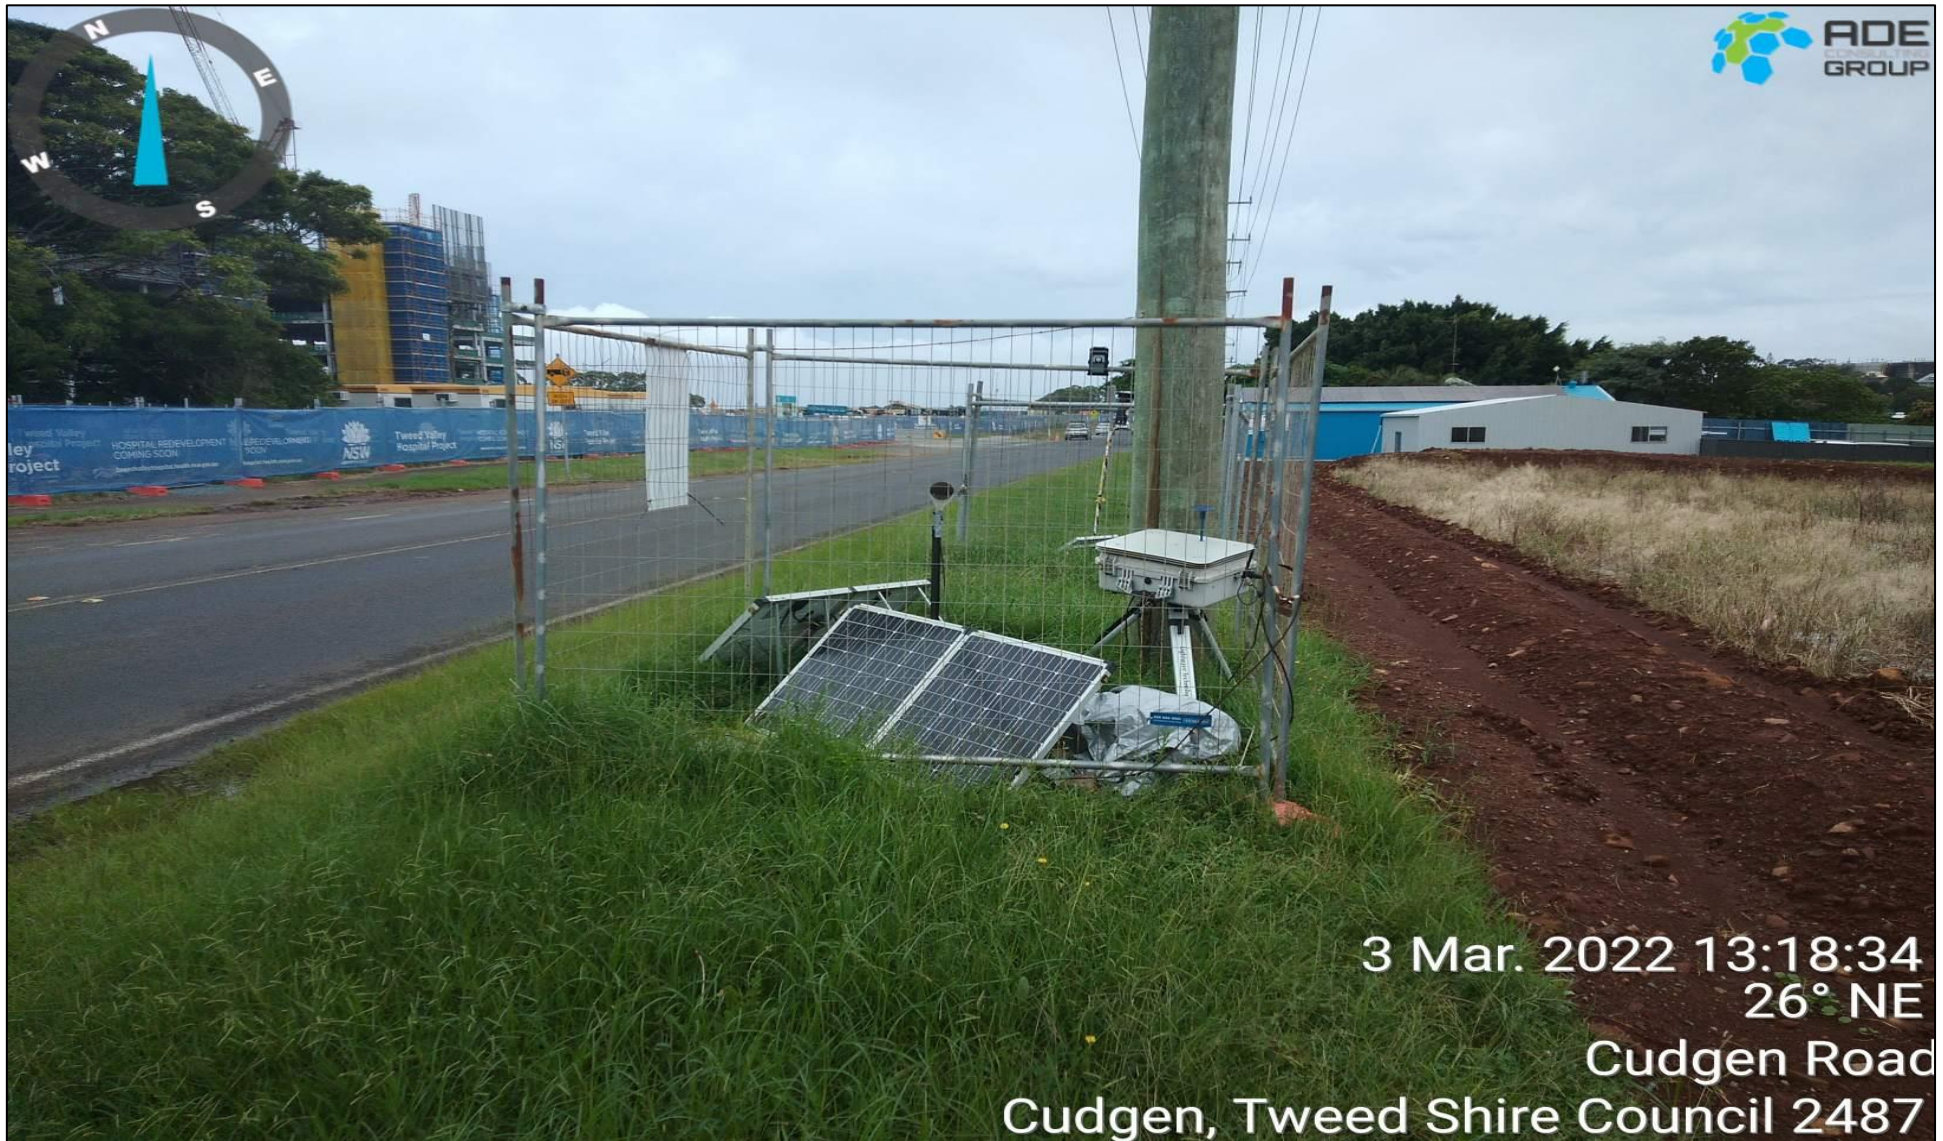
Photograph 3 Representative photograph of monitoring location 006 – Mate and Matts, as observed 03/03/2022
