Vibration Monitoring Assessment Report (June 2022)

Tweed Valley Hospital Project, Cudgen NSW

A101021.0286.00 | VIB35.Rev0 | Date: 21/07/2022

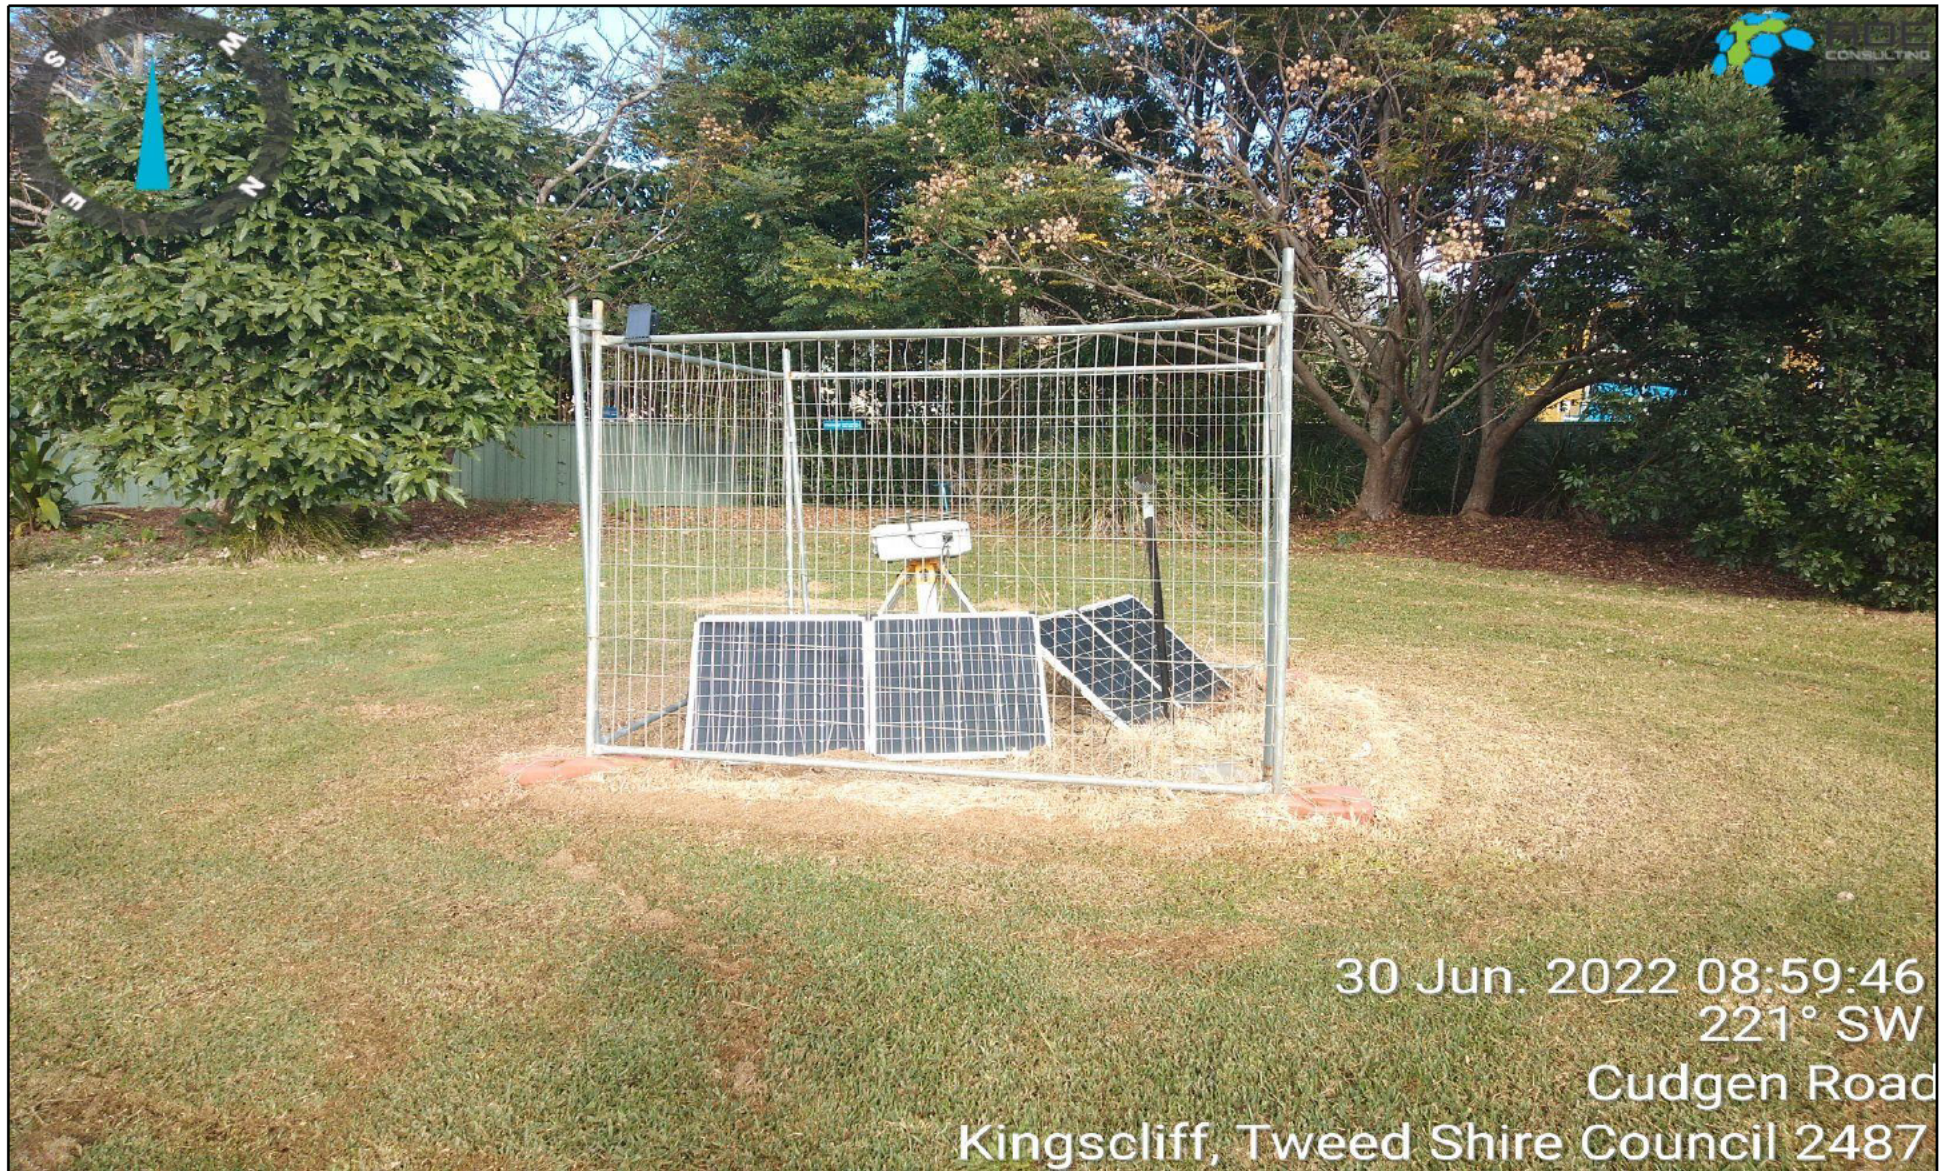
Photograph 1 Representative photograph of monitoring location 004 – TAFE East, as observed 30/06/2022

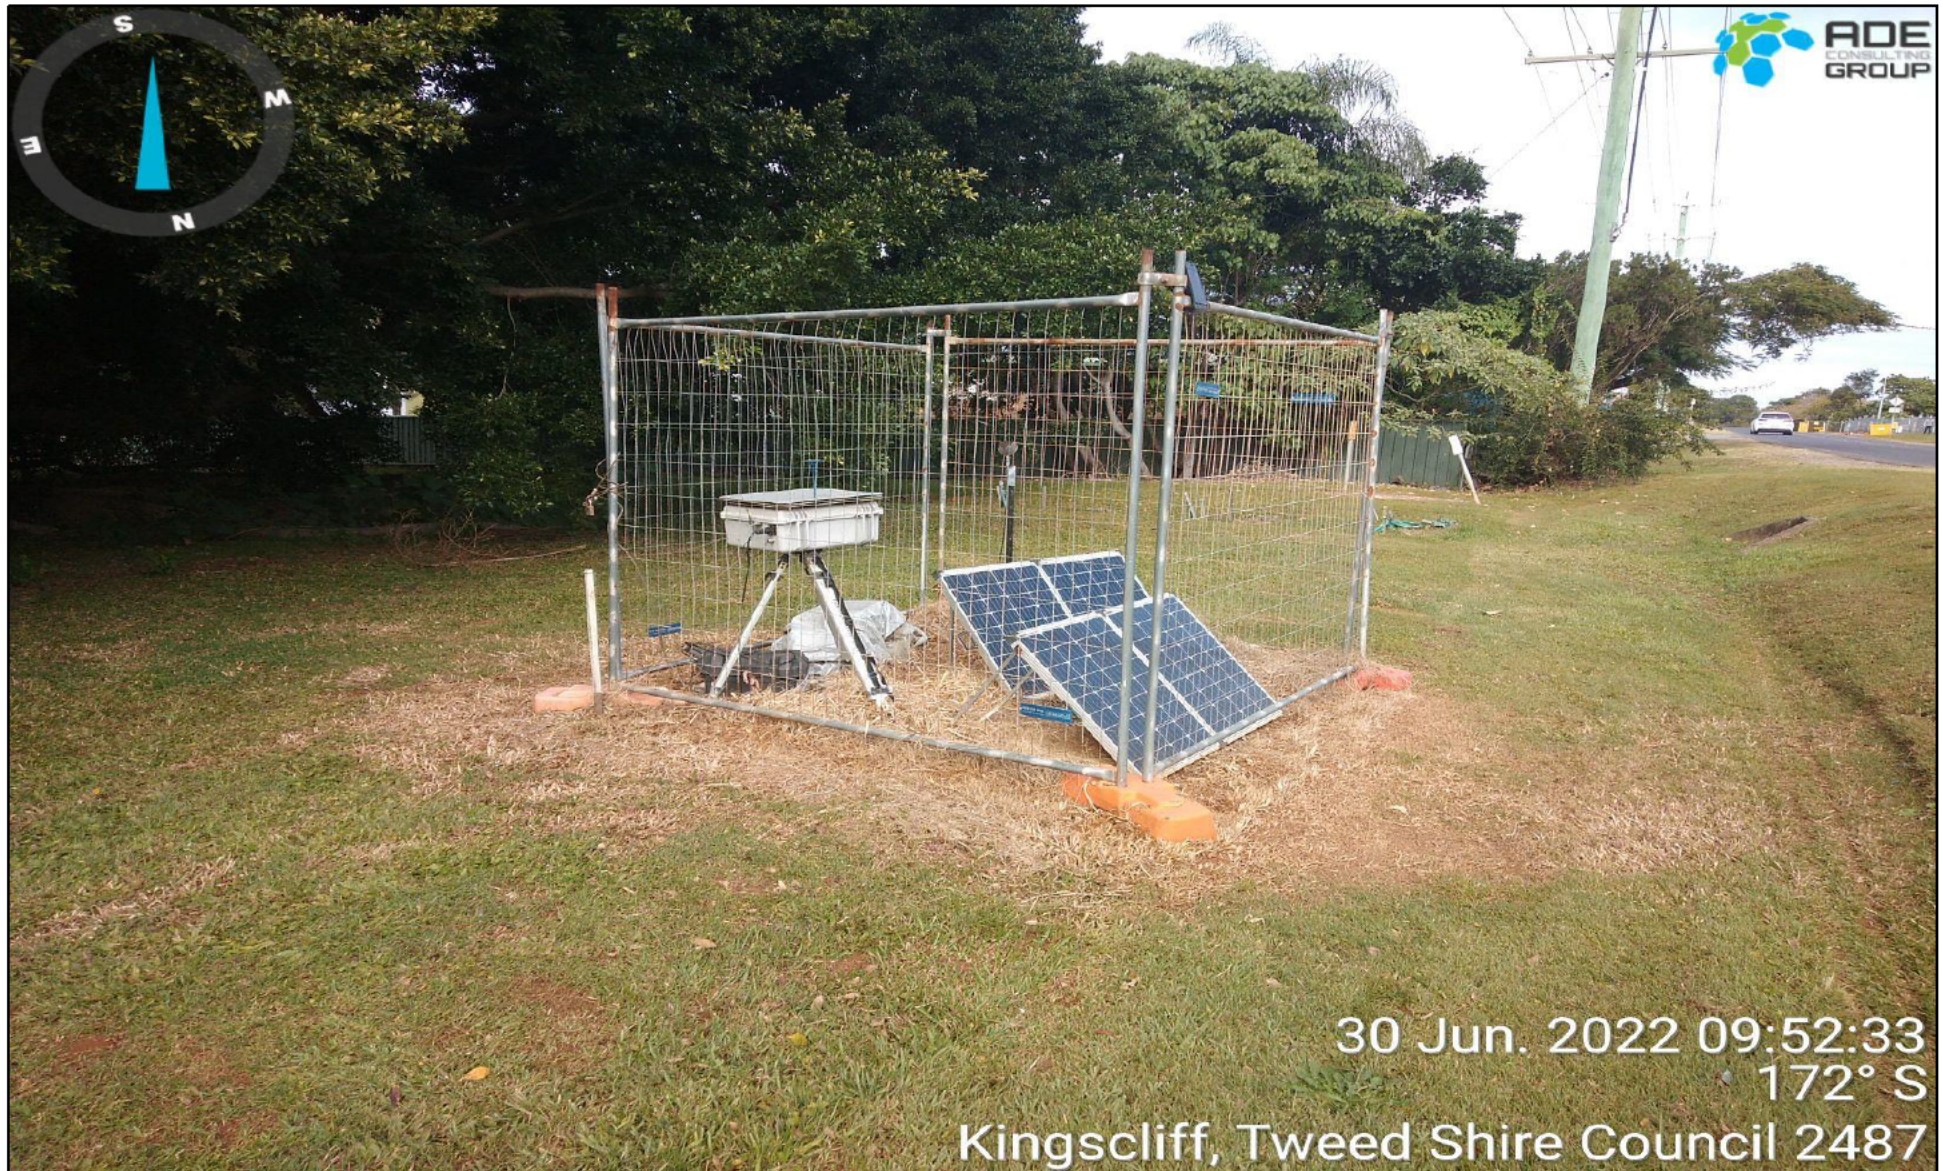
Photograph 2 Representative photograph of monitoring location 005 – TAFE West, as observed 30/06/2022

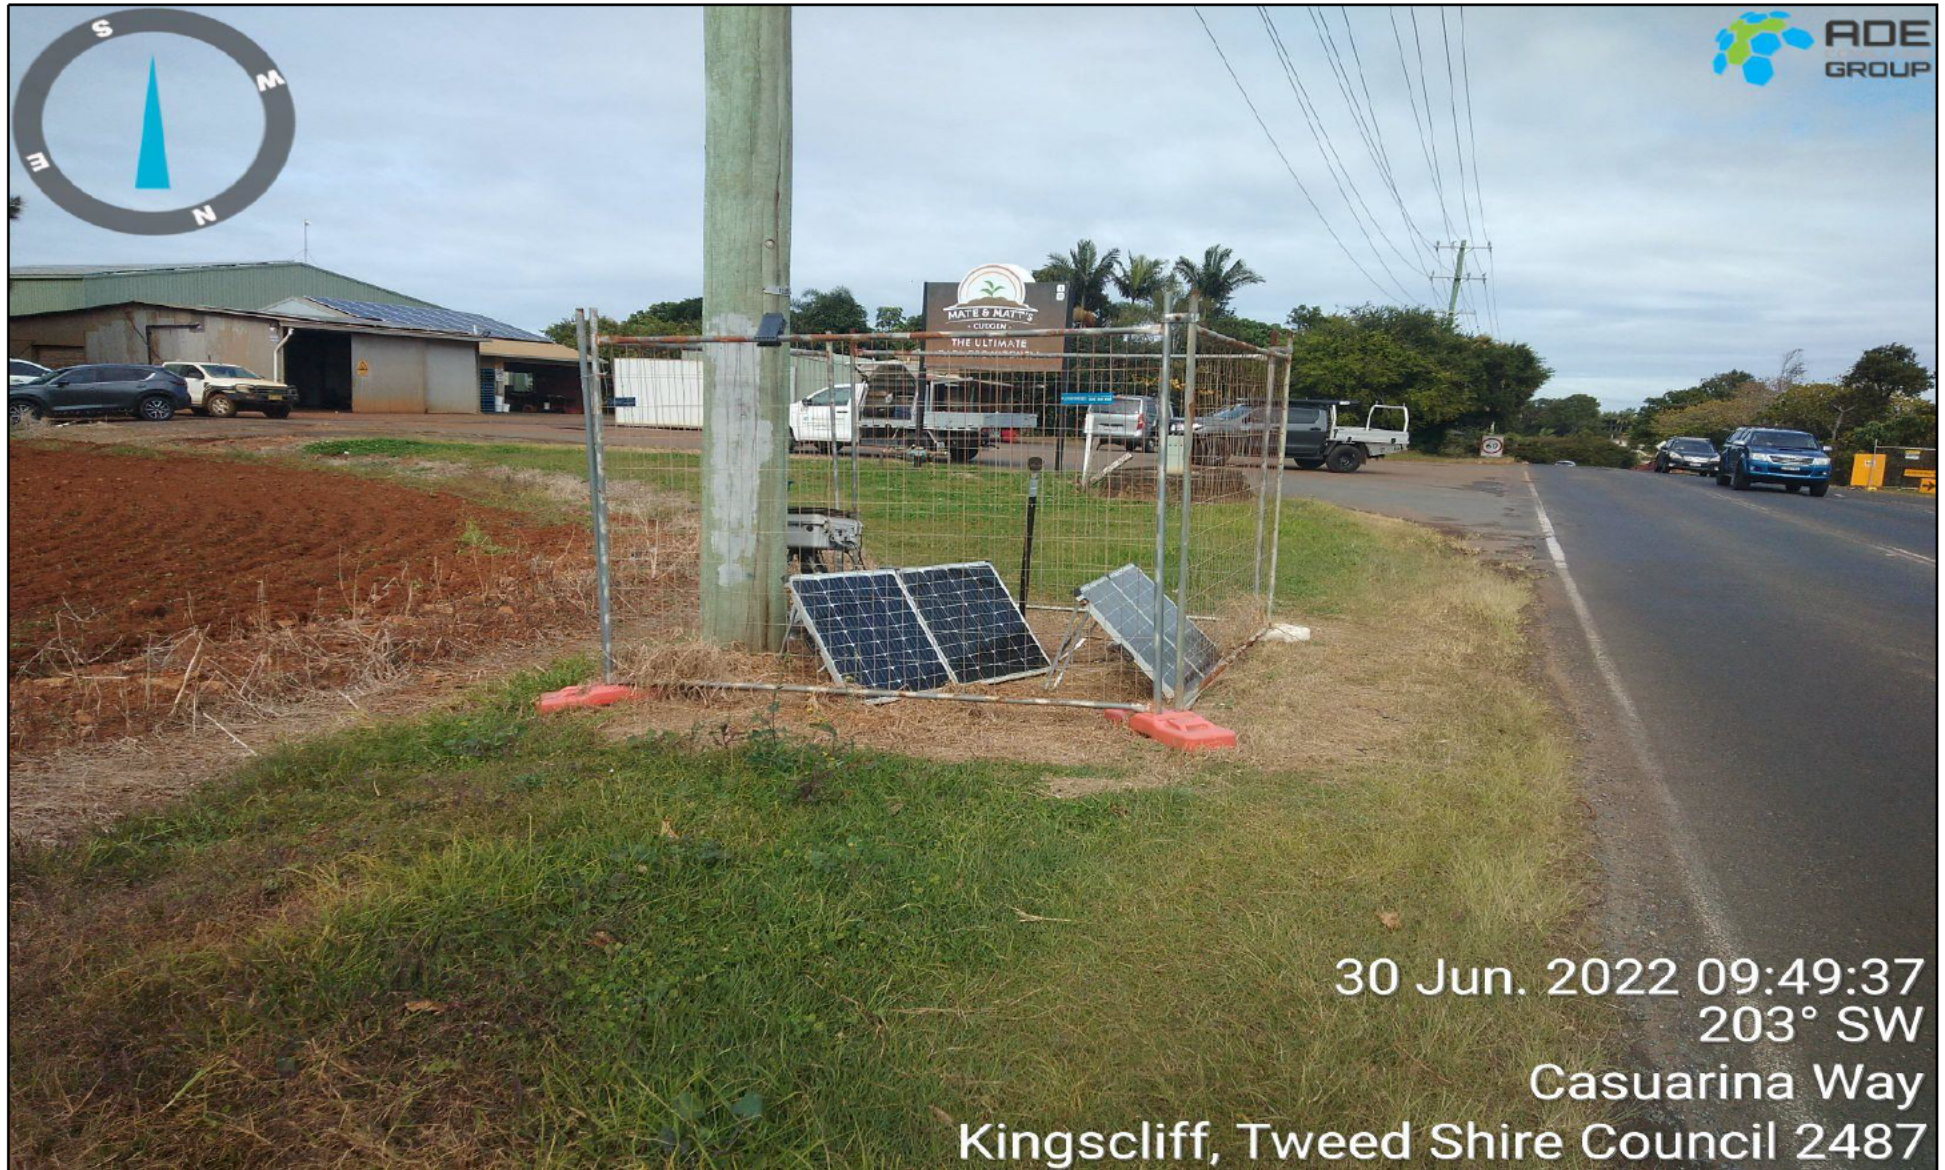
Photograph 3 Representative photograph of monitoring location 006 – Mate and Matts, as observed 30/06/2022
