Vibration Monitoring Assessment Report

771 Cudgen Road, Cudgen NSW

Job Number: A101021.0286.00 VIB40 Rev0.2d | Date: 19/12/2022

ADE Consulting Group Pty Ltd (ADE) was commissioned by Lendlease Group (Lendlease) to assess the levels of construction related vibration during the construction of the Tweed Valley Hospital Project, located at 771 Cudgen Road, Cudgen NSW.

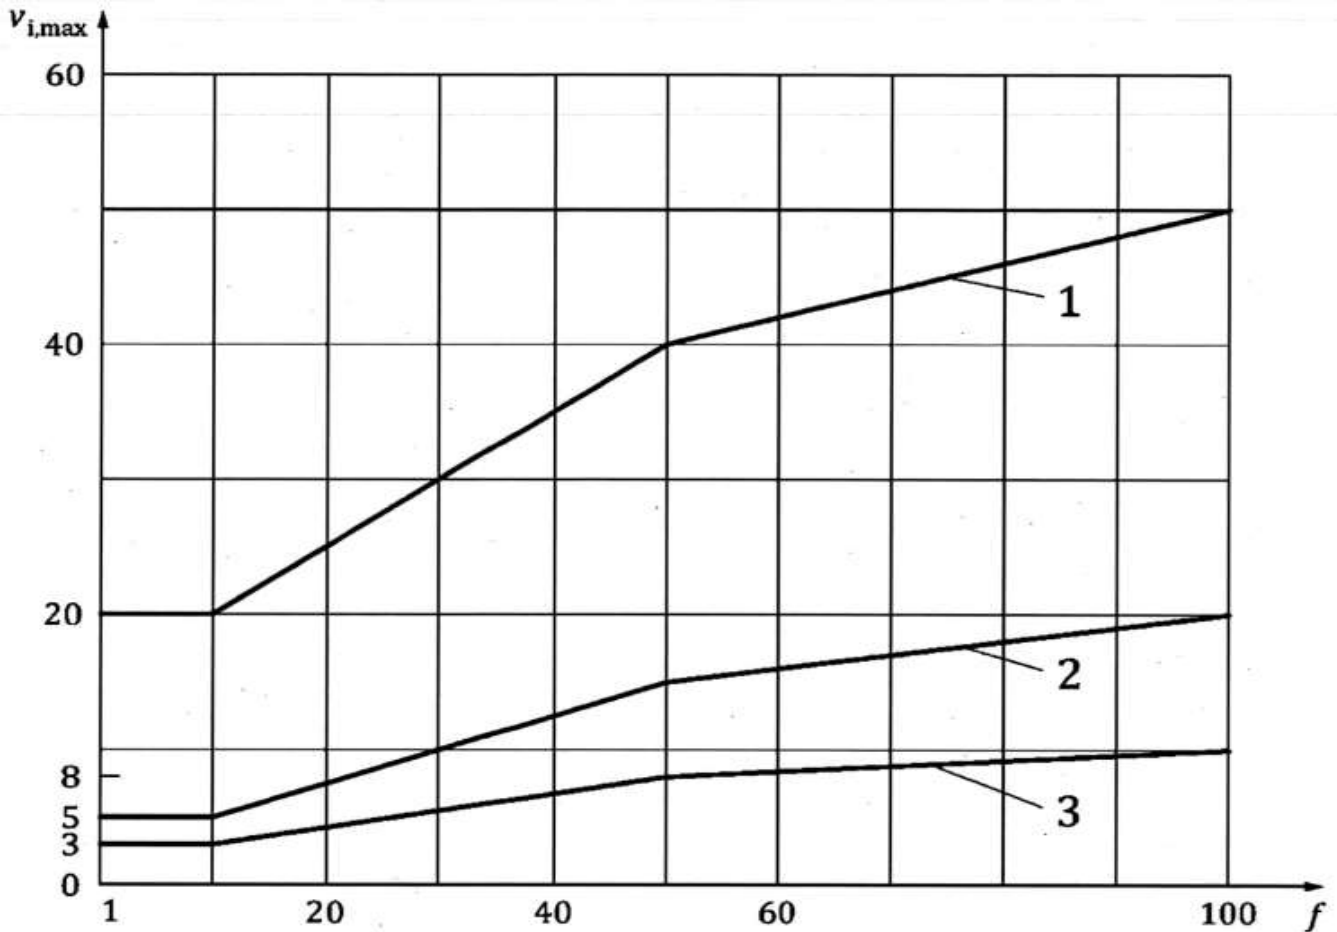
A visual representation of Table 4 is shown below in Figure 1.

Figure 1 Illustration of the DIN4150 guideline. Structural sensitive to vibration is a function of frequency and velocity

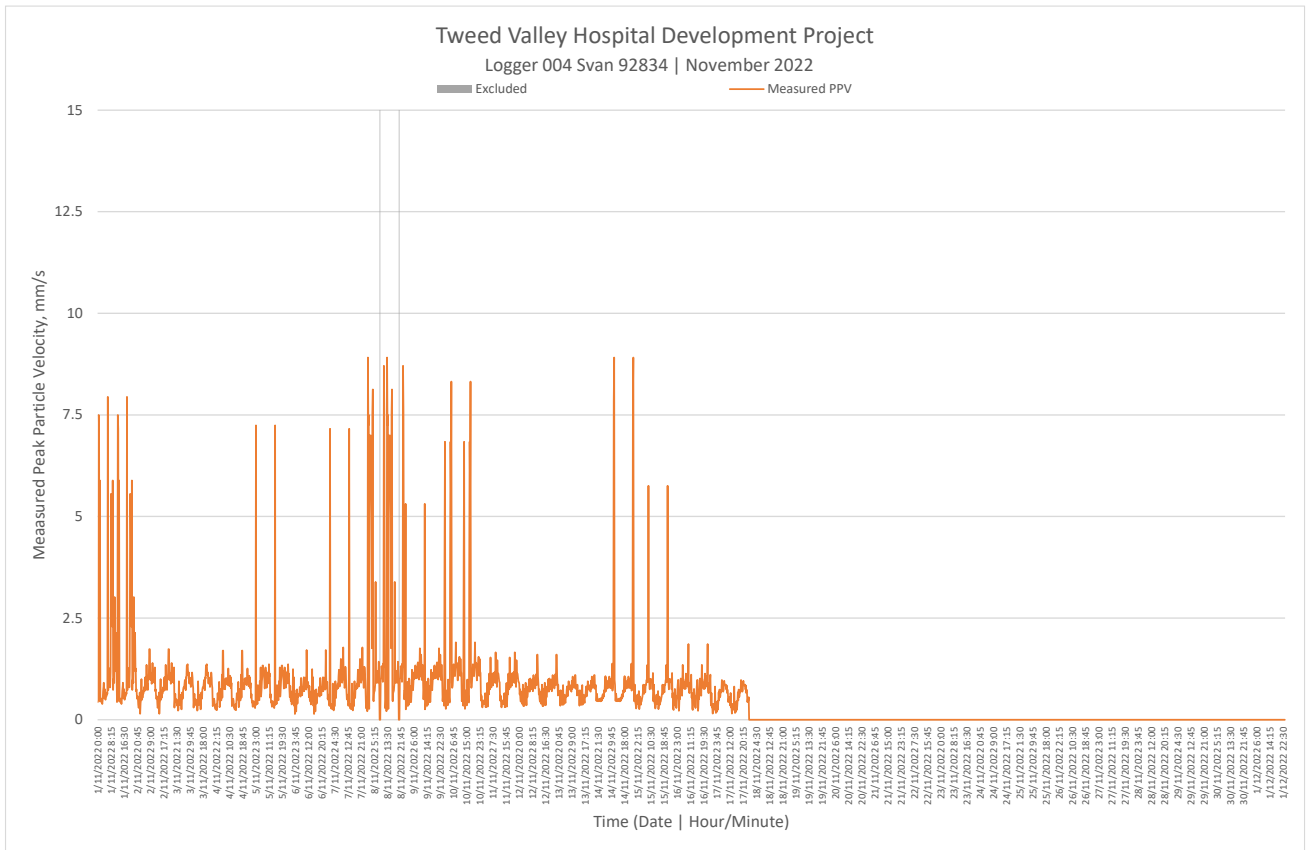
Figure 2 Velocity over time (Logger 004)

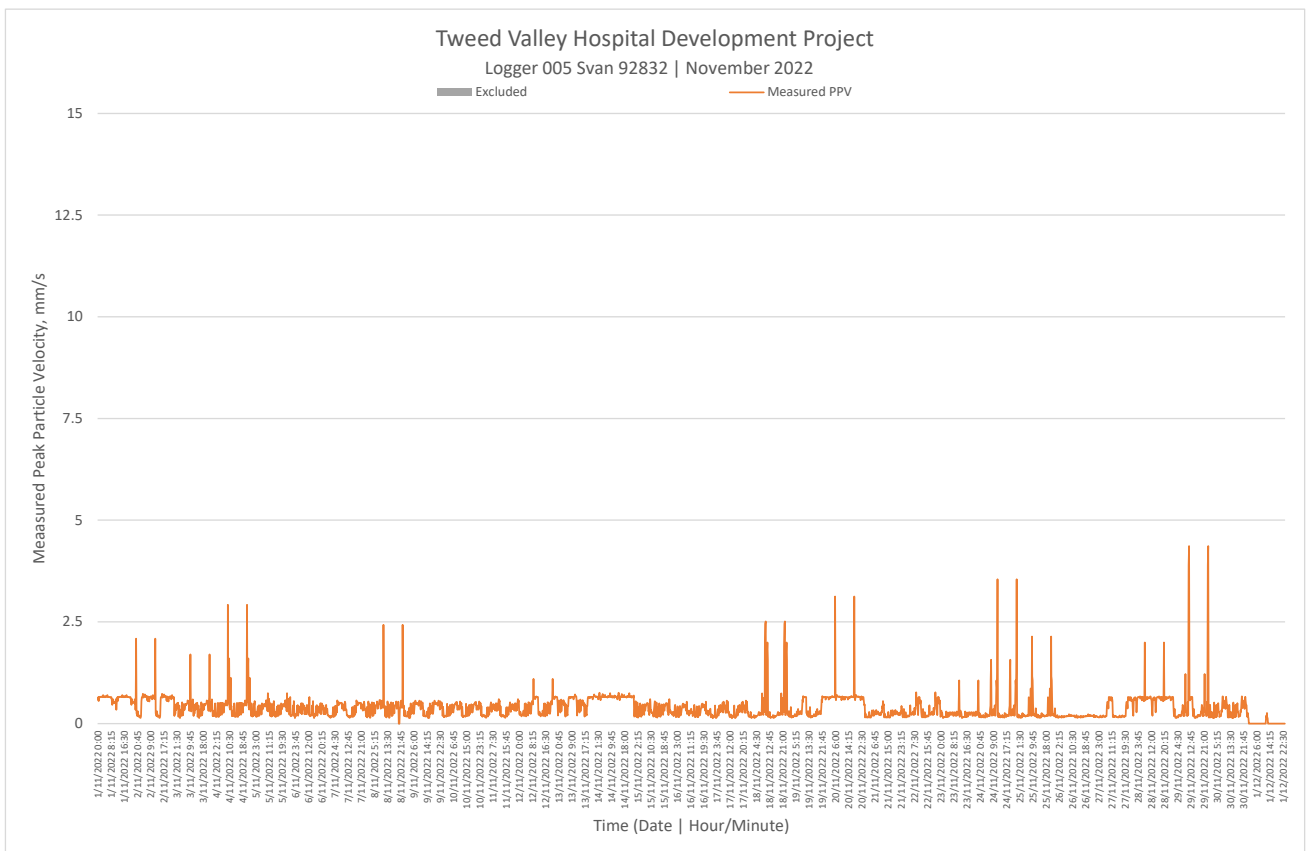
Figure 3 Velocity over time (Logger 005)

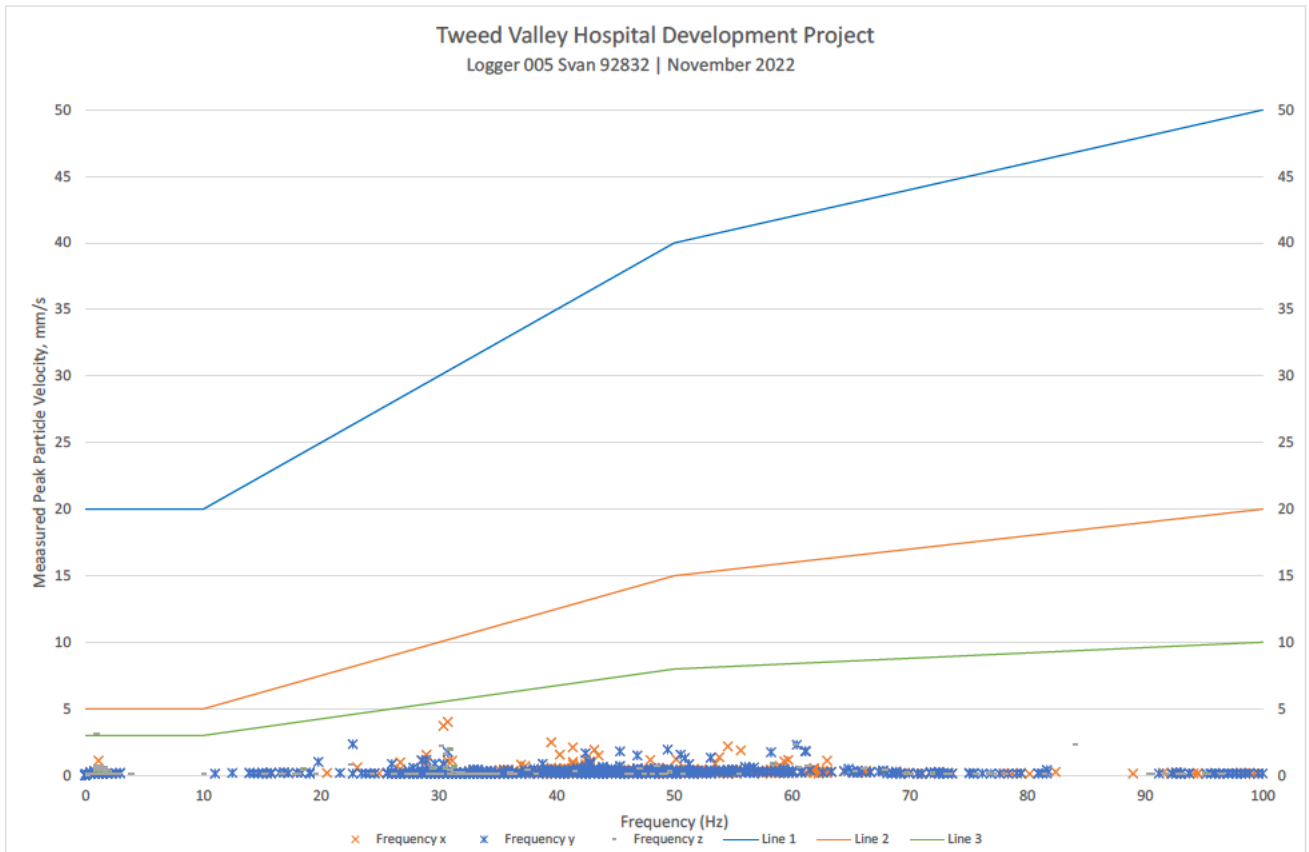
Frequency analysis has been undertaken on the data collected at Logger 005 and 006 (Logger 004/007 was not set up to measure the dominate frequency, this was corrected on 1 December during a routine site visit) and shows that the velocity measured does not exceed the DIN4150 values (refer to **Table 3** and **Table 4**) as the frequency of the velocity energy was not low frequency in nature.

Figure 4 Velocity over frequency (Logger 005)

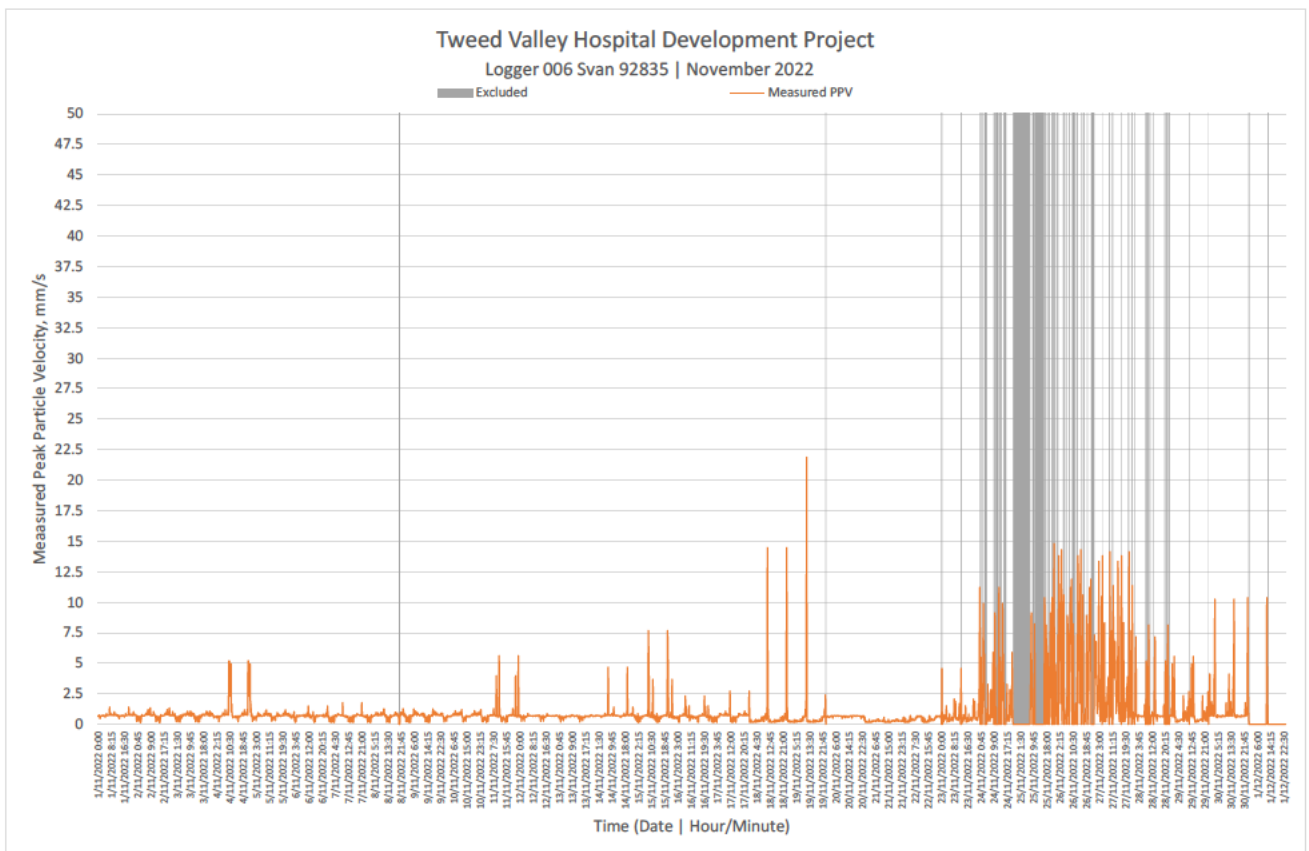
Figure 5 Velocity over time (Logger 006 – Residential/Commercial)

Figure 5 above has the x-axis expanded to 50 mm/s to include some data exceeding 15 mm/s.

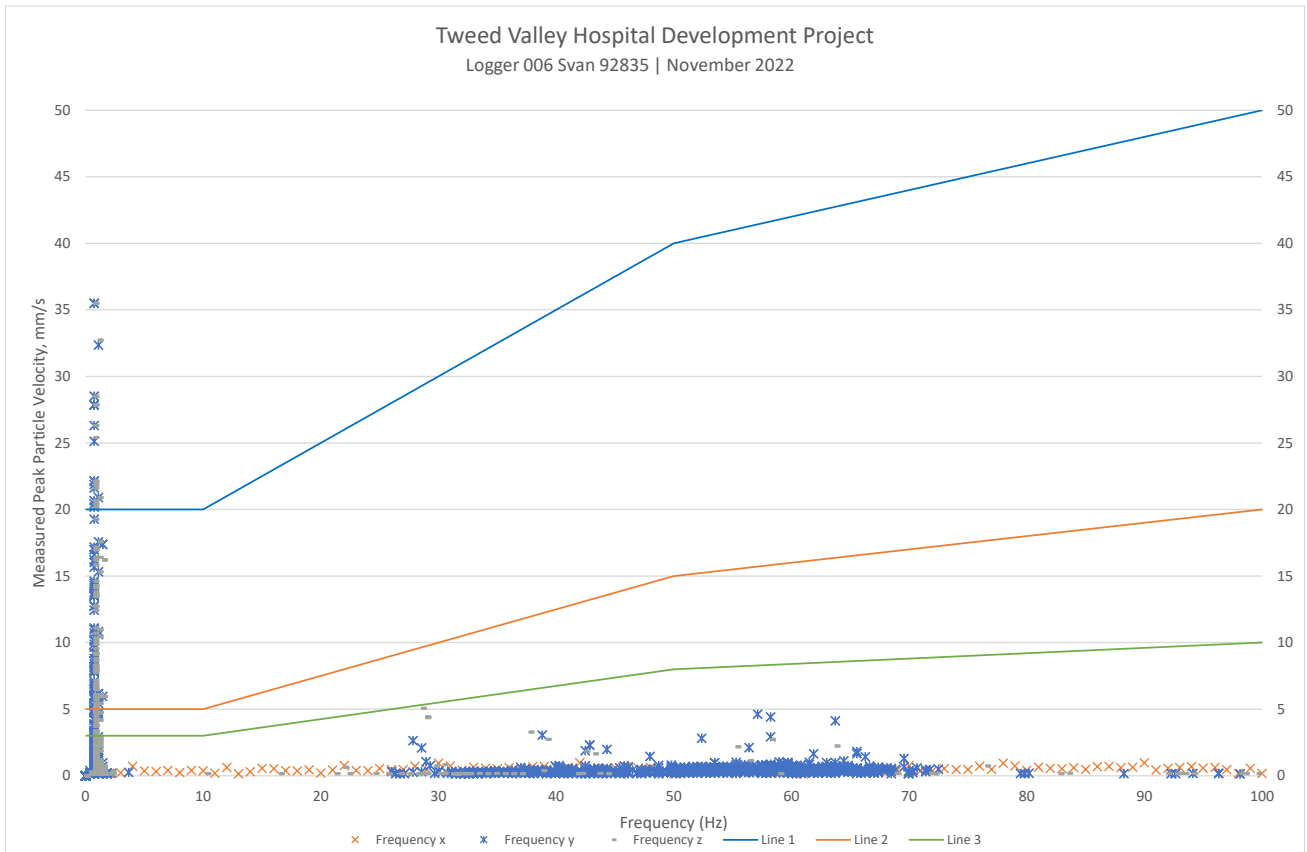
Figure 6 Velocity over frequency (Logger 006)

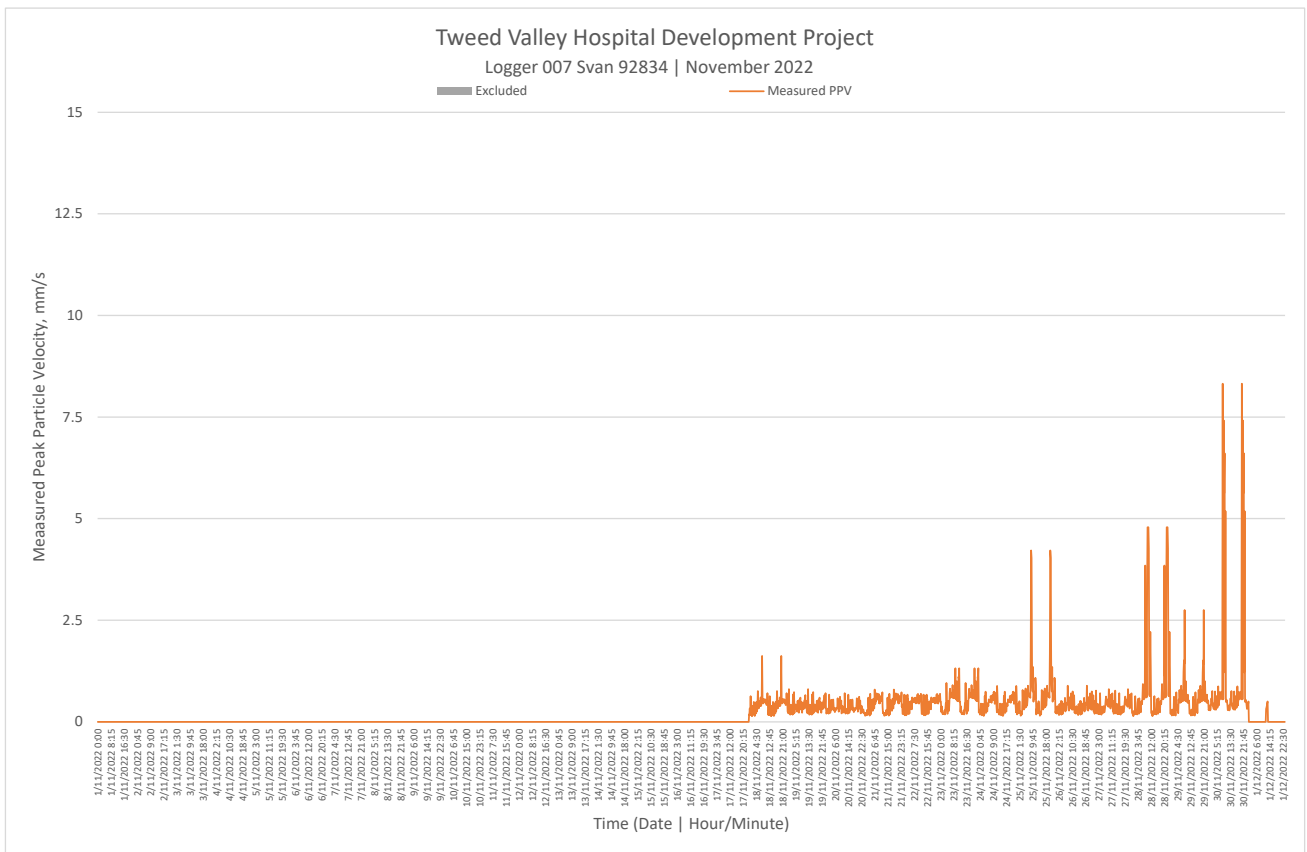
Figure 7 below presented velocity data for the logger located in close proximity to a residential premises.

Figure 7 Velocity over time (Logger 007 – Residential)

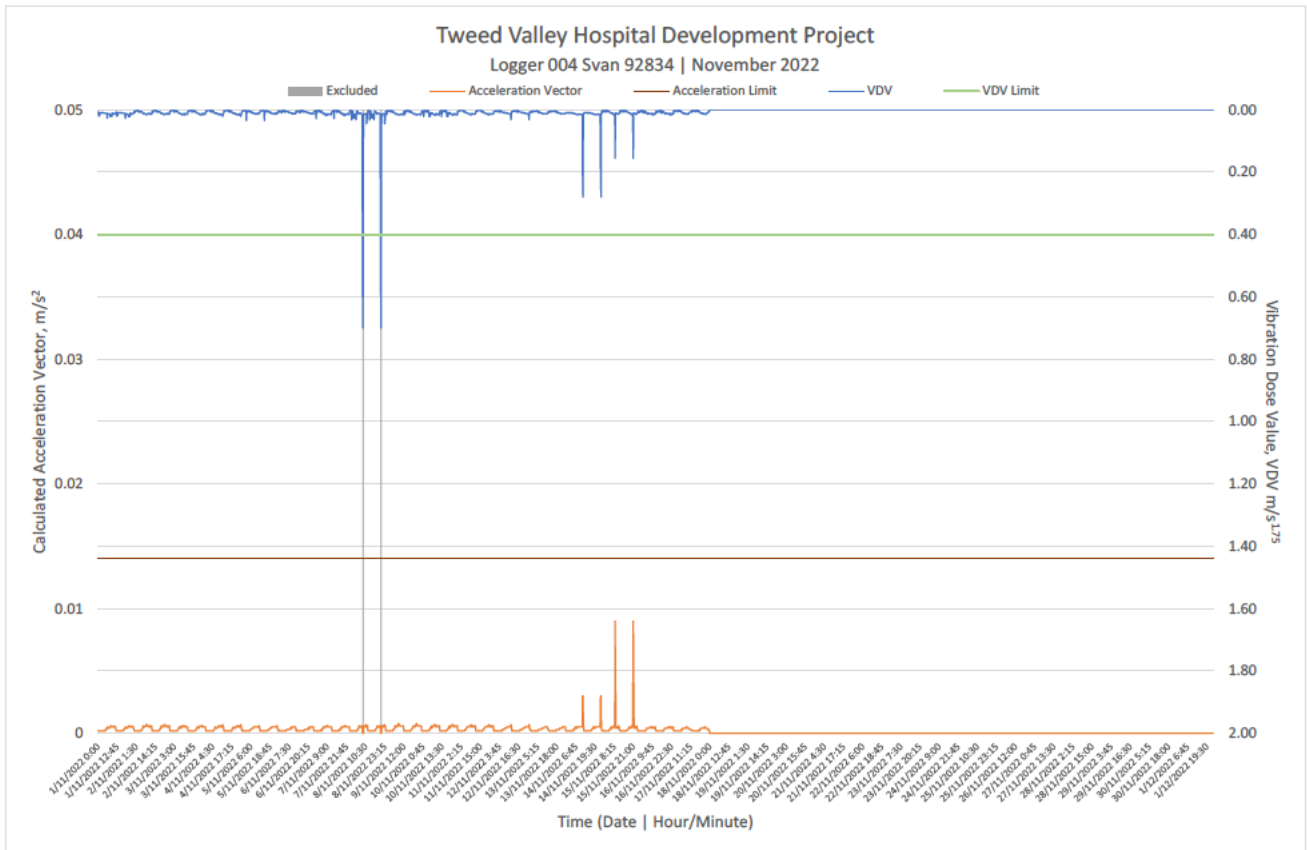
Figure 8 Acceleration and Vibration Dose Value over time (Logger 004)

Logger 004 was relocated to a residential premises southwest of the project site along Cudgen Road, on 17 November.

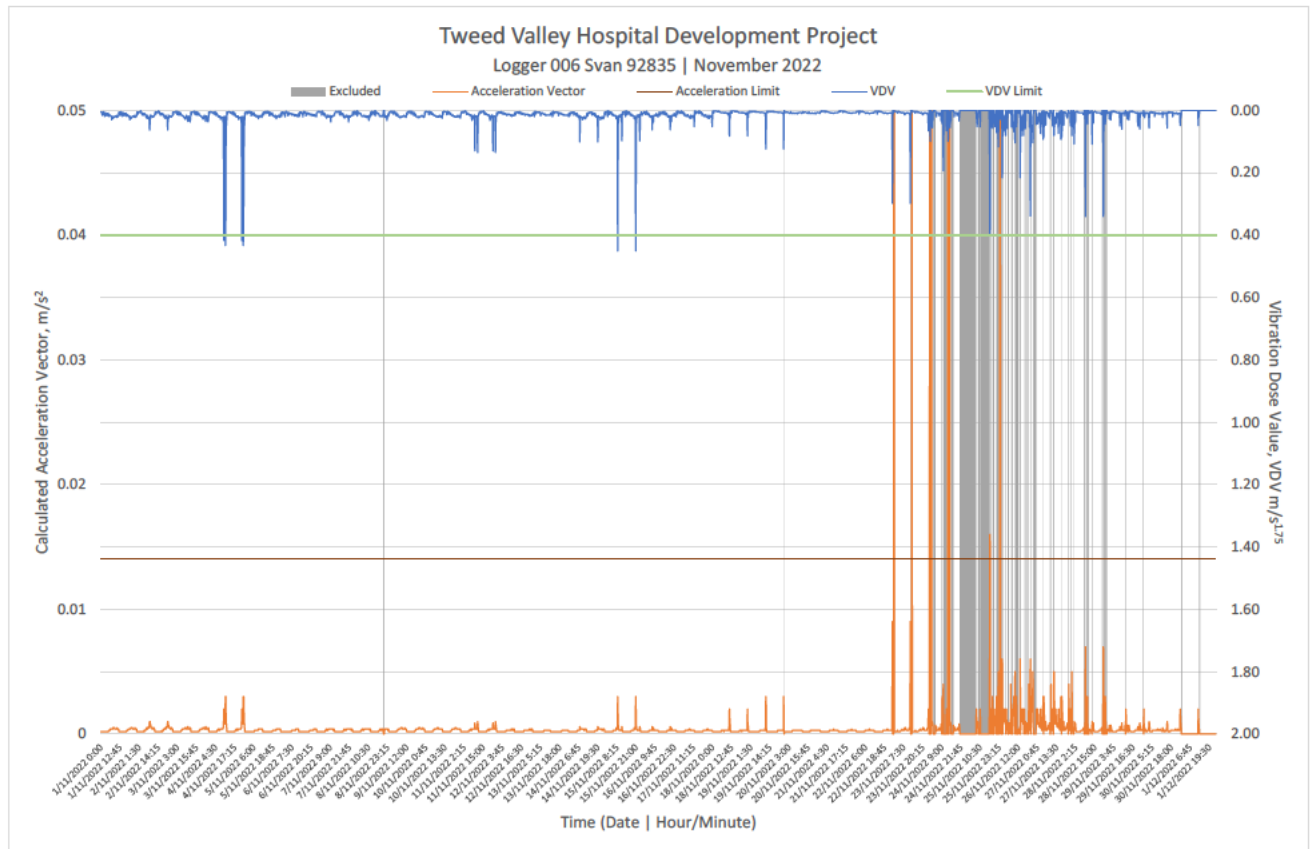
The vibration impact at the residential premises is presented below in Figure 10. Data considered extraneous in nature has been removed from the data analysis and the graph.

Figure 10 Acceleration and Vibration Dose Value over time (Logger 006 – Residential/Commercial)

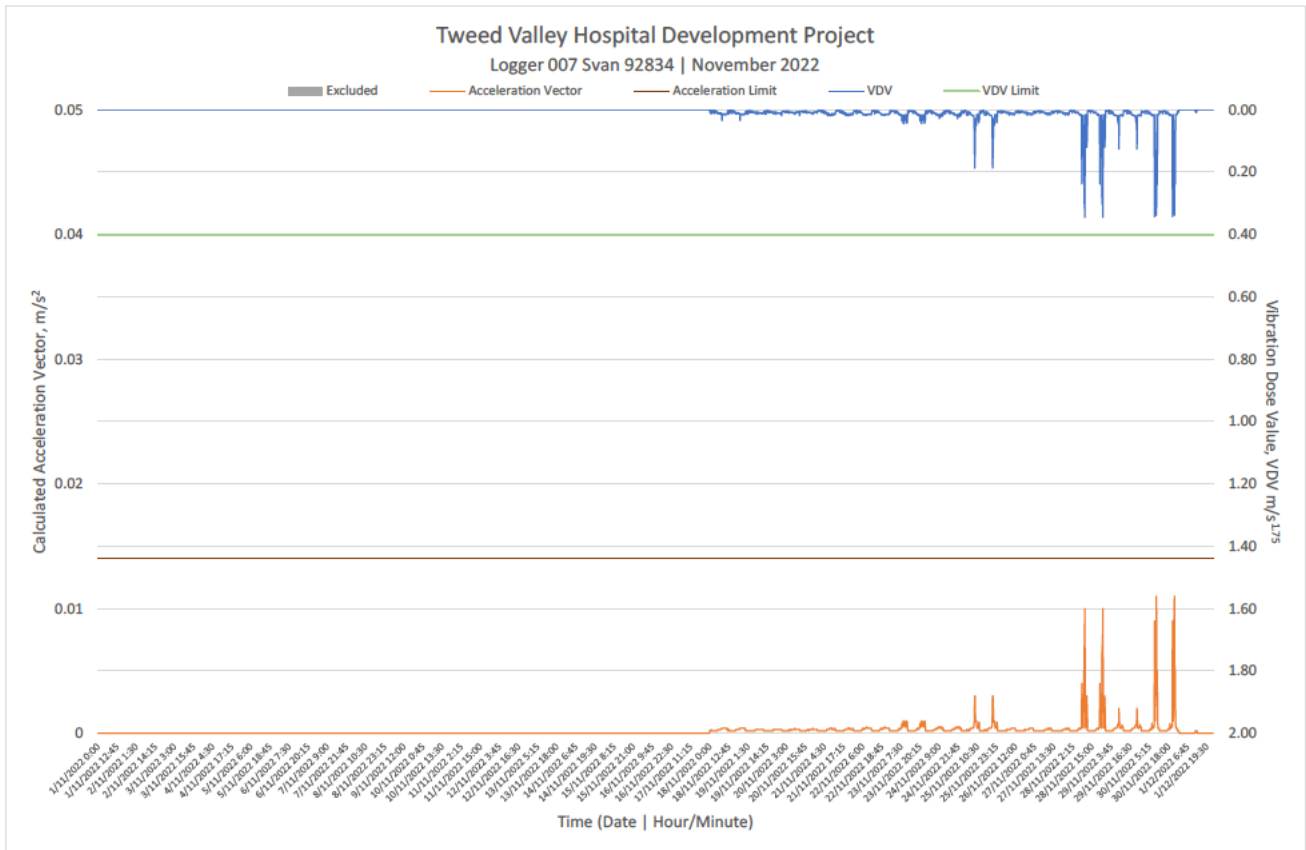
Figure 11 which follows presents the increase in perceptible vibration at the southwestern residential receiver nominated as Location 007. The logger was installed at this location on 17 November. No data at this location is considered extraneous. The total accumulated vibration energy exceeds the recommended values presented in this report, and the DEC guideline which Condition of Approval C18 is approved under.

The occupants at this location are likely to have experienced an increase of perceptible vibration during the days where a vibratory roller was in use, and the likelihood of adverse comment is probable.

Figure 11 Acceleration and Vibration Dose Value over time (Logger 007 – Residential)

As outlined in **Table 5**, a 10T vibratory roller has a subjectively perceptible distance of approximately 100 m. Vibratory roller may be required to be undertaken in shorter period of time (less than 4 hours), and, letterbox drops are applicable when the roller is anticipated for use. Other feasible and reasonable mitigation measures may include respite offers during the daytime period.

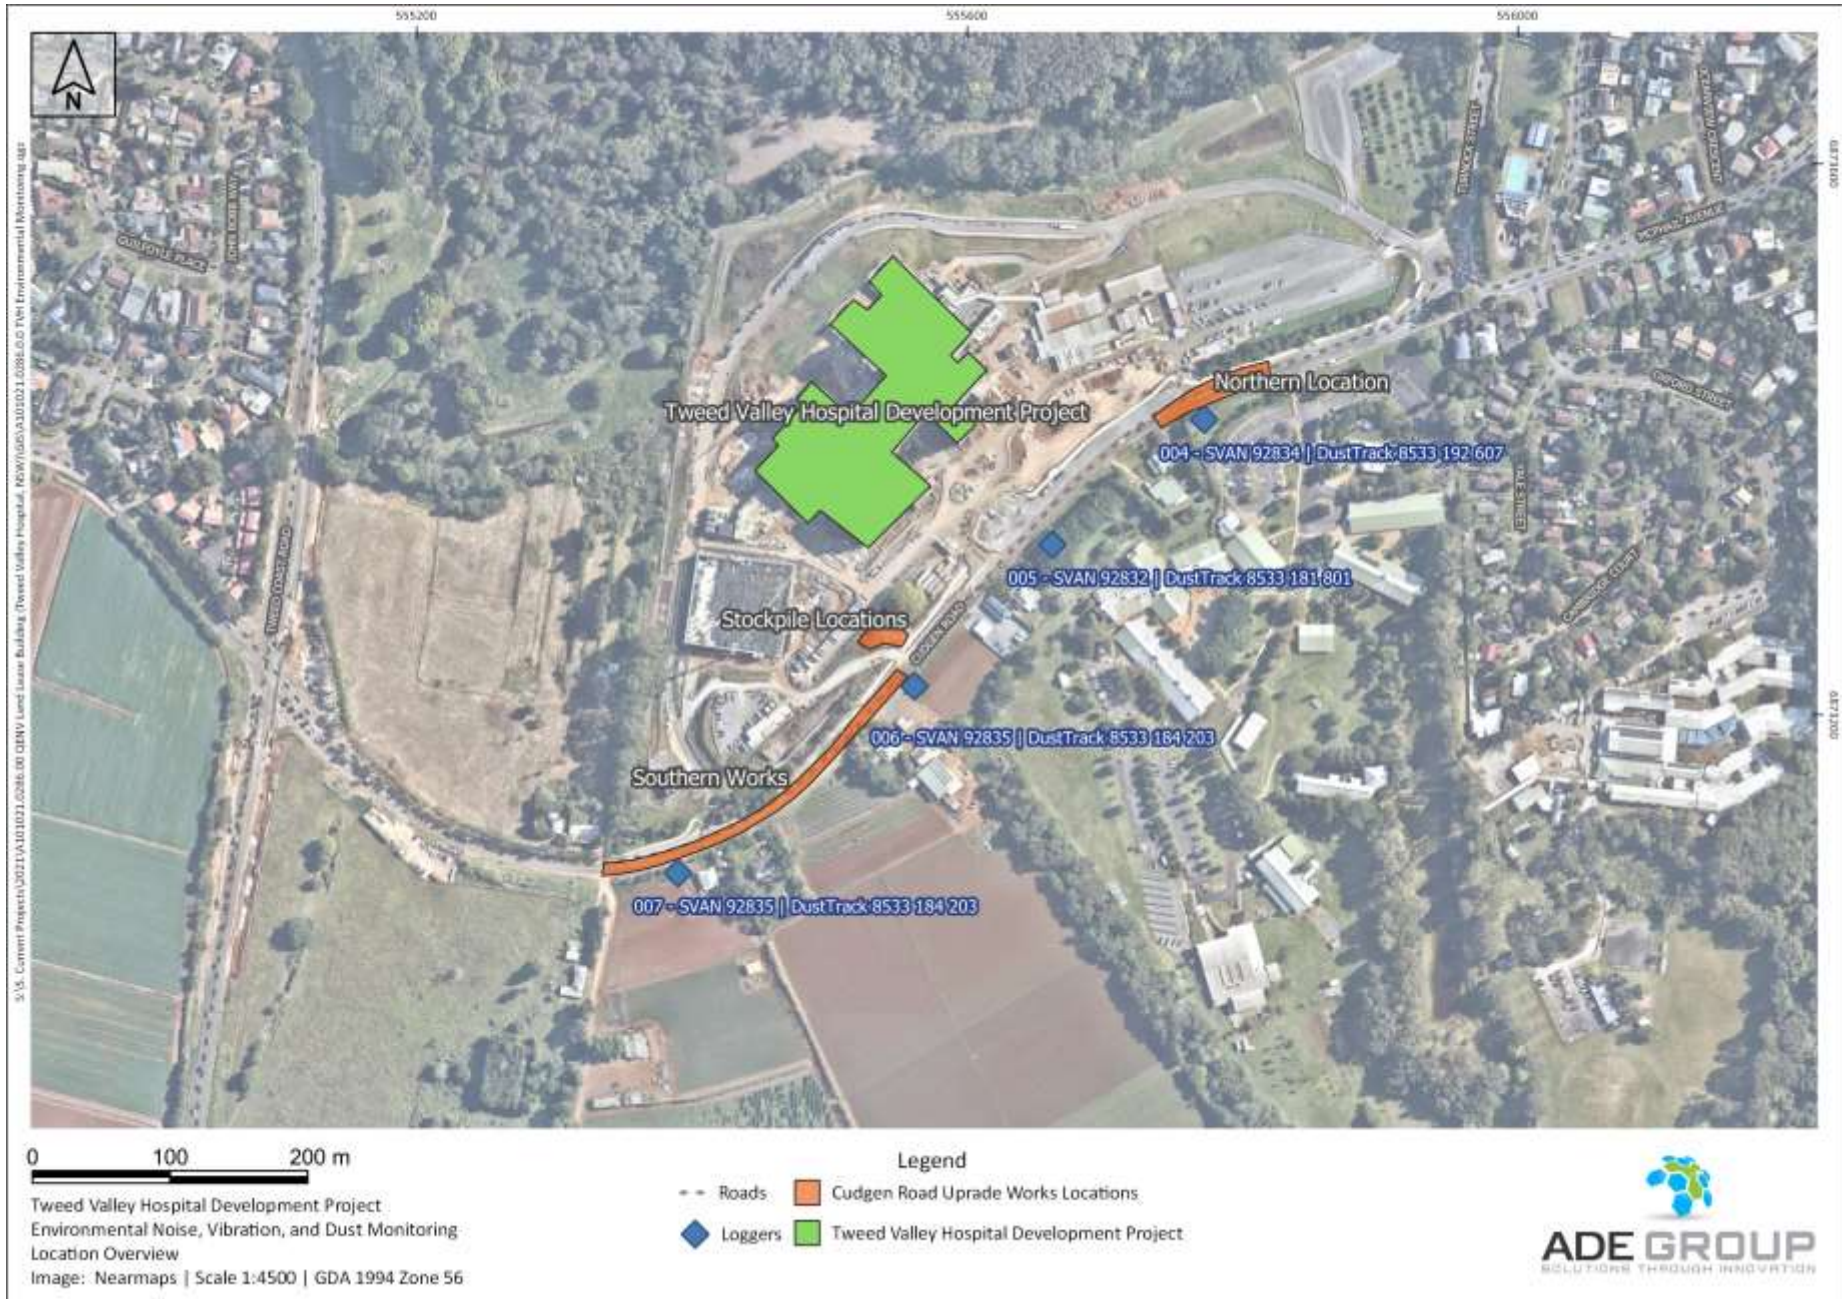
Appendix II – Aerial Photograph

ADE Monitoring locations, site location (including CD Civil's Cudgen Road Upgrade works) are presented below.

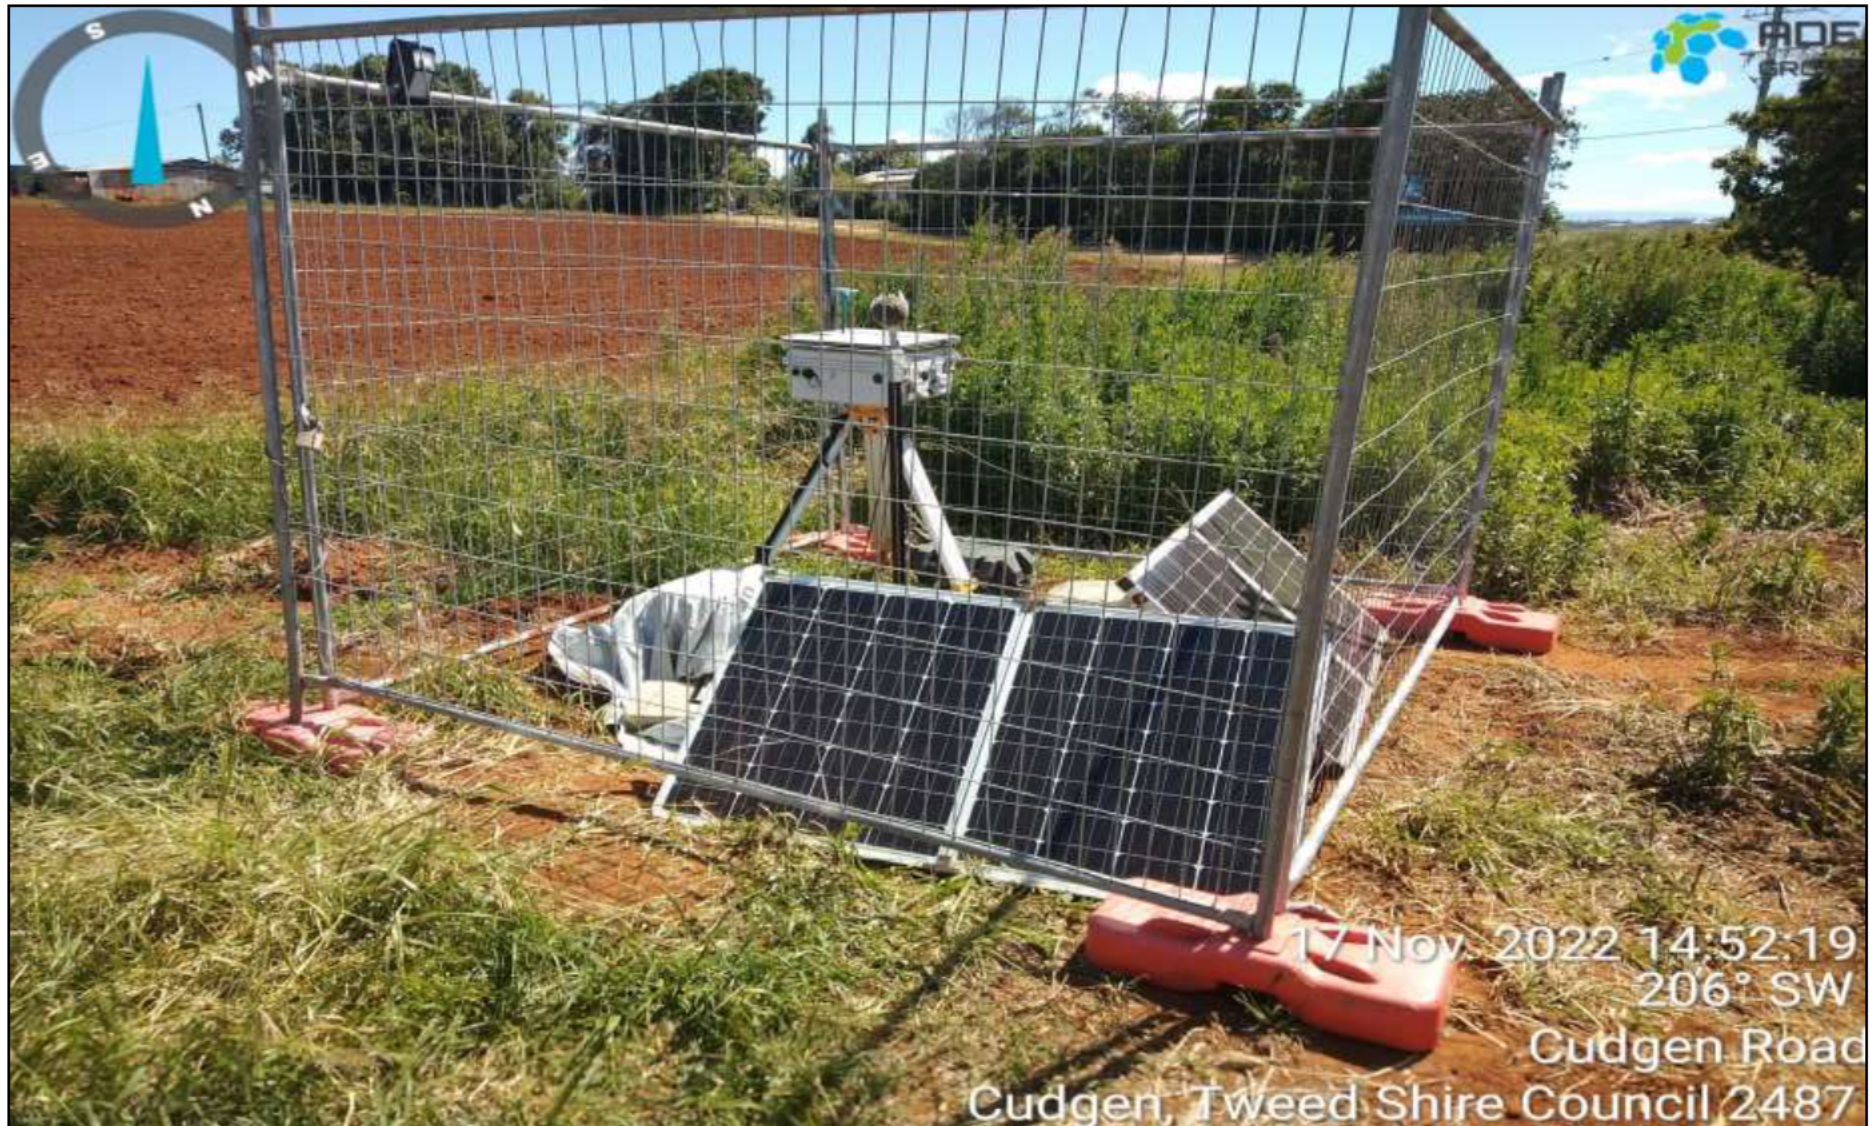
Photograph 1 Representative photograph of monitoring location 007 – Residential, as observed 17/11/2022

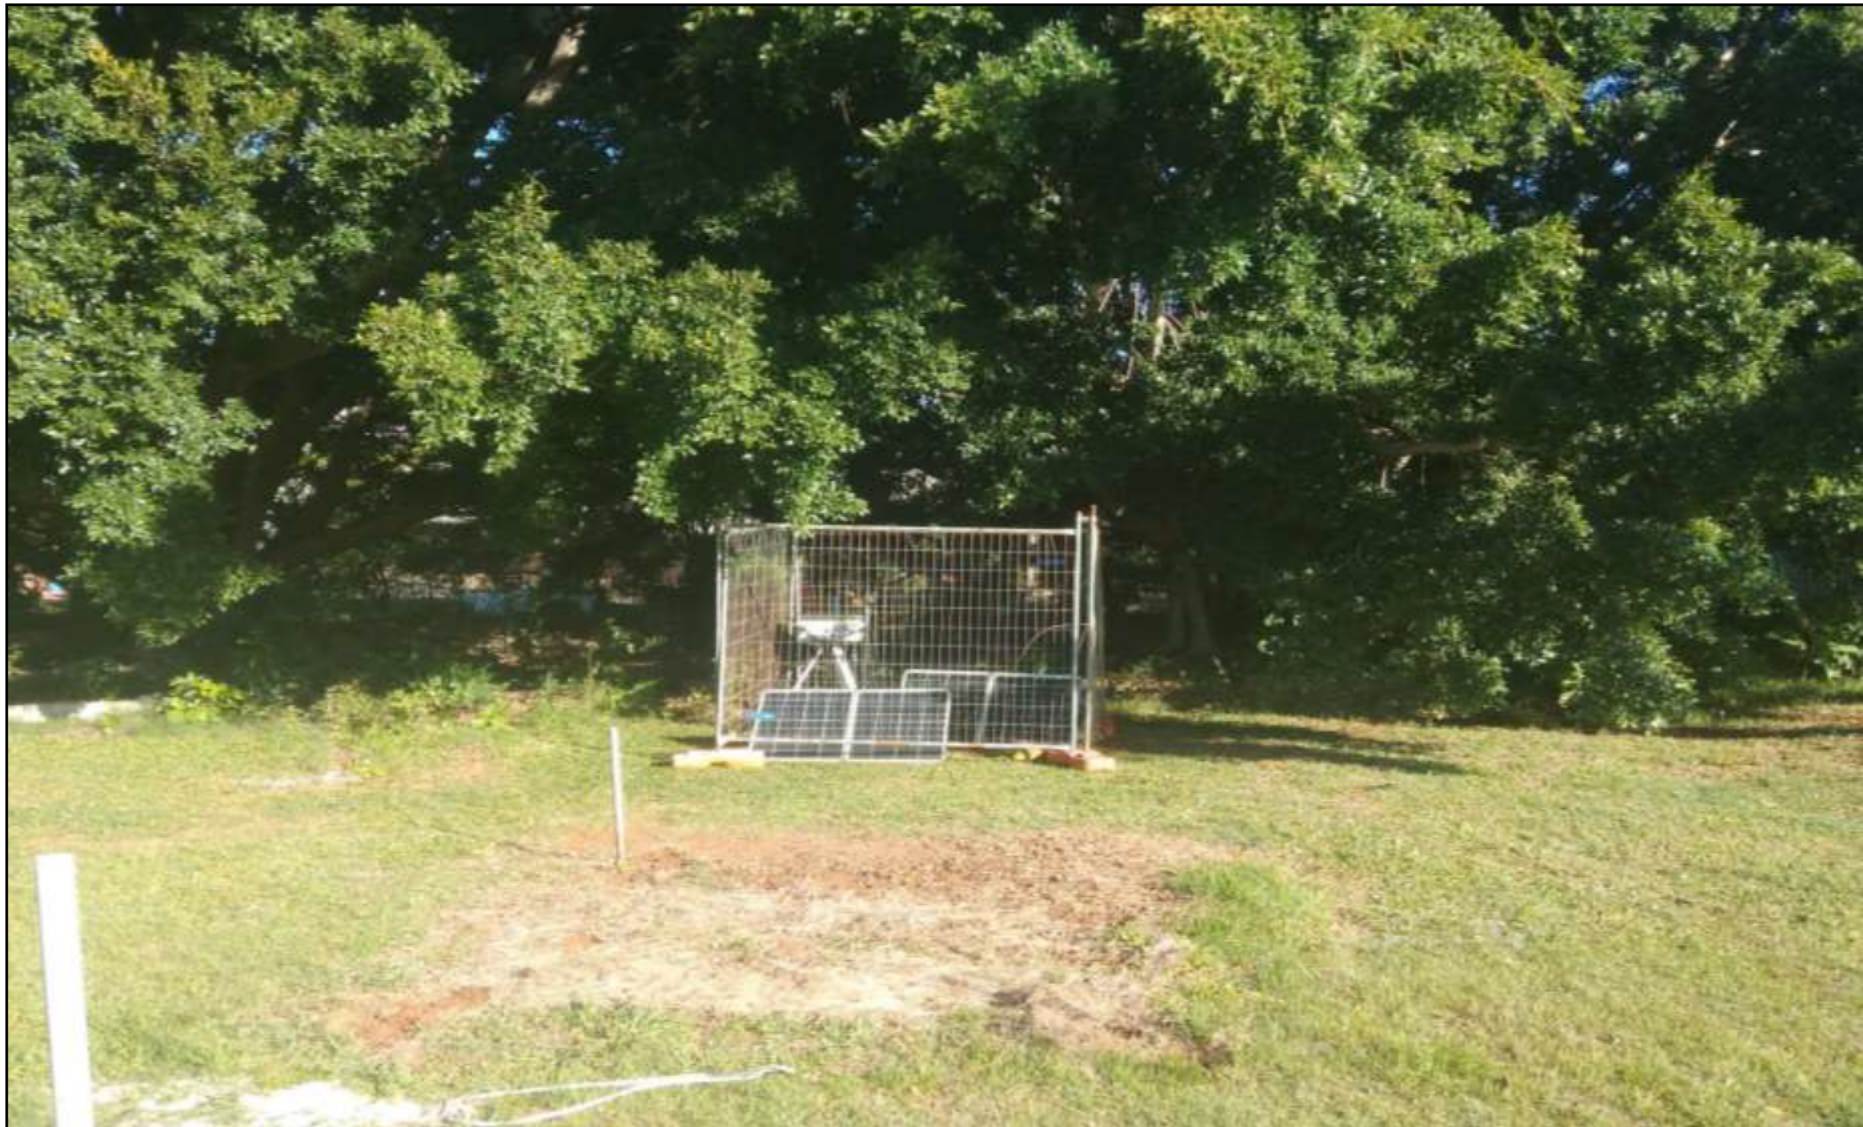
Photograph 2 Representative photograph of monitoring location 005 – Solar Industry, as observed 17/11/2022

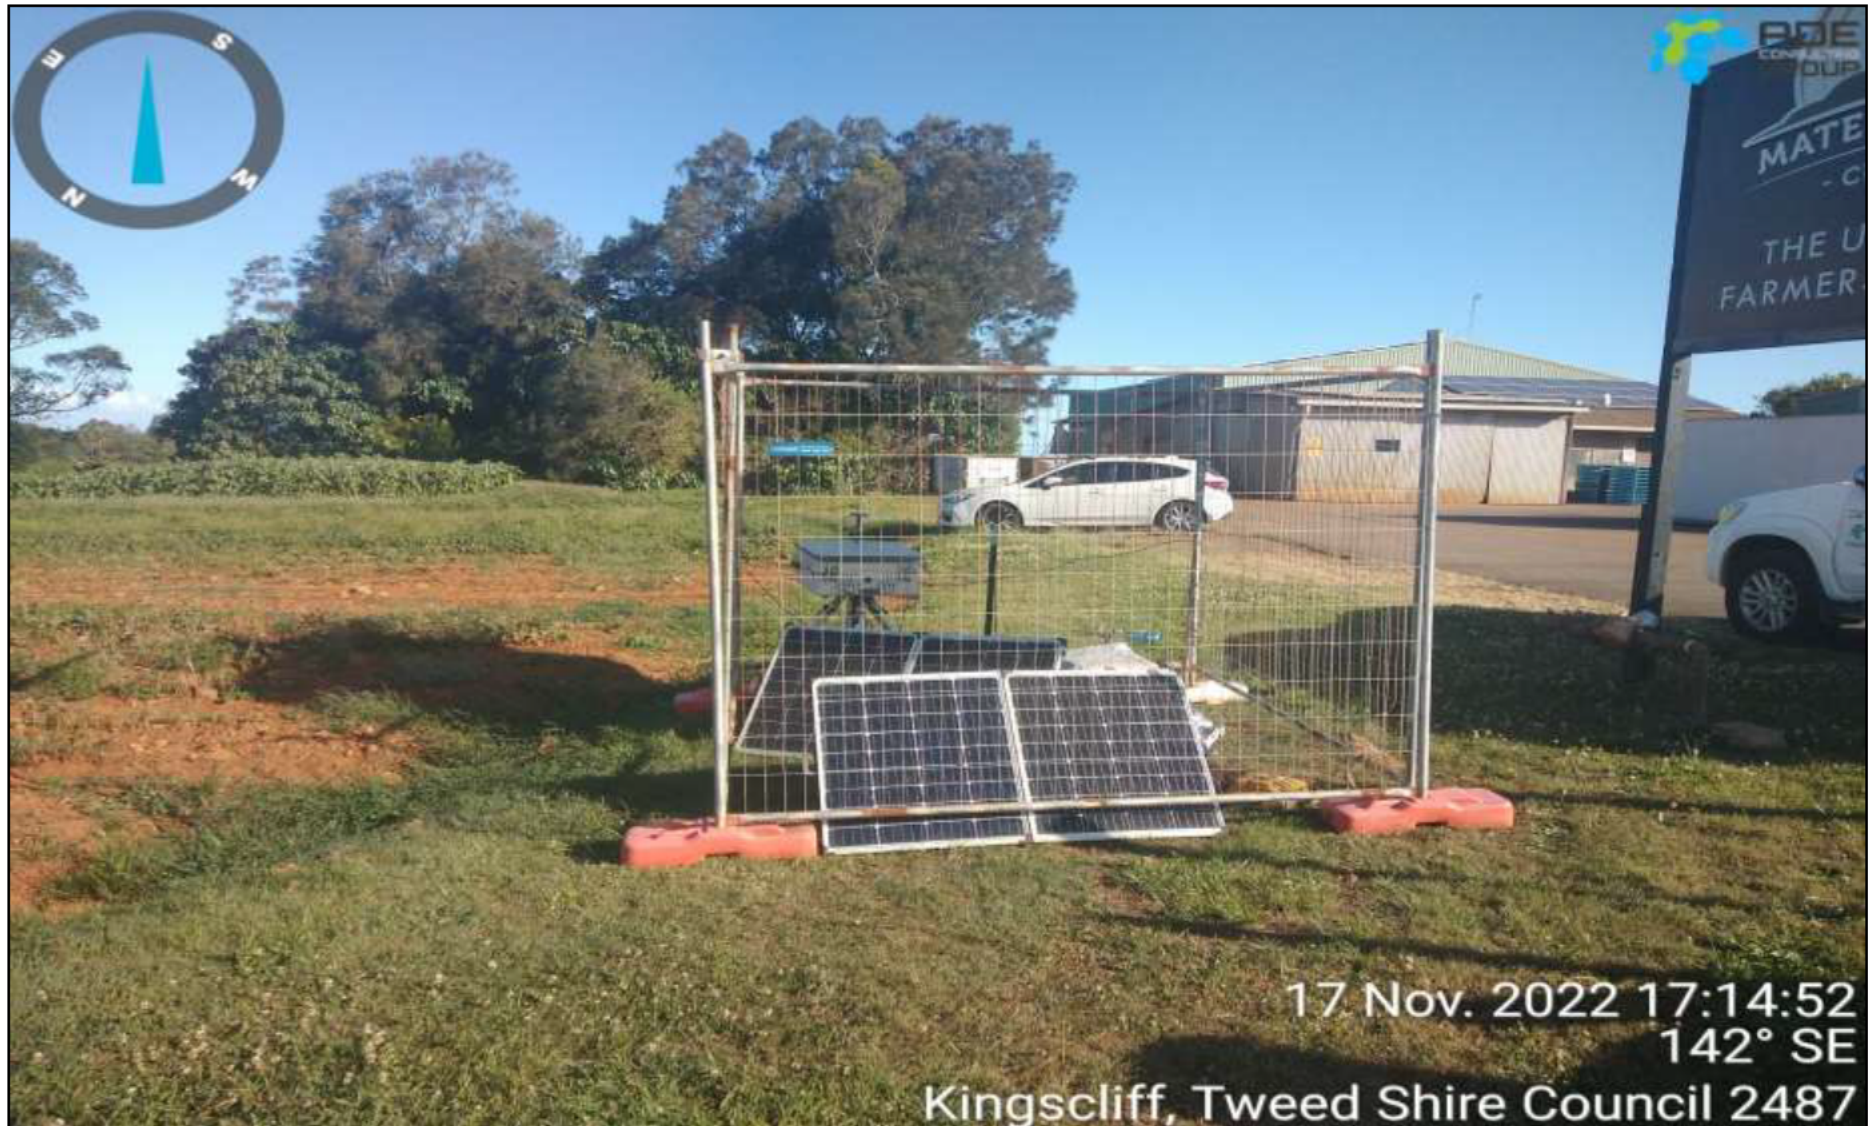
Photograph 3 Representative photograph of monitoring location 006 – Mate and Matts, as observed 17/11/2022
