# Vibration Monitoring Assessment Report | June 2023

**Tweed Valley Hospital 771 Cudgen Road, Cudgen NSW**

Job Number: A101021.0286.00 VIB47 v1f | Date: 27/07/2023

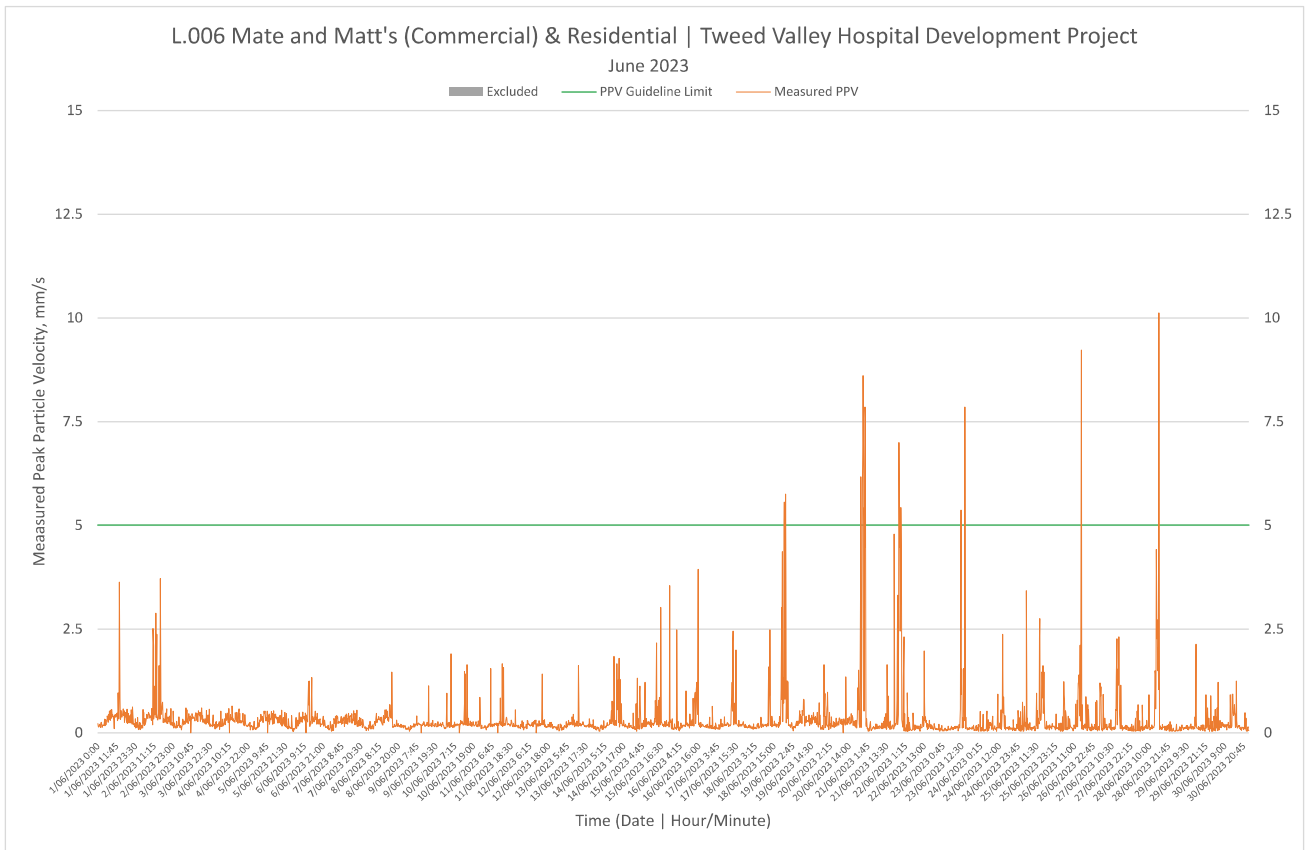
**Figure 3** below presents the velocity (PPV mm/s) at Location L.006 situated by a residential and commercial receiver (Mate and Matts).

**Figure 3** Velocity over time (Logger 006 – Residential/Commercial)

Throughout the survey period, Location L.005 and L.007 do not have any velocity energy of any concern, a large portion of the measurement data at L.006 illustrates the velocity levels (as a function of frequency) measured are below the DIN4150 Line 2 guidelines.

Neither locations L.005 or L.007 d recorded significant vibration regarding risks to cosmetic damage. Though some velocity measured at L.006 would have had the potential to cause some degree of cosmetic damage, frequency analysis of measured exceedances does not support a concern.

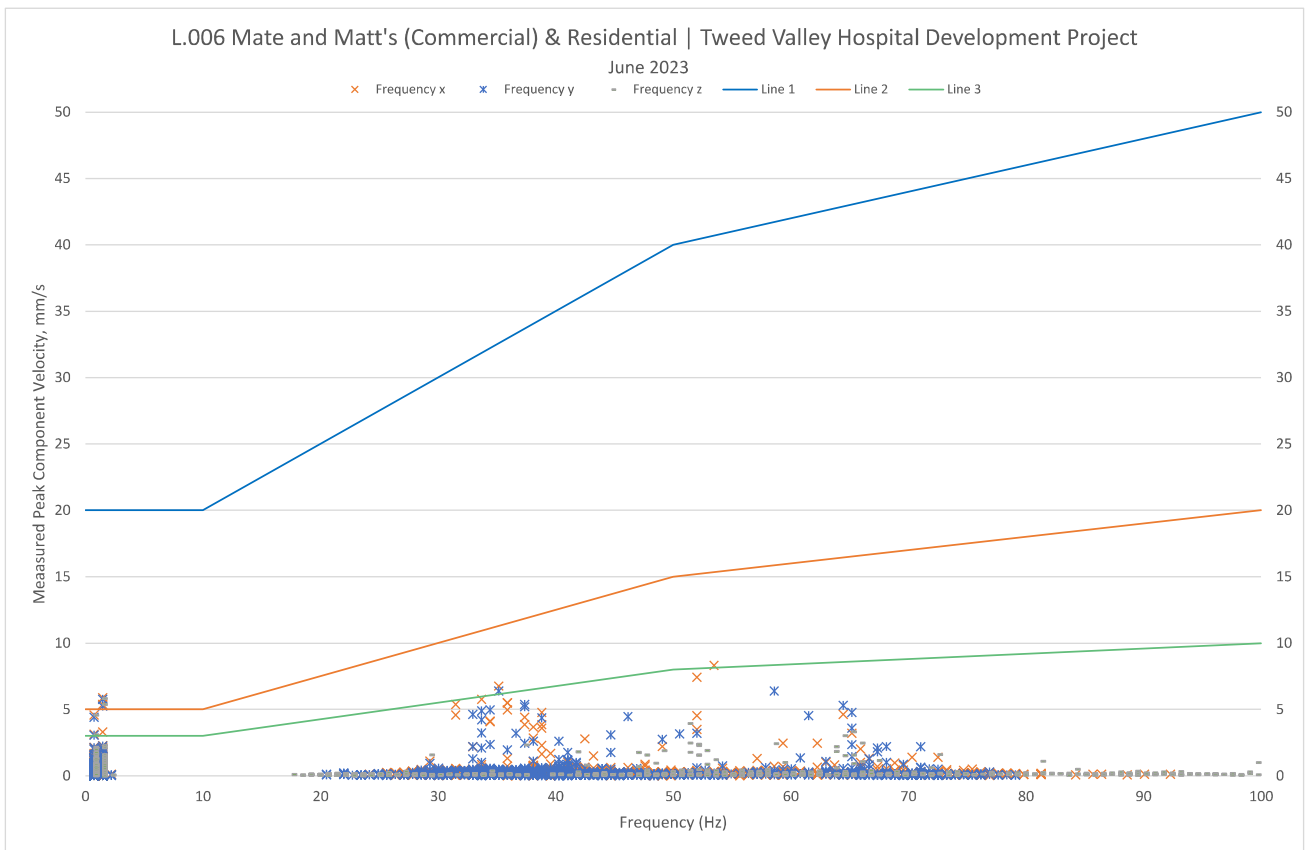
**Figure 4** below illustrates the frequency over the velocity for each axis at Location L.006.

**Figure 4** Frequency over Velocity (Logger 006 – Residential/Commercial)

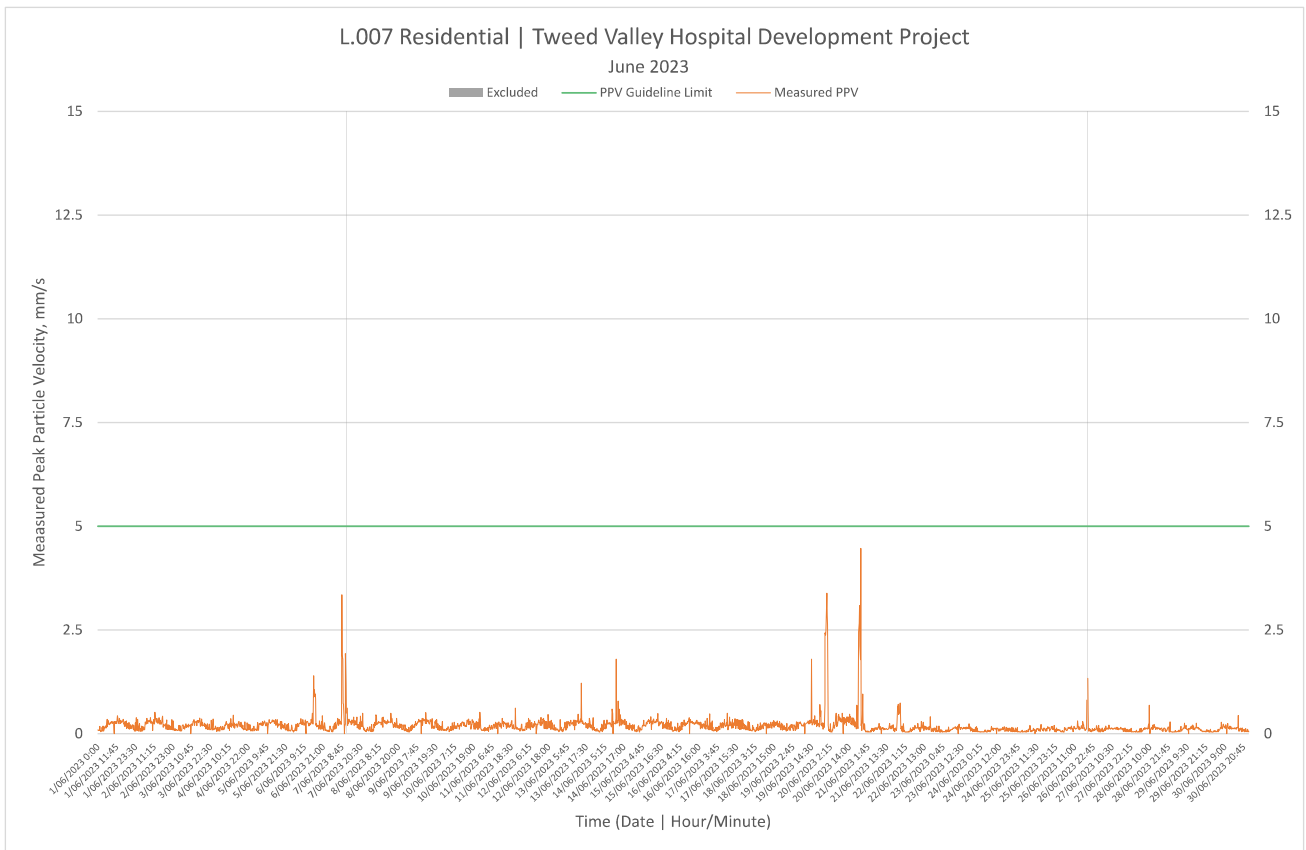
Figure 5 below presents velocity data for the logger located in close proximity to a residential premises, nominated as Location L.007.

Figure 5 Velocity over time (Logger 007 – Residential)

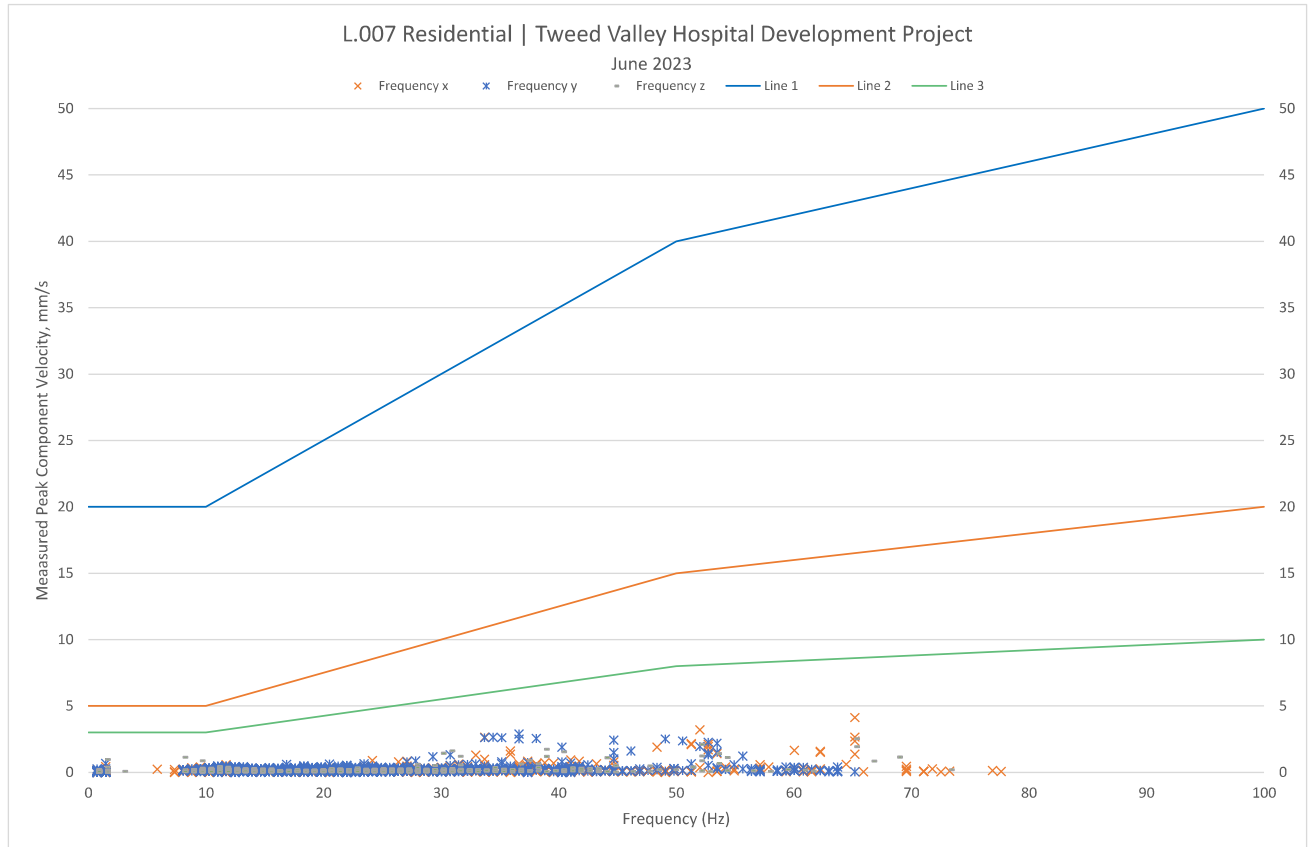
**Figure 6** illustrates the Frequency over Velocity for the data collected and analysed at Location L.007.

**Figure 6** Frequency over Velocity (Logger 007 – Residential)

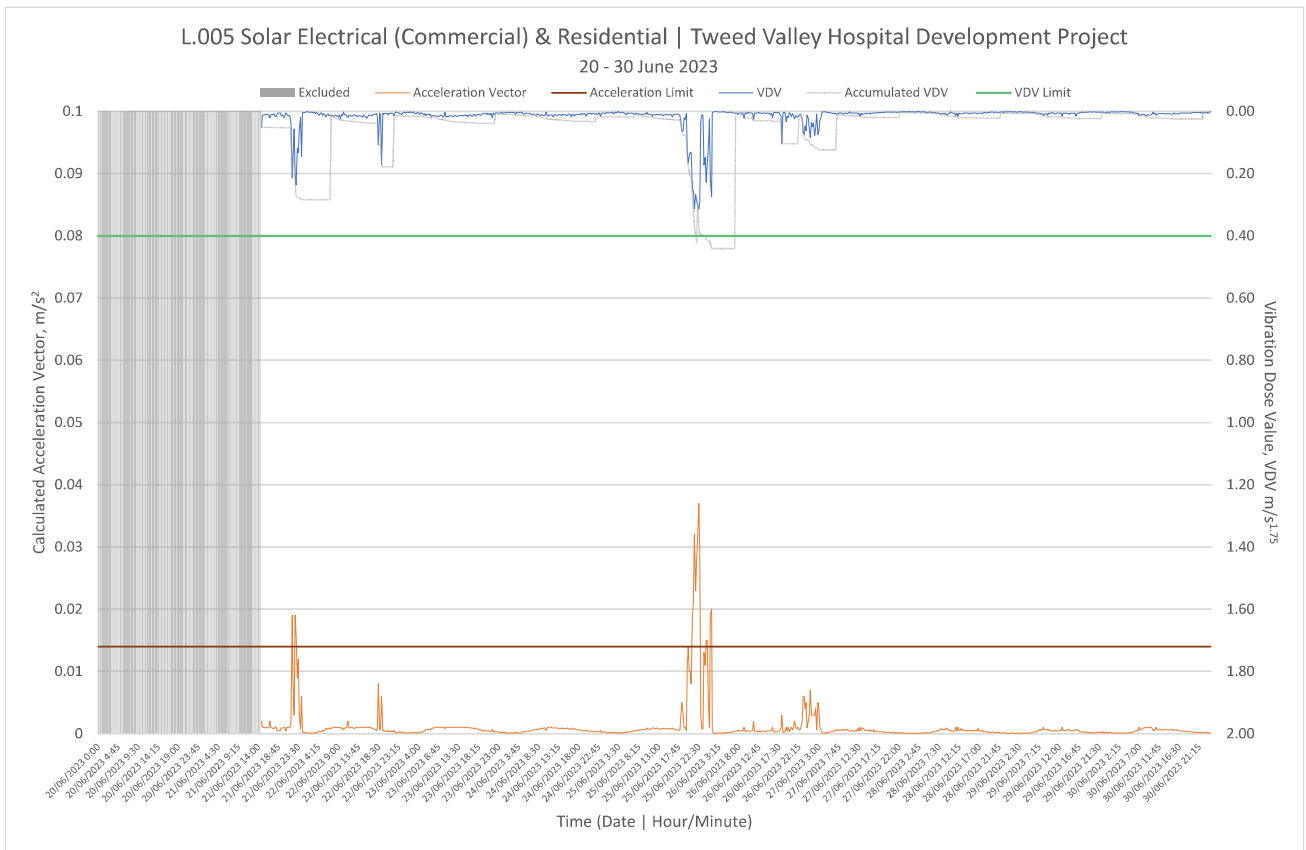
**Figure 7** below presents iVDV, accumulated VDV (per period), and weighted RMS Acceleration ( $\alpha_{rms}$ ) data measured at L.005.

**Figure 7** Acceleration and Vibration Dose Value over time (Logger 005)

At Location L.005, two (2) nights (Wednesday 21 and Sunday 25) measured dosage of 0.3 and 0.5  $m/s^{1.75}$  exceeding the nighttime 0.26  $m/s^{1.75}$  goals.

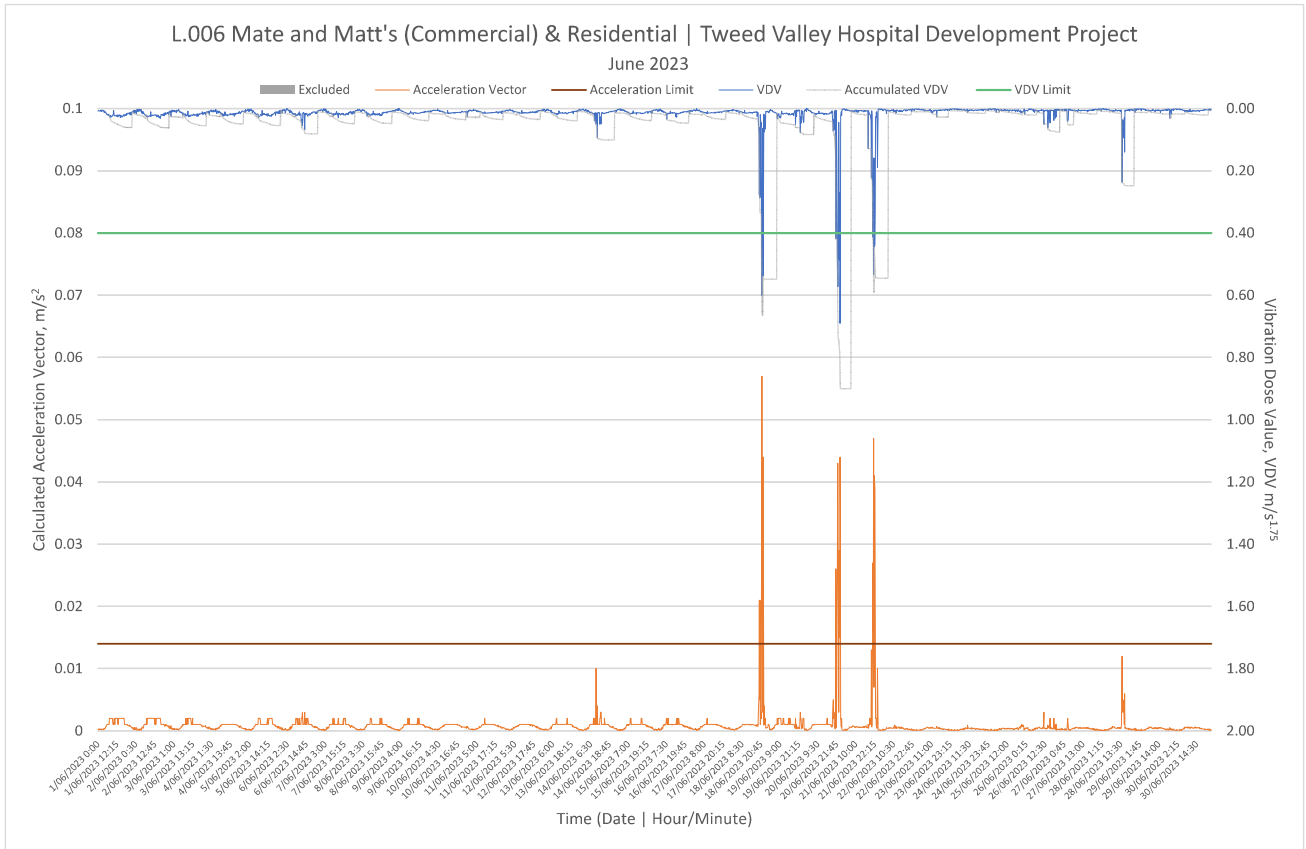
The vibration impact at the commercial and residential premises is presented below in **Figure 8**.

**Figure 8** Acceleration and Vibration Dose Value over time (Logger 006 – Residential/Commercial)

At Location L.006, three (3) nights (Sunday 18, Tuesday 20, and Wednesday 21) measured dosage of 0.5, 0.9, and 0.5  $m/s^{1.75}$  exceeding the nighttime 0.26  $m/s^{1.75}$  goals.

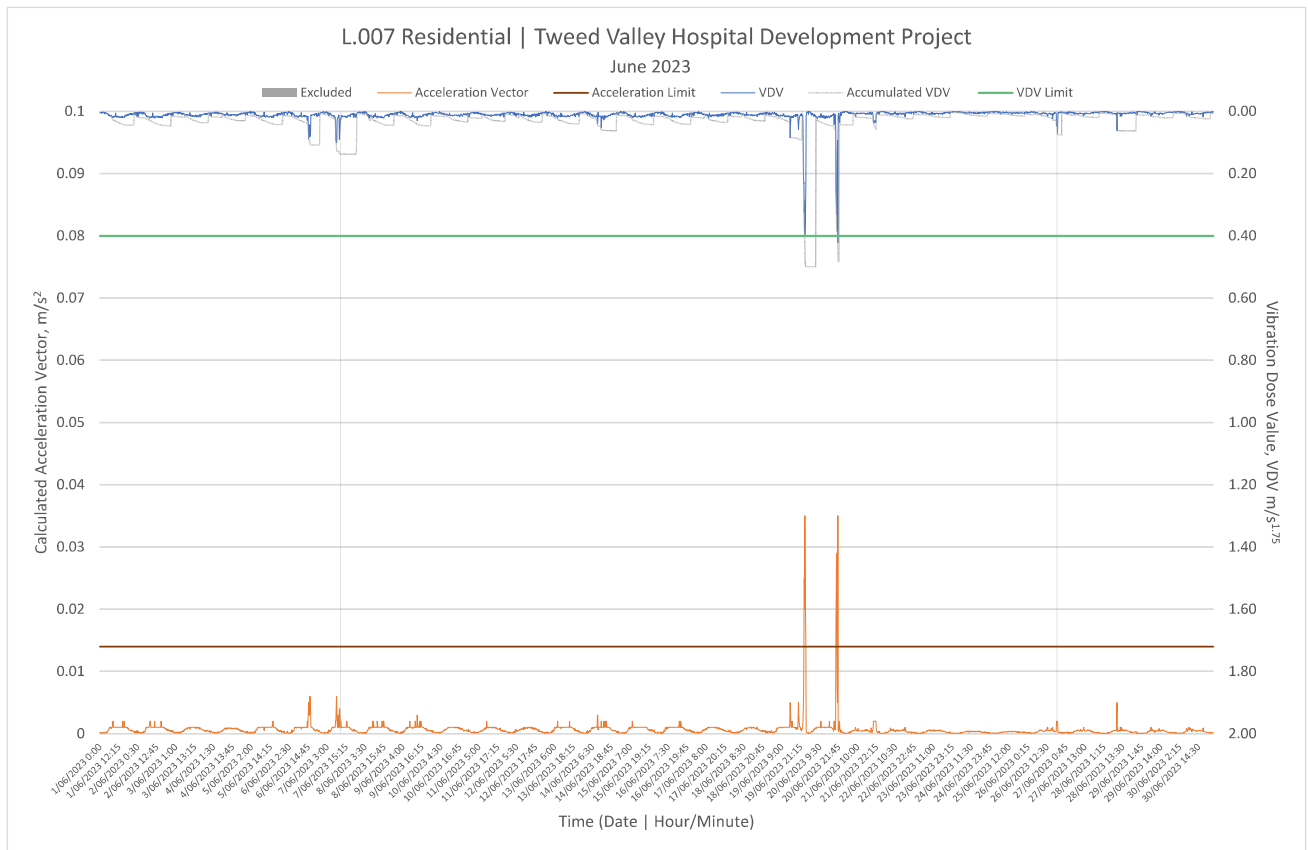
**Figure 9** which follows presents the increase in perceptible vibration at the southwestern residential receiver nominated Location L.007.

**Figure 9** Acceleration and Vibration Dose Value over time (Logger 007 – Residential)

At Location L.007, one (1) night (Monday 19) measured dosage of 0.5  $m/s^{1.75}$  exceeding the nighttime goals.

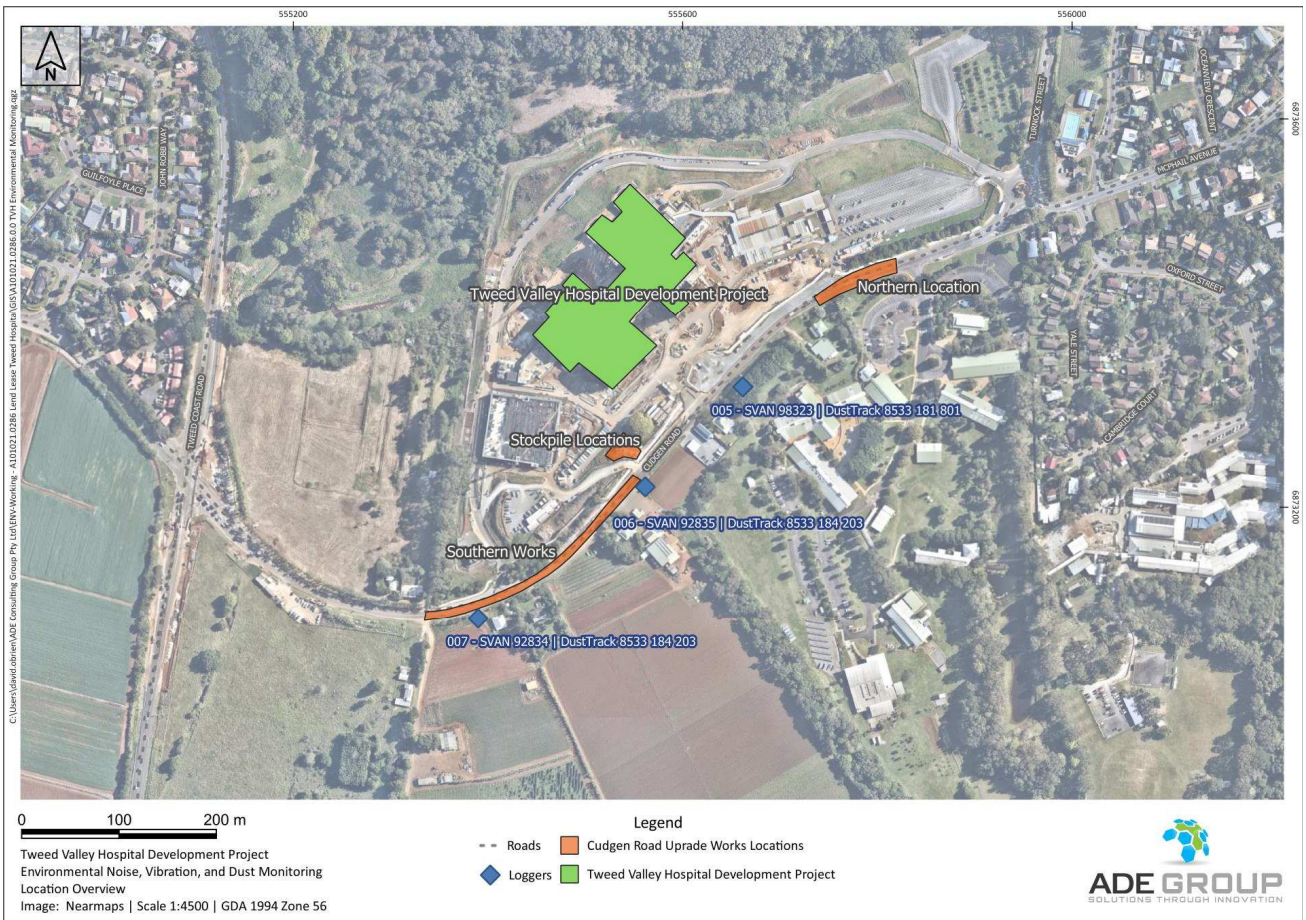
## Appendix II – Aerial Photograph

ADE Monitoring locations, site location (including CD Civil's Cudgen Road Upgrade works) are presented below.

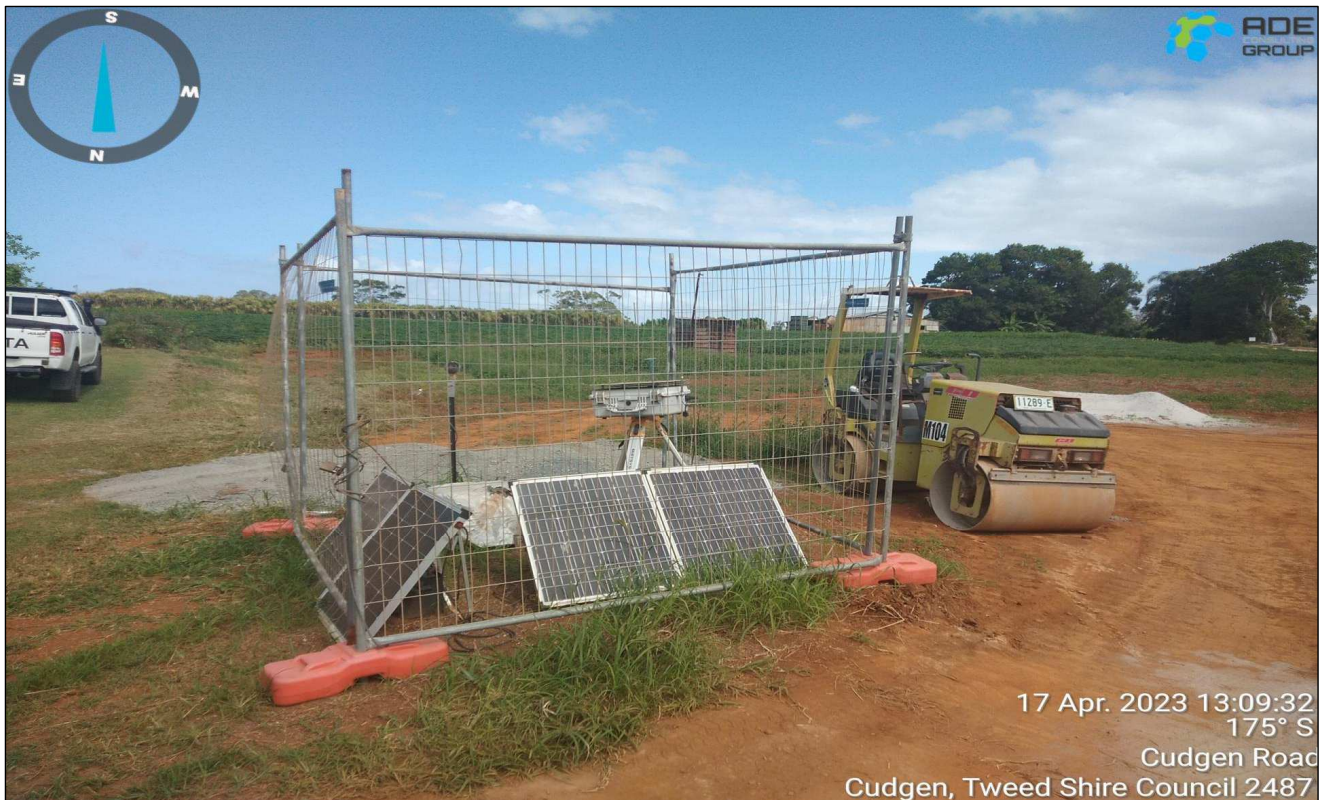
Photograph 1 Representative photograph of monitoring location 007 – Residential, as observed 17/04/2023

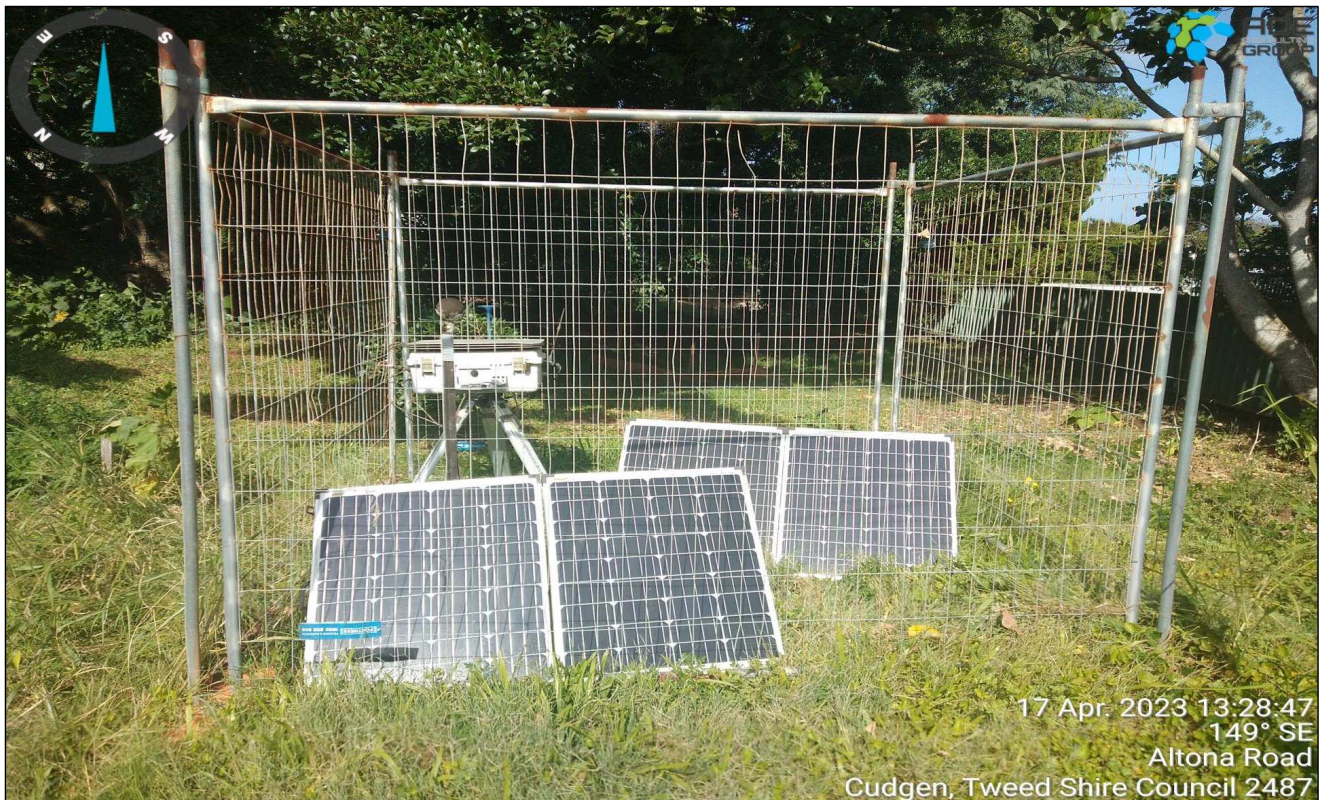
Photograph 2 Representative photograph of monitoring location 005 – Solar Industry, as observed 17/04/2023

Note: Svan 92832 (L05) was replaced by Svan 98323 on 15 June. The location of the replacement device was not compliant against AS1055 'free field' distance requirements and was relocated on 21 June to approximately 4 m from a Colorbond(R) fence. Data from prior to this date is not valid nor presented in this report.

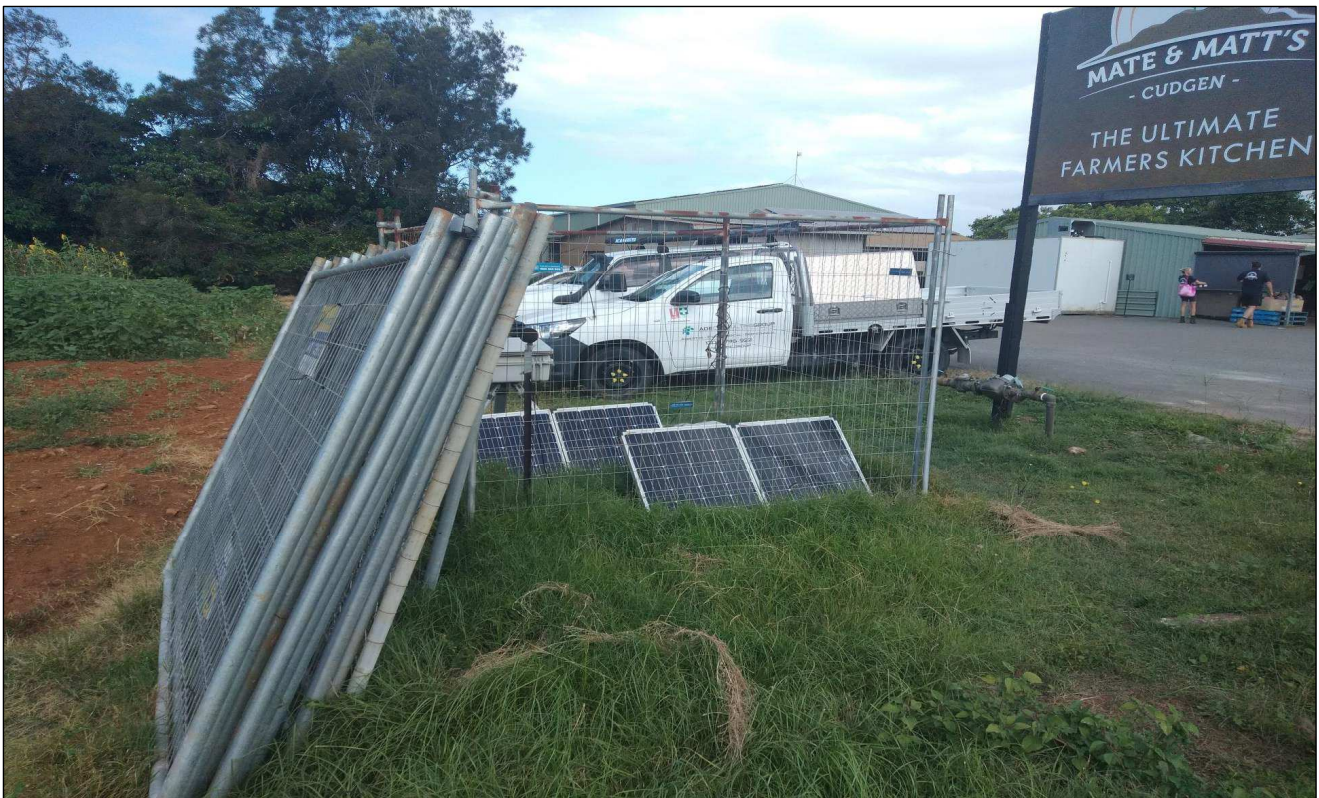
Photograph 3 Representative photograph of monitoring location 006 – Mate and Matts, as observed 17/04/2023
