Environmental Dust Assessment Report (January 2022)

Tweed Valley Hospital Project, Cudgen NSW

A101021.0286.00 | EDM30.Rev0 | Date: 8/02/2022

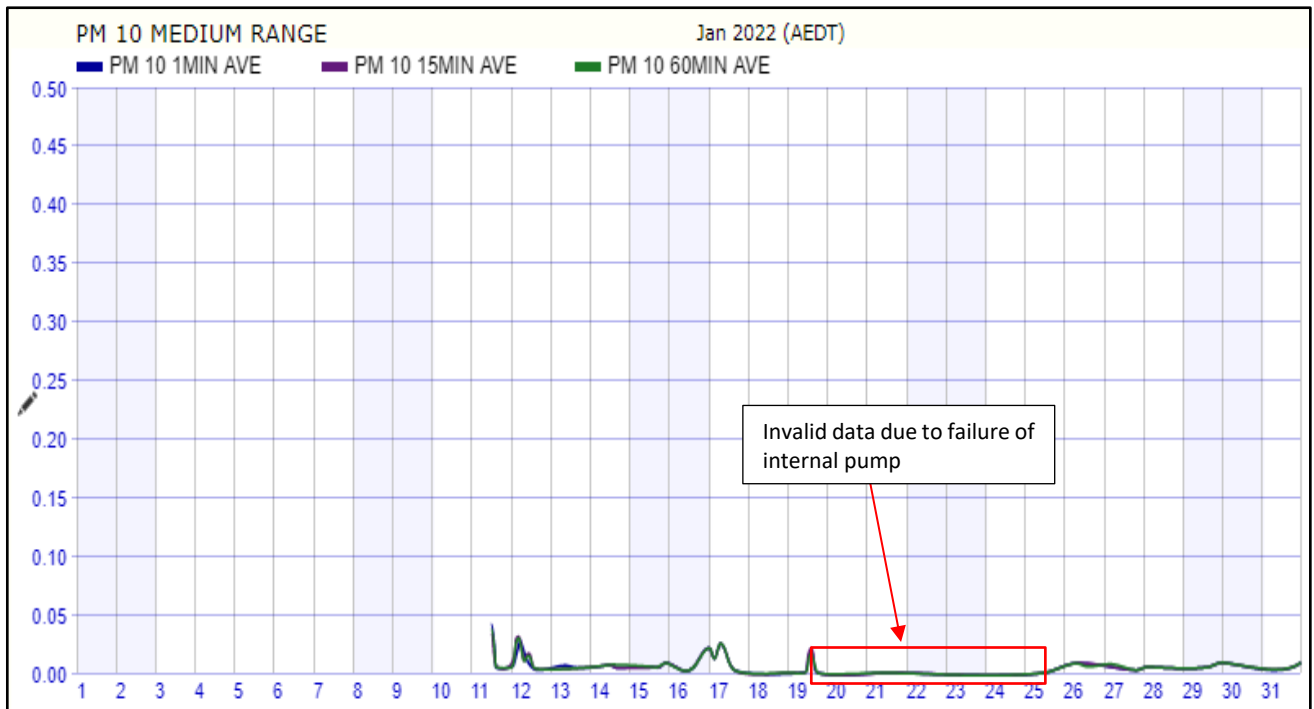
Dust monitor 005 was noted to have a recurring flow error during the daily checks on 19 January 2022. ADE attended site to troubleshoot on 19 January 2022 and discovered the internal pump was faulty and was unable to pull air into the monitor. The monitor was removed from site for replacement was reinstalled on 25 January 2022.

Figure 2. Summary of PM10 from the real time monitoring at location 005 – TAFE West for the month of January 2022.

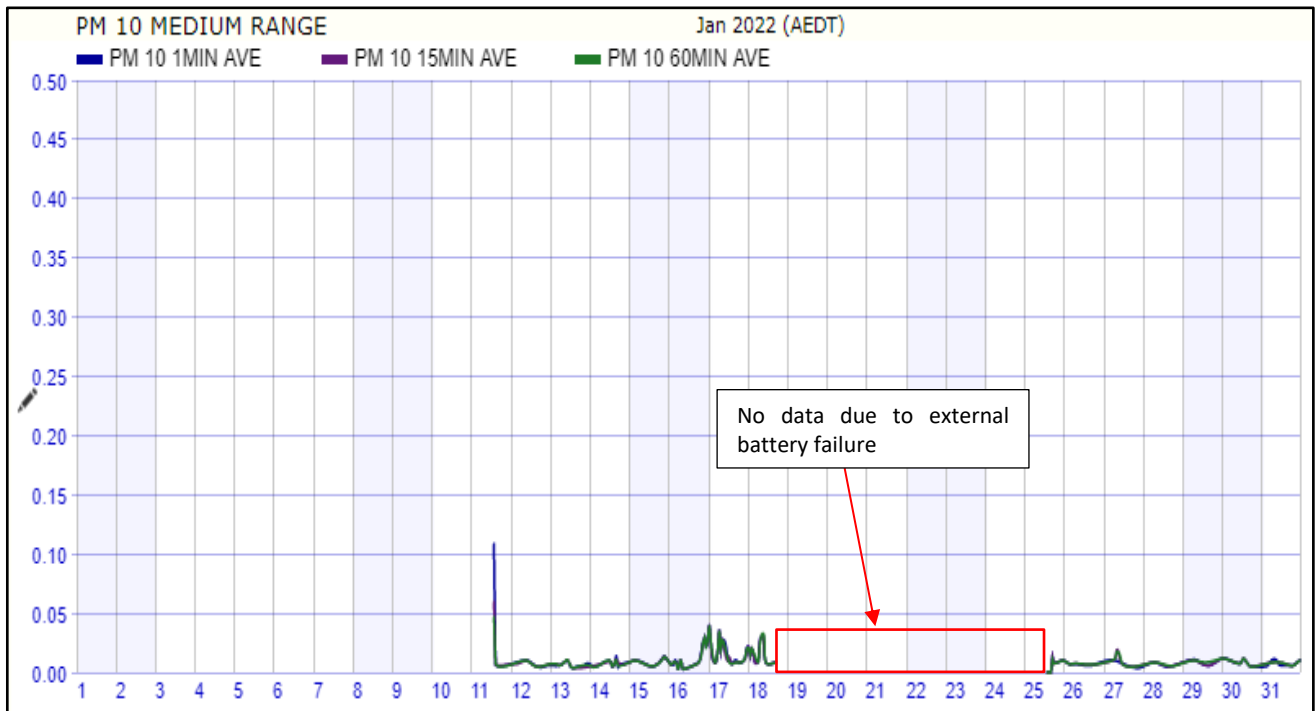
Dust monitor 006 was noted to have a flat battery during the daily checks on 19 January 2022. ADE attended site to check power connections and optimise the angle of the solar panels on 19 January 2022. The monitor ran normally from 1400 – 1500 AEDT on 19 January 2022. However, the battery died shortly after 1500 AEDT. A replacement battery arrived at 1600 AEDT on 24 January 2022. ADE attended site on 25 January 2022 to reinstall the battery on-site.

Figure 3. Summary of PM10 from the real time monitoring at location 006 – Mate and Matts for the month of January 2022.

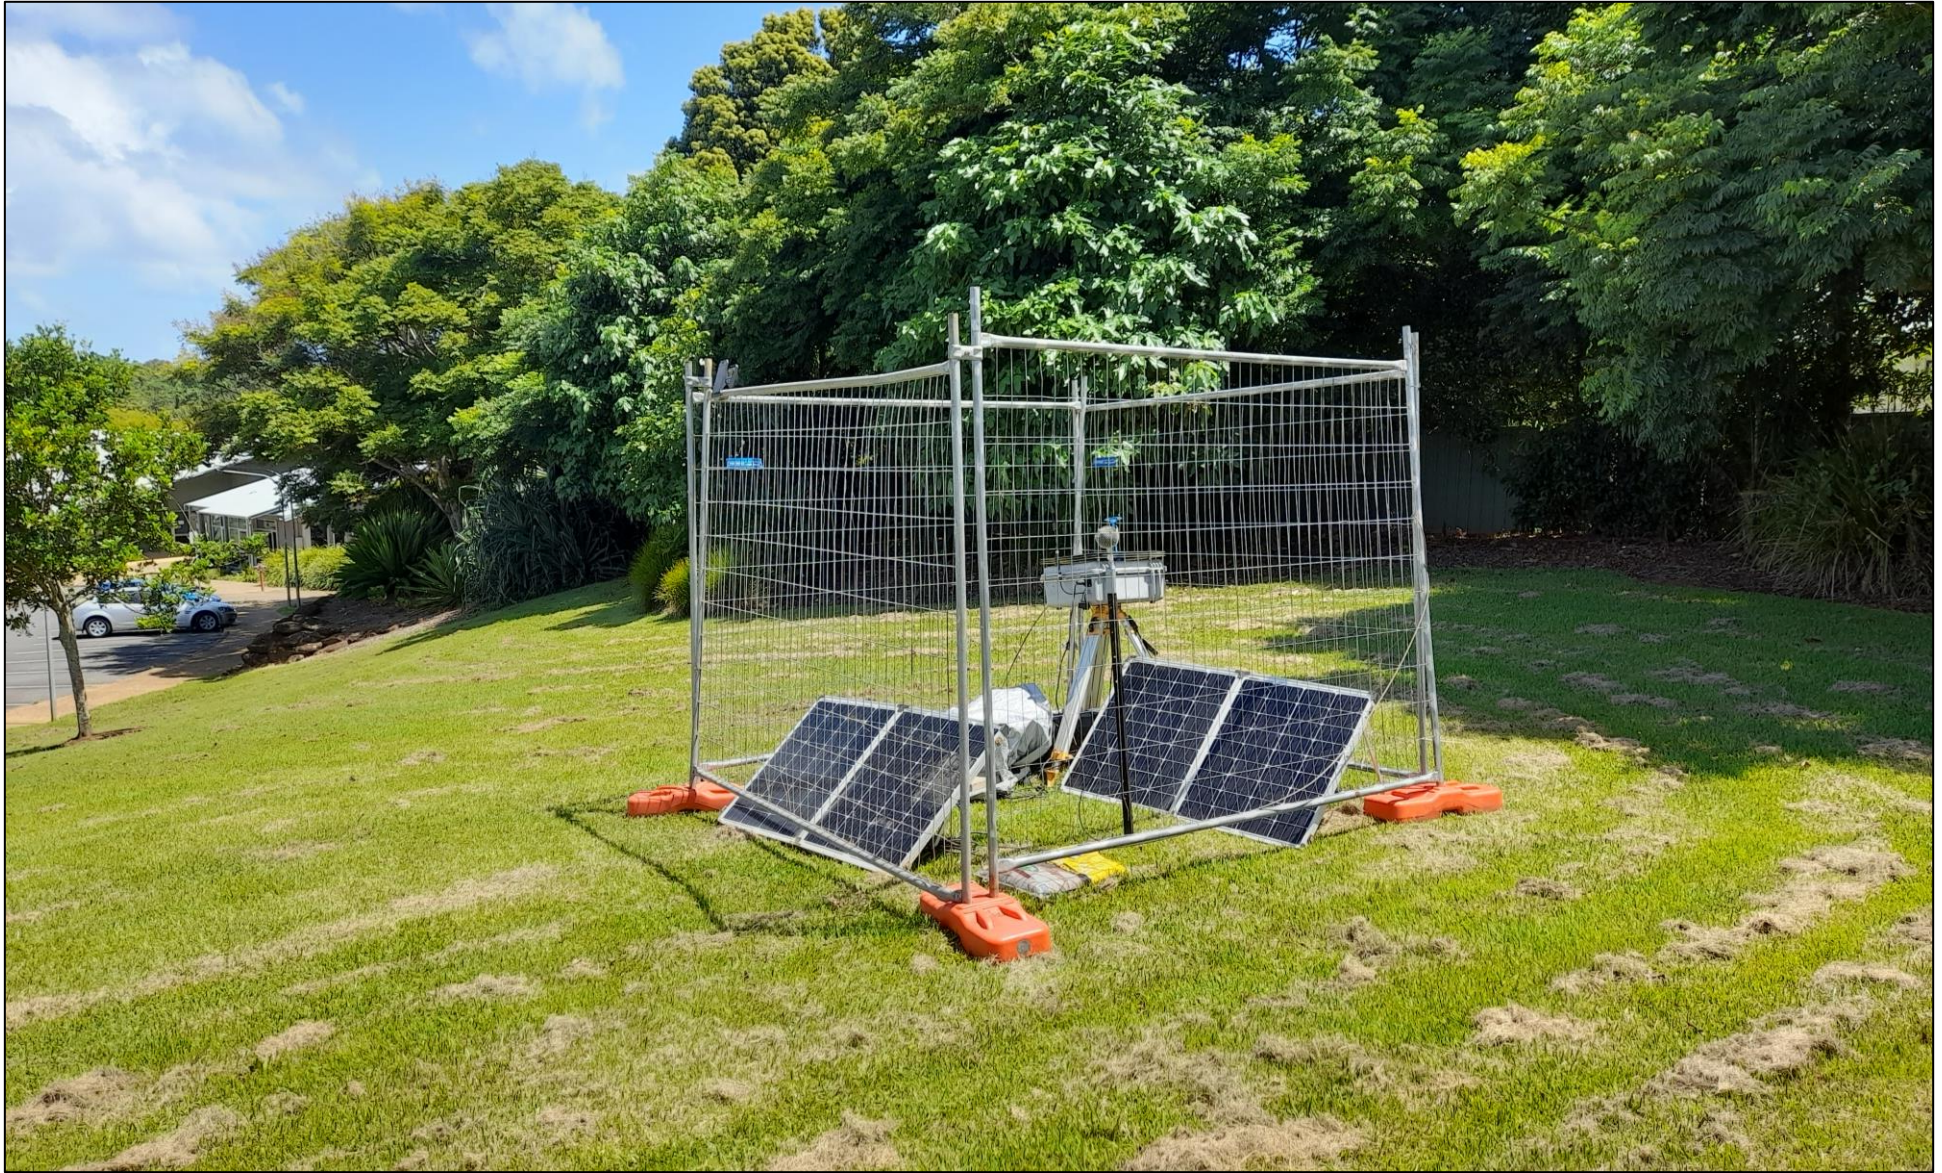
Photograph 1 Representative photograph of monitoring location 004 – TAFE East, as observed 06/01/2022

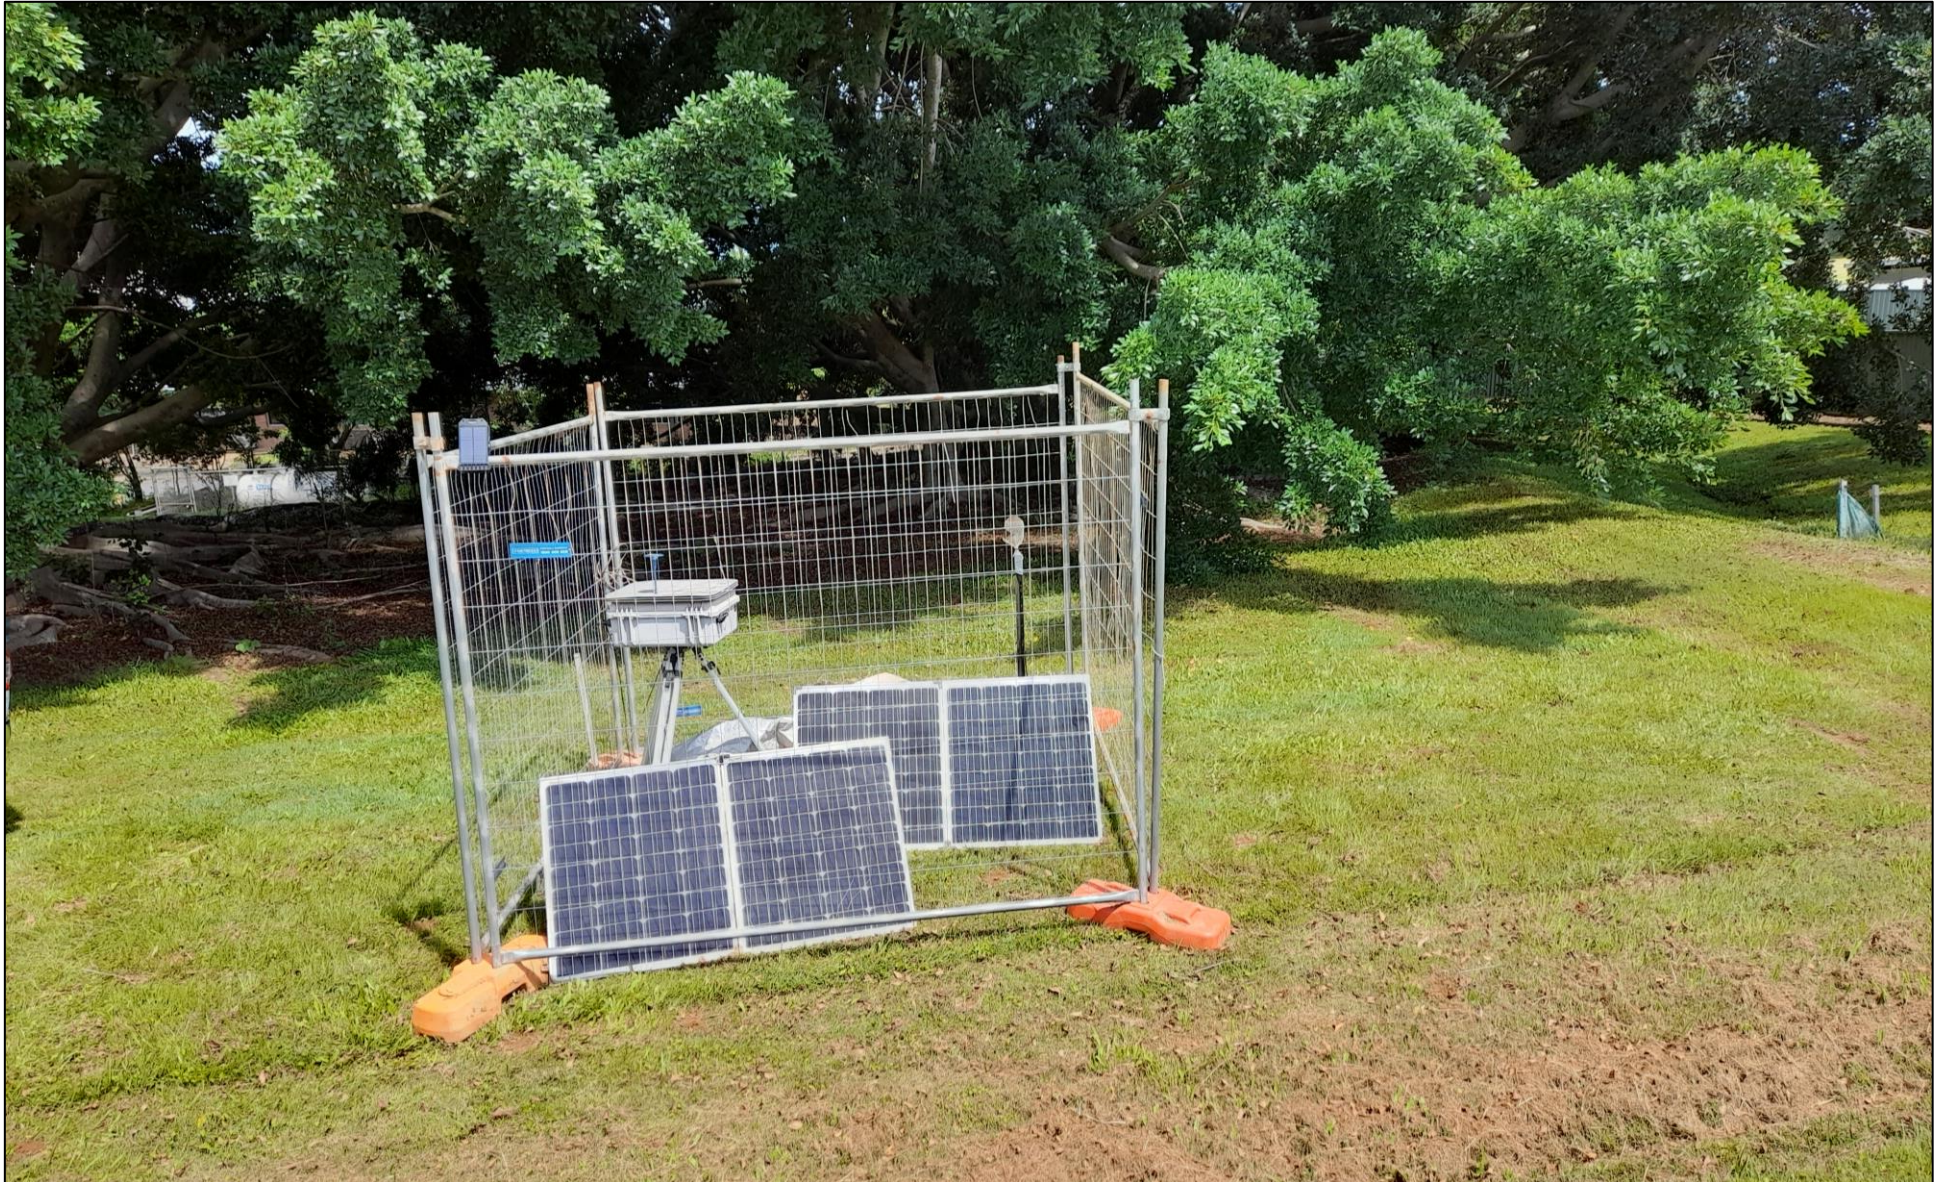
Photograph 2 Representative photograph of monitoring location 005 – TAFE West, as observed 06/01/2022

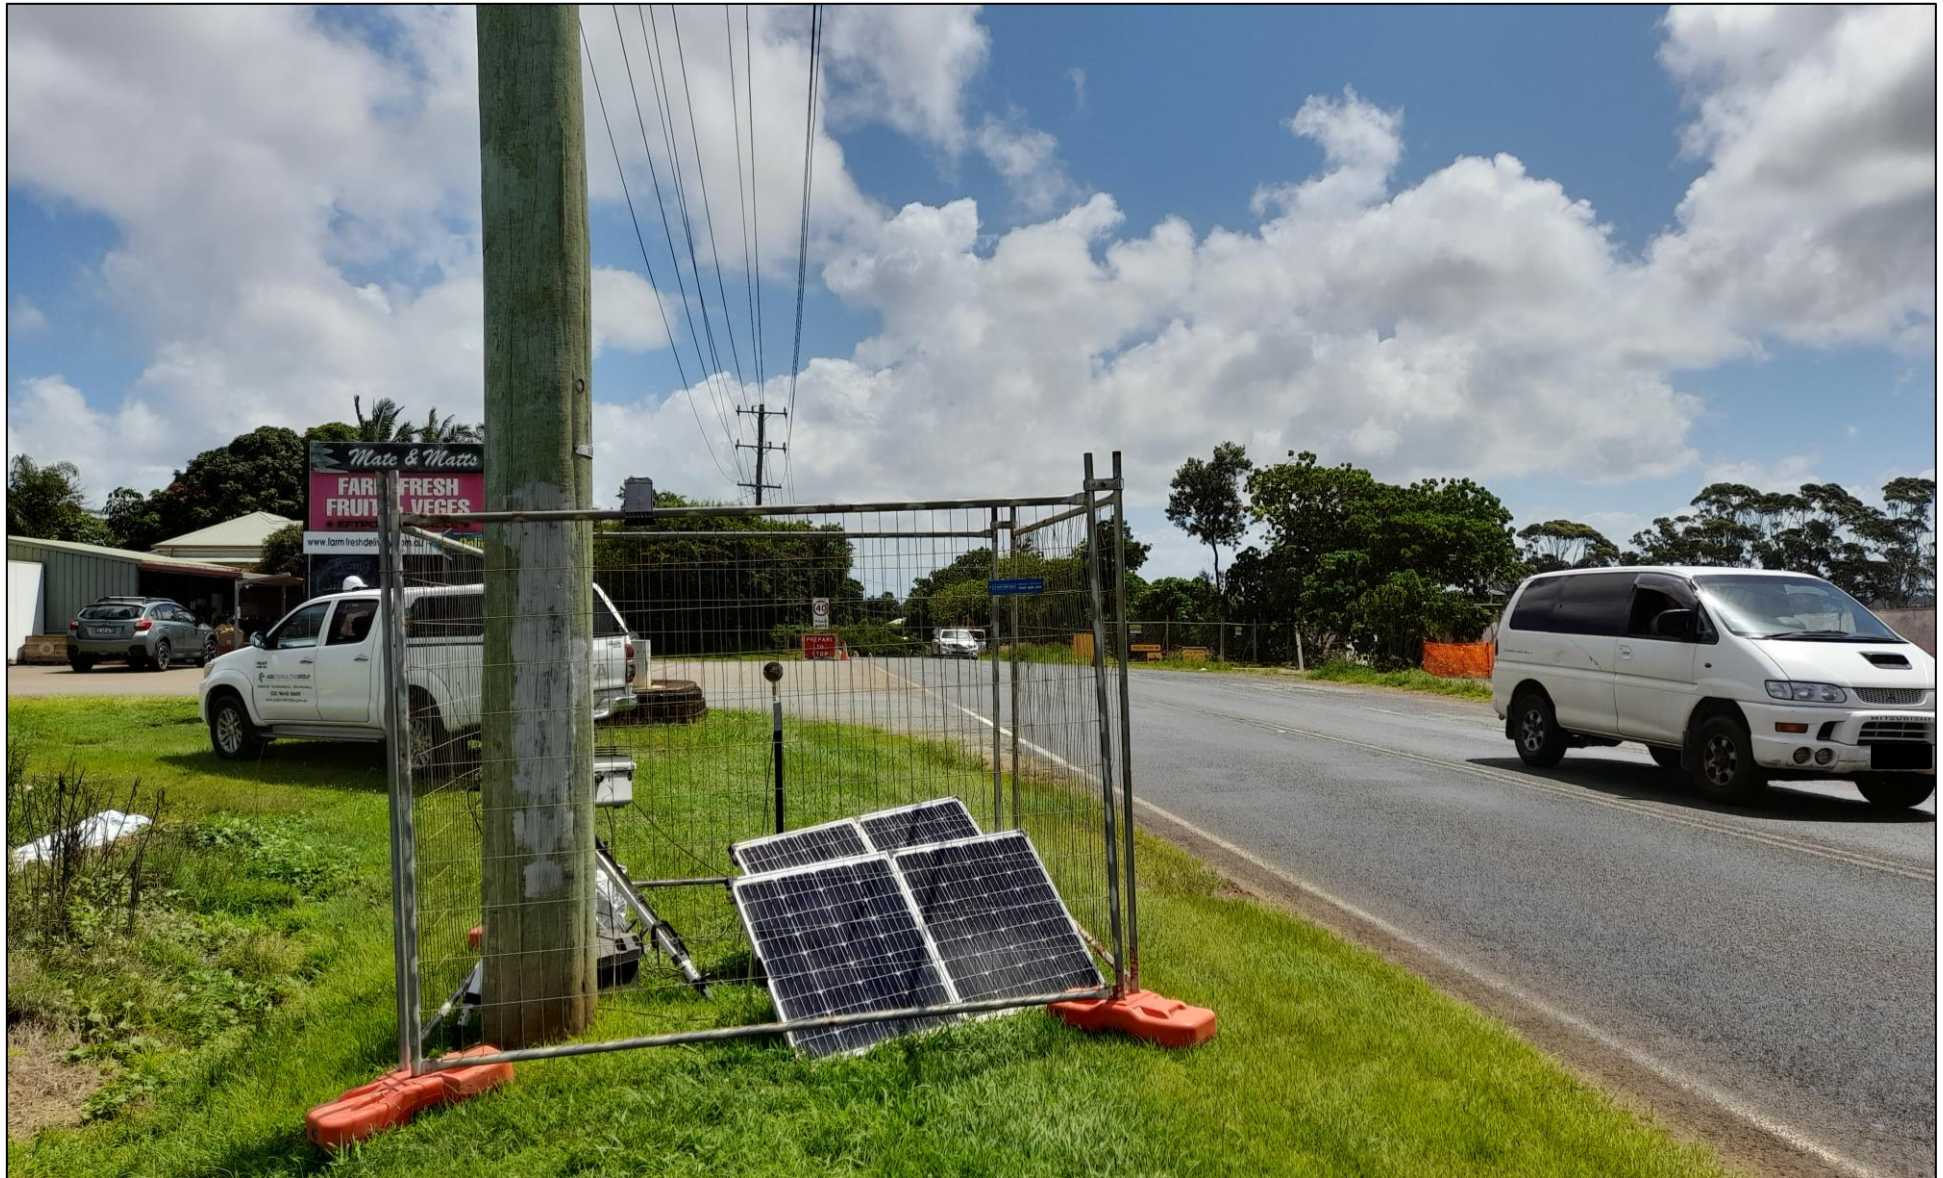
Photograph 3 Representative photograph of monitoring location 006 – Mate and Matts, as observed 06/01/2022
