# Vibration Monitoring Assessment Report (March 2020)

771 Cudgen Road, Kingscliff NSW

Prepared for: Delta Group

DLT-01-Q1013 / VIB8 / v1.4f  
24<sup>th</sup> June 2020

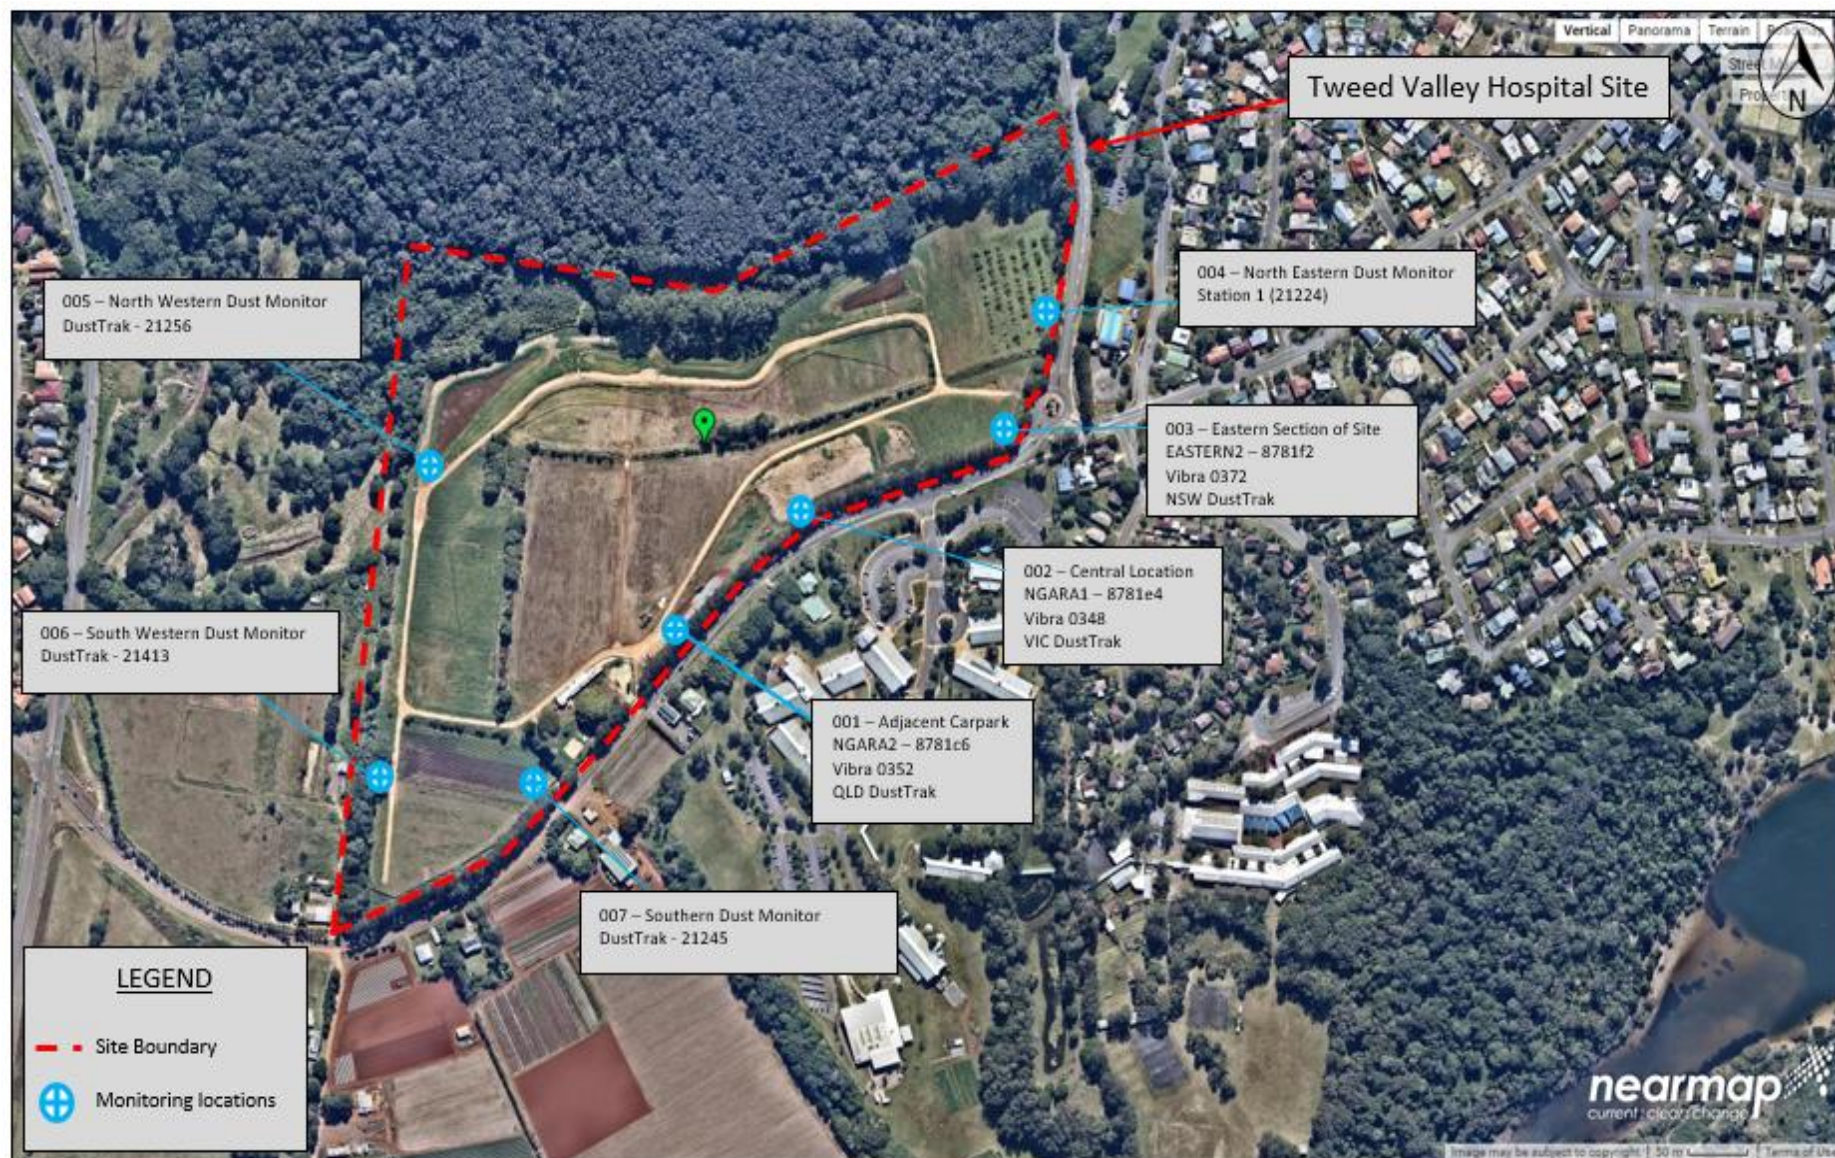
The three (3) vibration monitors are located within the confines of the site adjacent to Cudgen Road and were supplied by the client (*refer to Figure 1 – Aerial Photograph*).

**Figure 1.** Aerial photograph of the site at Kingscliff NSW

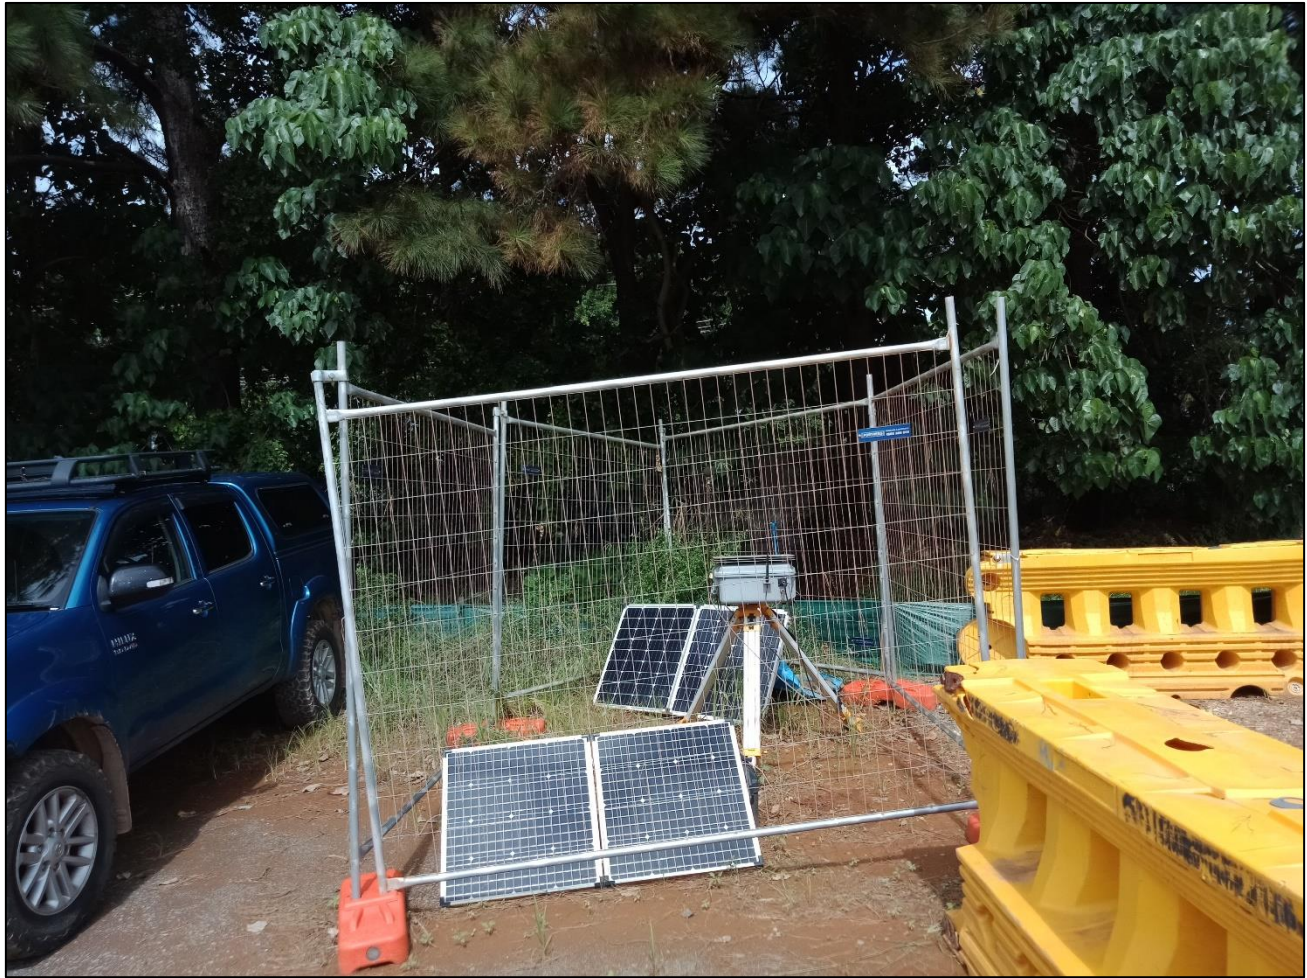
**Photograph 1.** Representative photo of the monitoring location 001 – Adjacent Carpark location, as observed on the 13.03.2020.

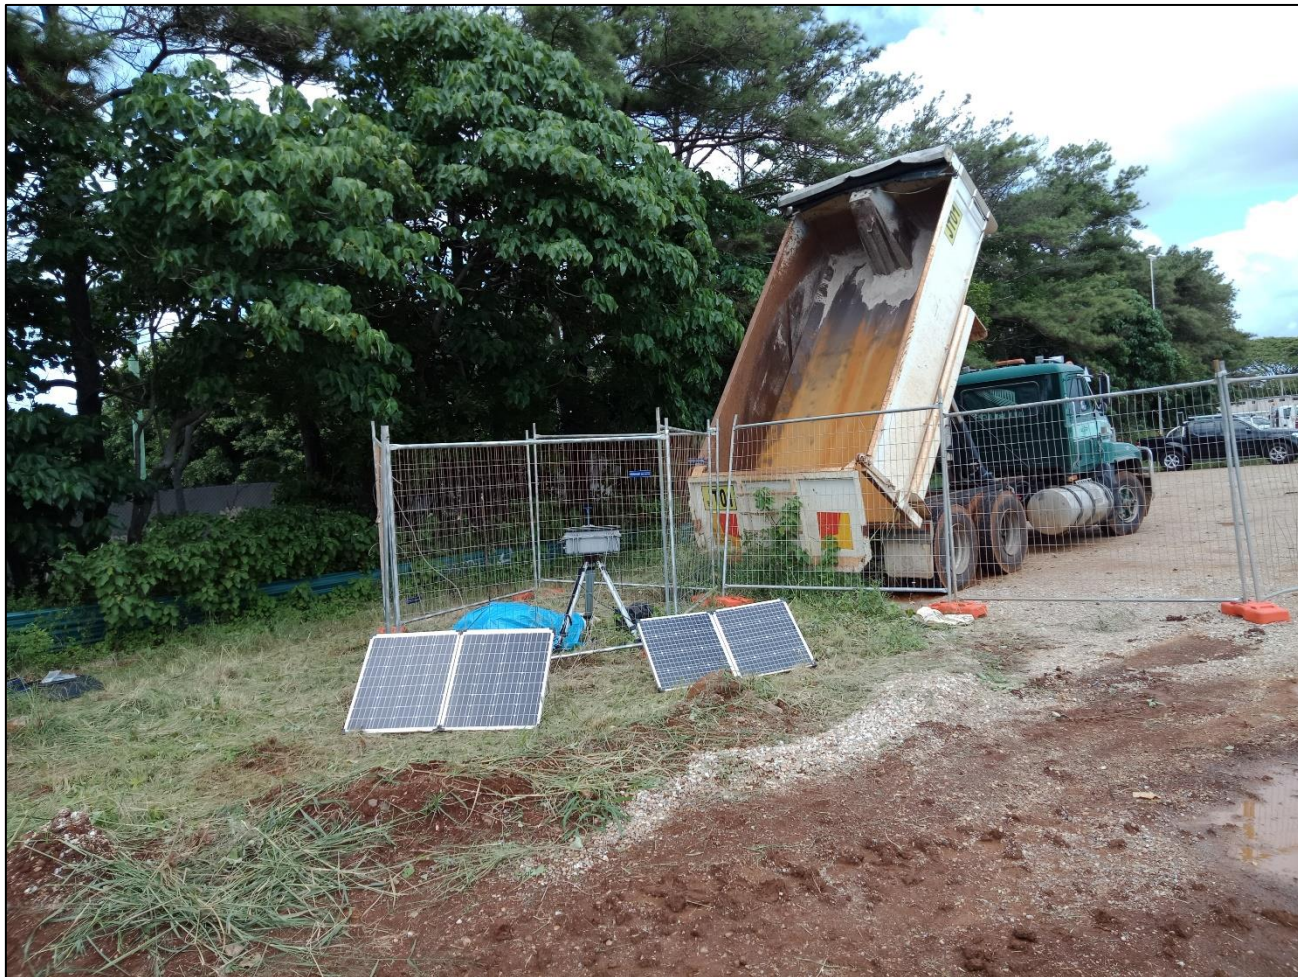
Vibration values >5mm/s on the 13<sup>th</sup> of March 2020 at monitoring location 002 were caused by ADE performing maintenance on the monitors and are not due to construction works. All other values are below Line 1 and Line 2.

**Photograph 2.** Representative photo of the monitoring location 002 – Central location, as observed on the 13.03.2020.

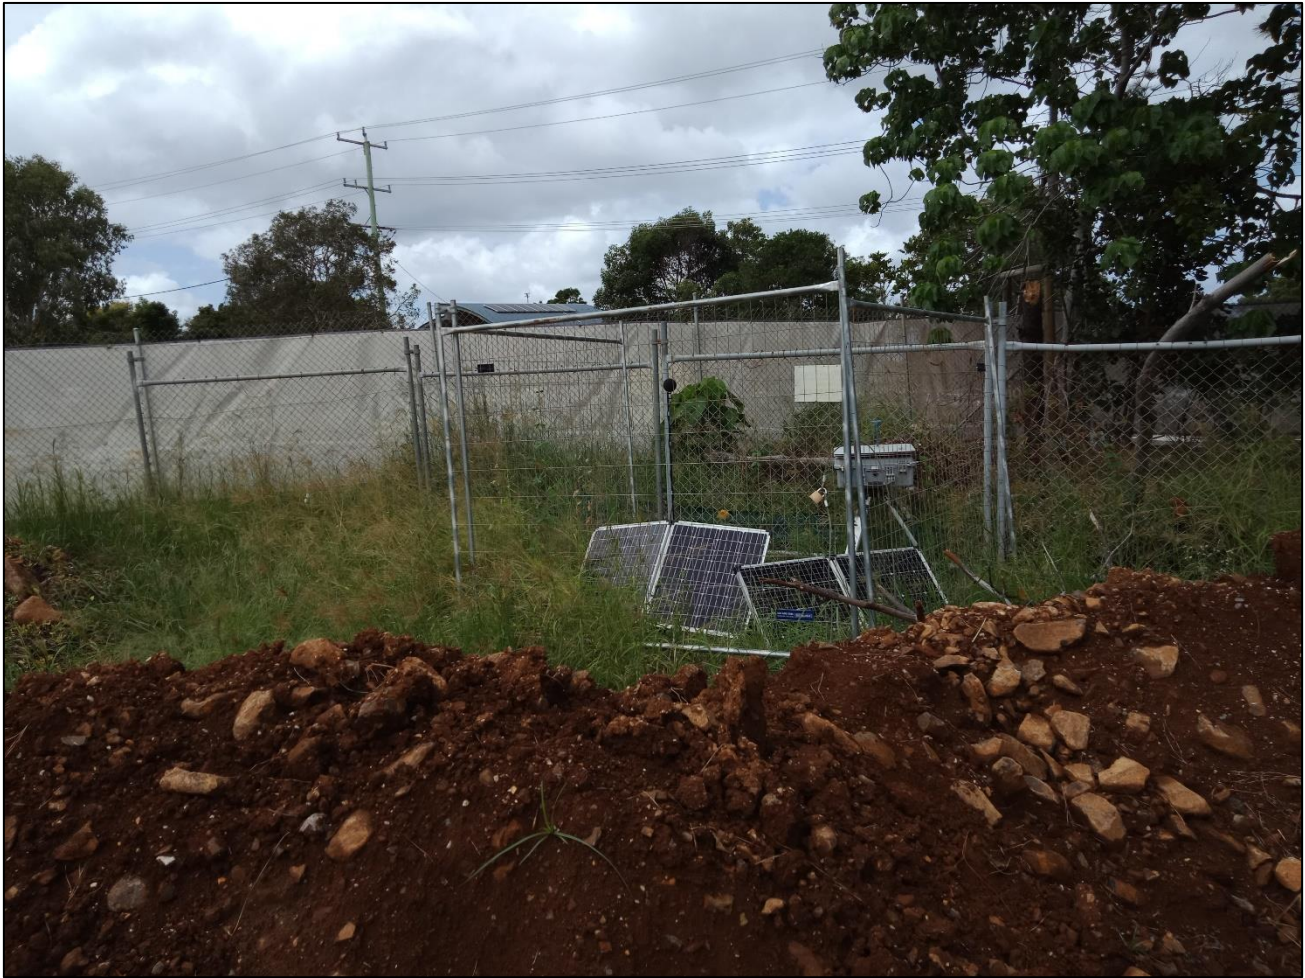
**Photograph 3.** Representative photo of the monitoring location 003 – Eastern Section of Site, as observed on the 13.03.2020.
