Environmental Dust Assessment Report (April 2020)

Tweed Valley Hospital Project

DLT-01-Q1013 / EDM9 / v1.4f

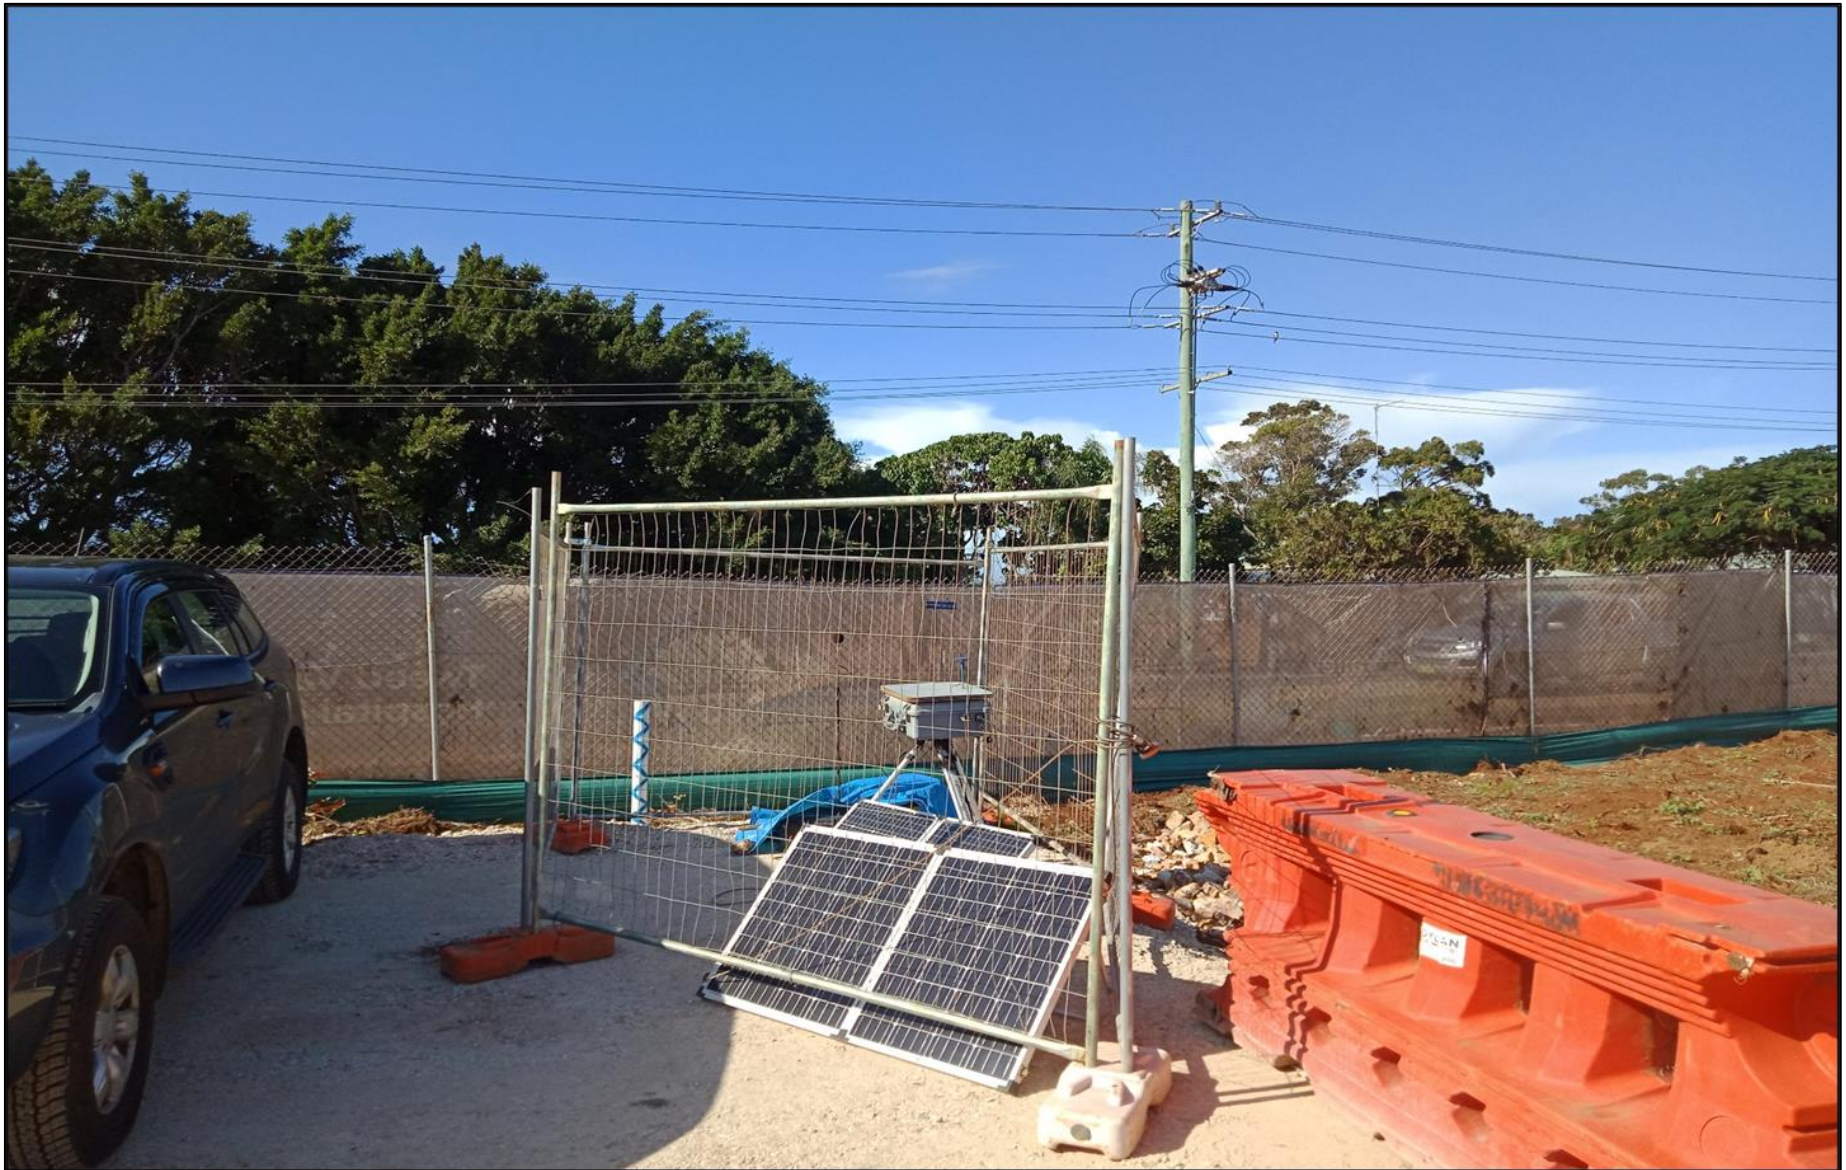
Photograph 1. Representative photo of the monitoring location 001 – Adjacent Carpark location, as observed on the 05.05.2020.

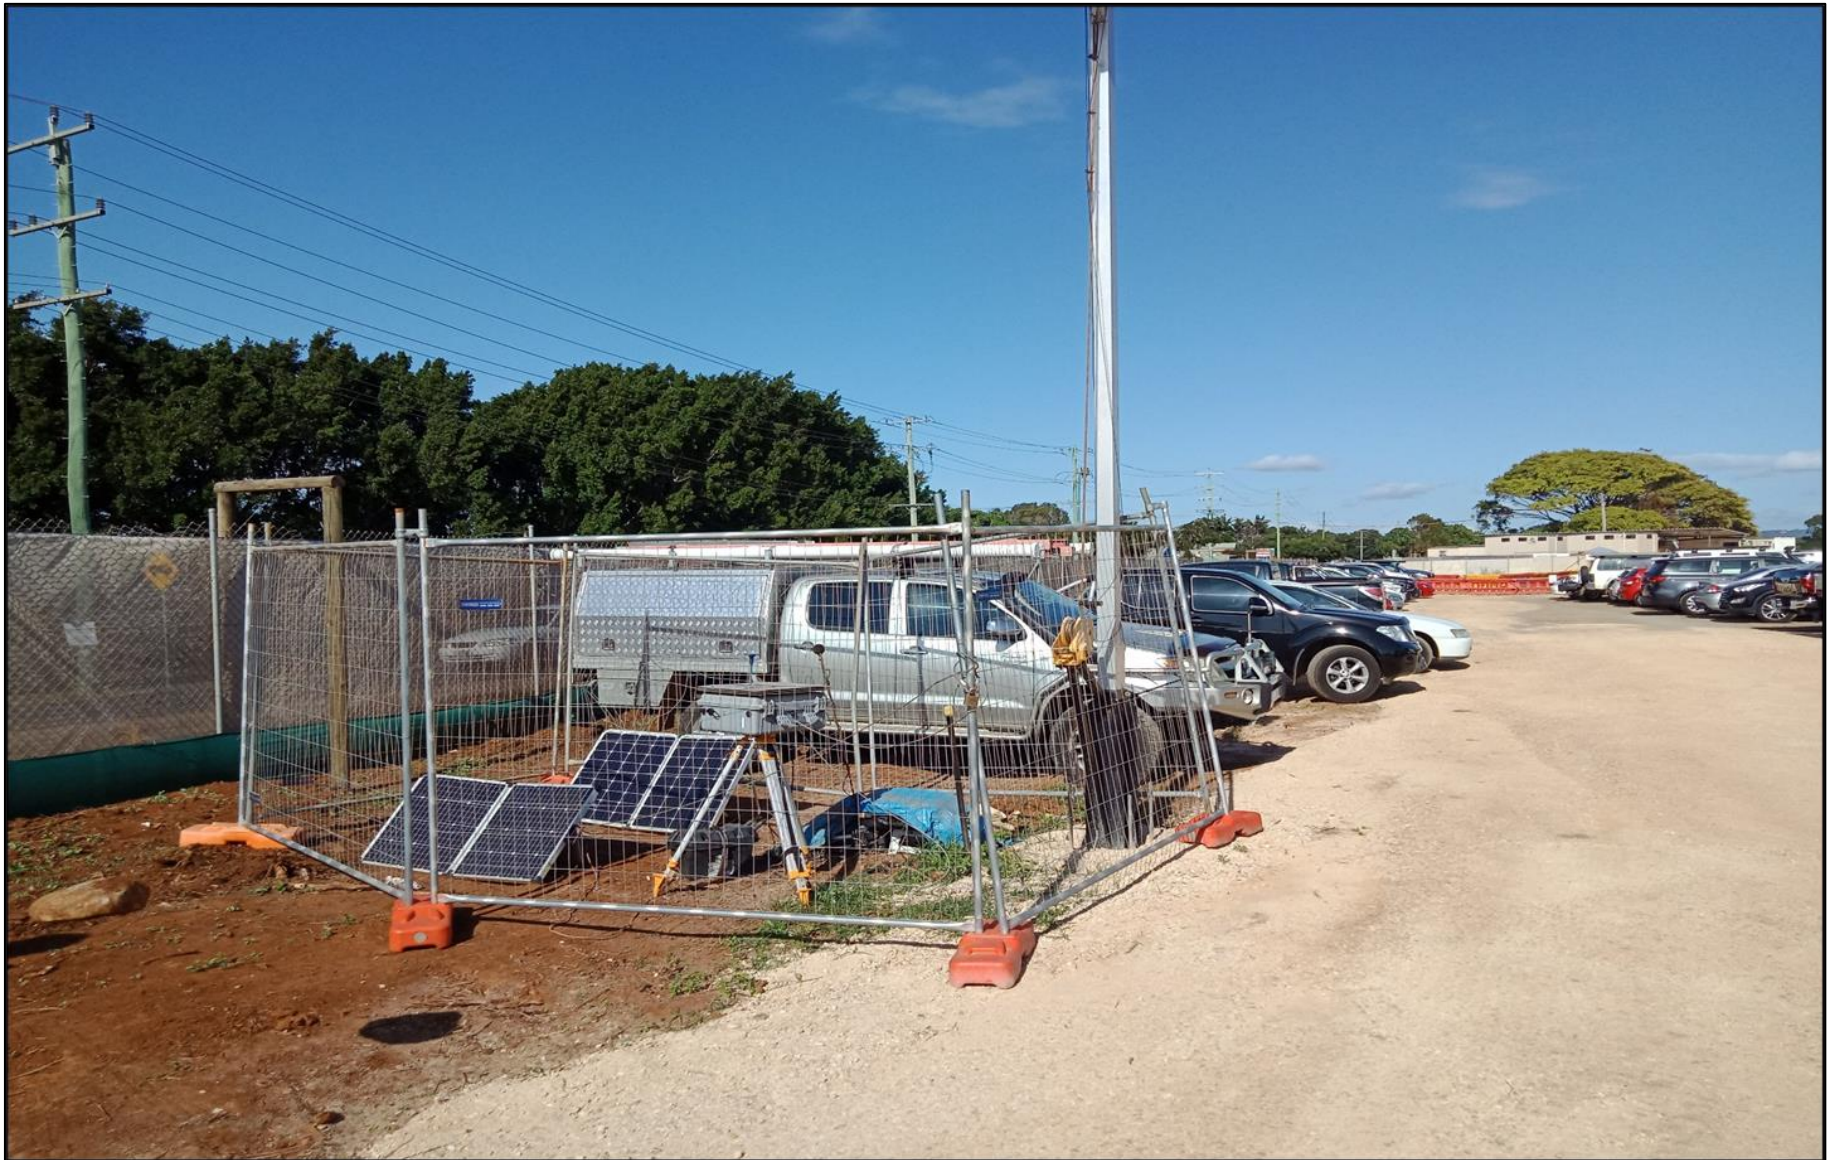
Photograph 2. Representative photo of the monitoring location 002 – Central location, as observed on the 05.05.2020.

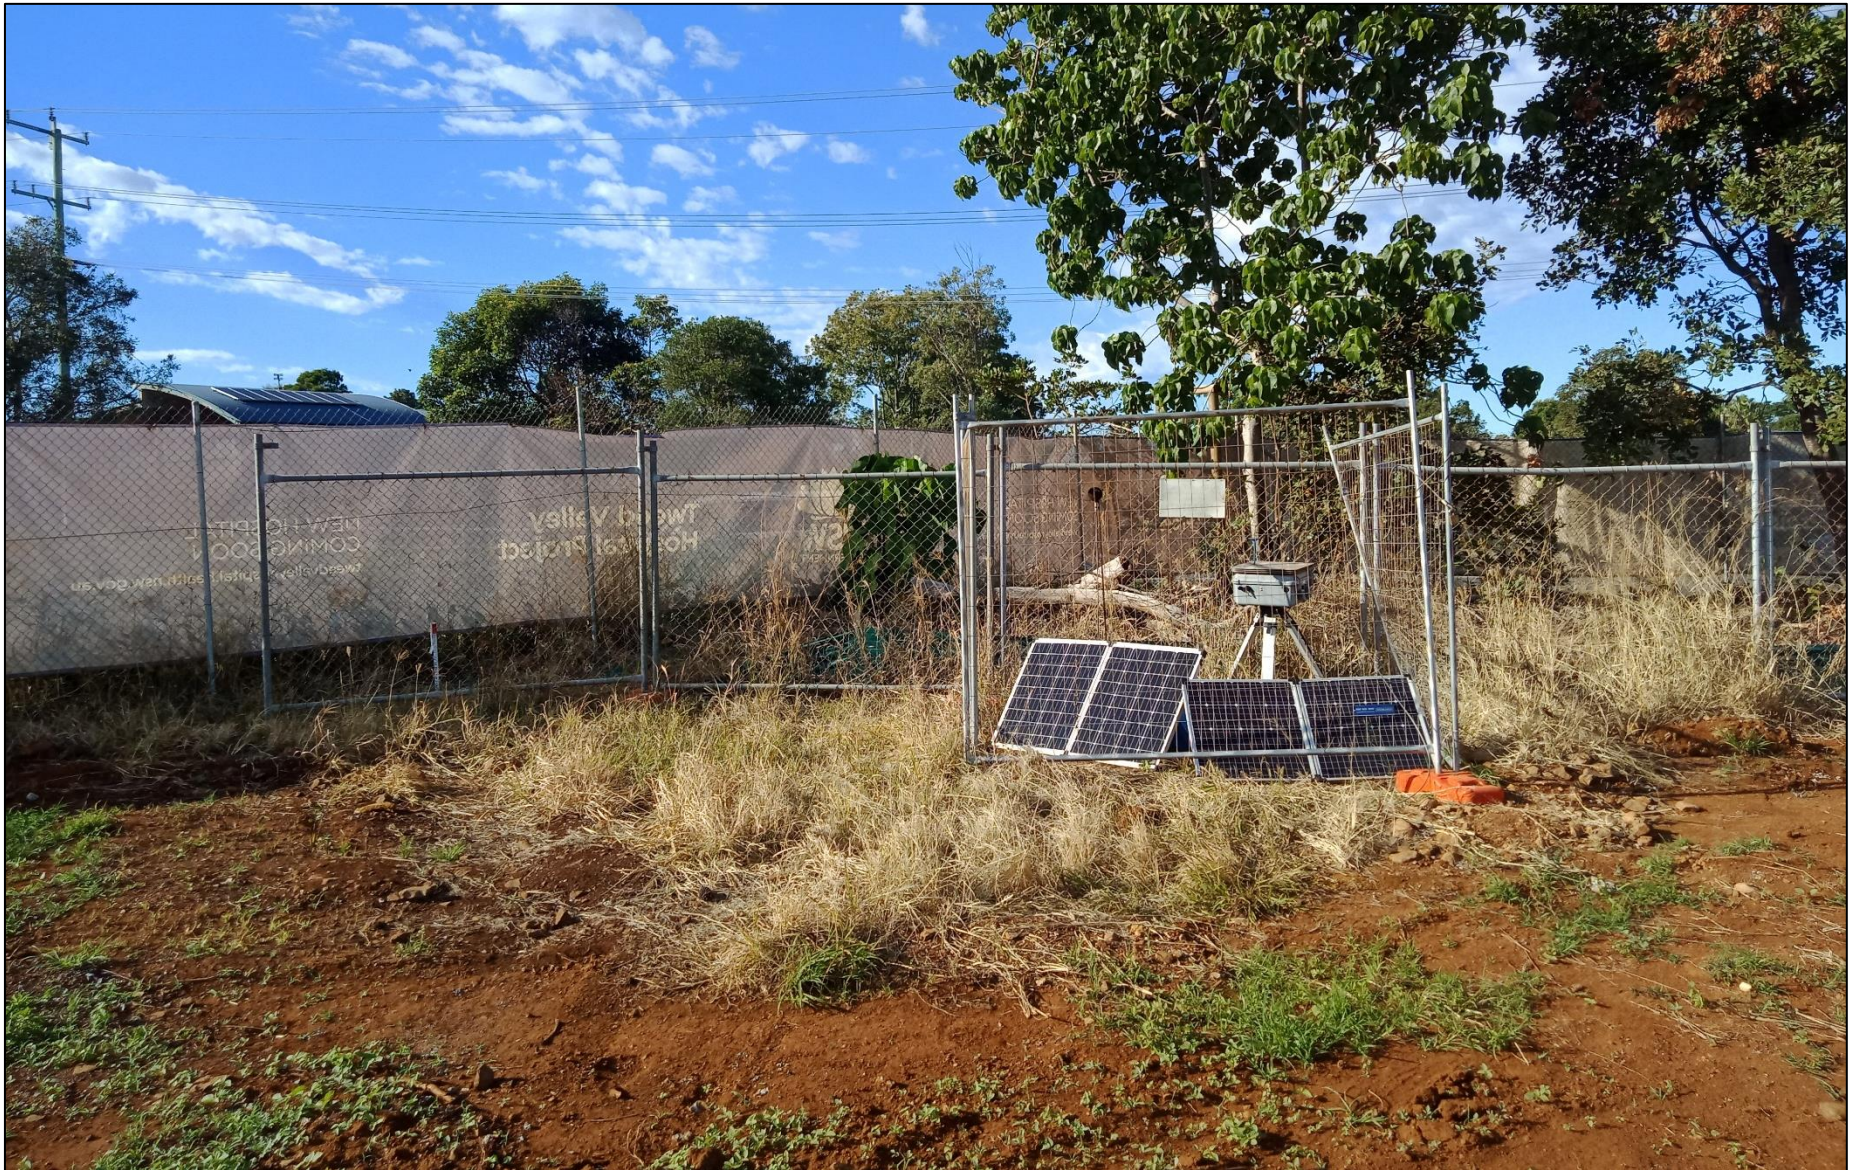
Data gaps from the 11th - 16th at location 003 were the result of the monitor displaying constant values of 0.00 and failing to record and upload any readings. ADE attended Site on the 16th of April to investigate and rectify the issues (*refer to Appendix II – ADE Site Time Summary*). The filters of the dust monitor were replaced, all cables and connections were checked for damage, power to the monitor was reset and each monitor was calibrated by ADE while on site.

Photograph 3. Representative photo of the monitoring location 003 – Eastern Section of Site, as observed on the 01.05.2020.

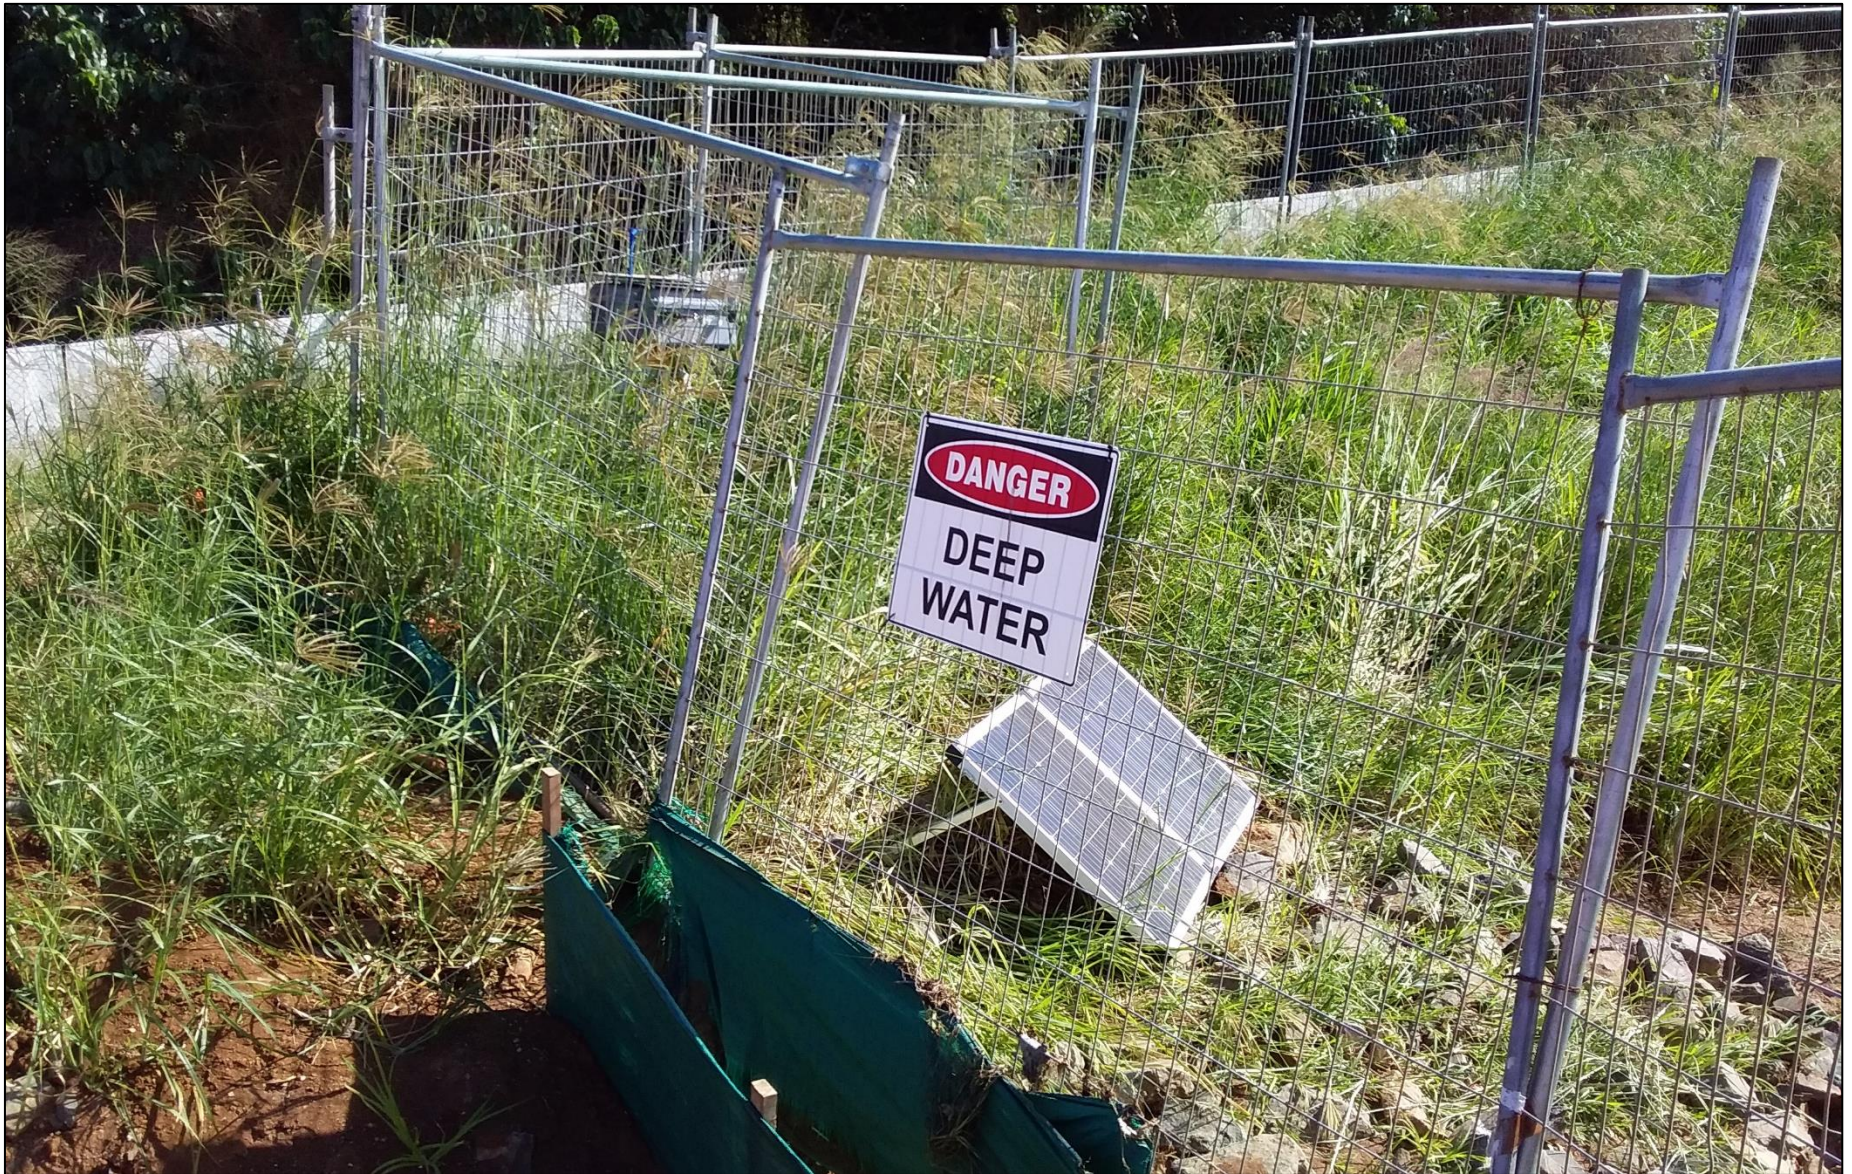
Photograph 5. Representative photo of the monitoring location 005 – North Western section of Site, as observed on the 05.05.2020.

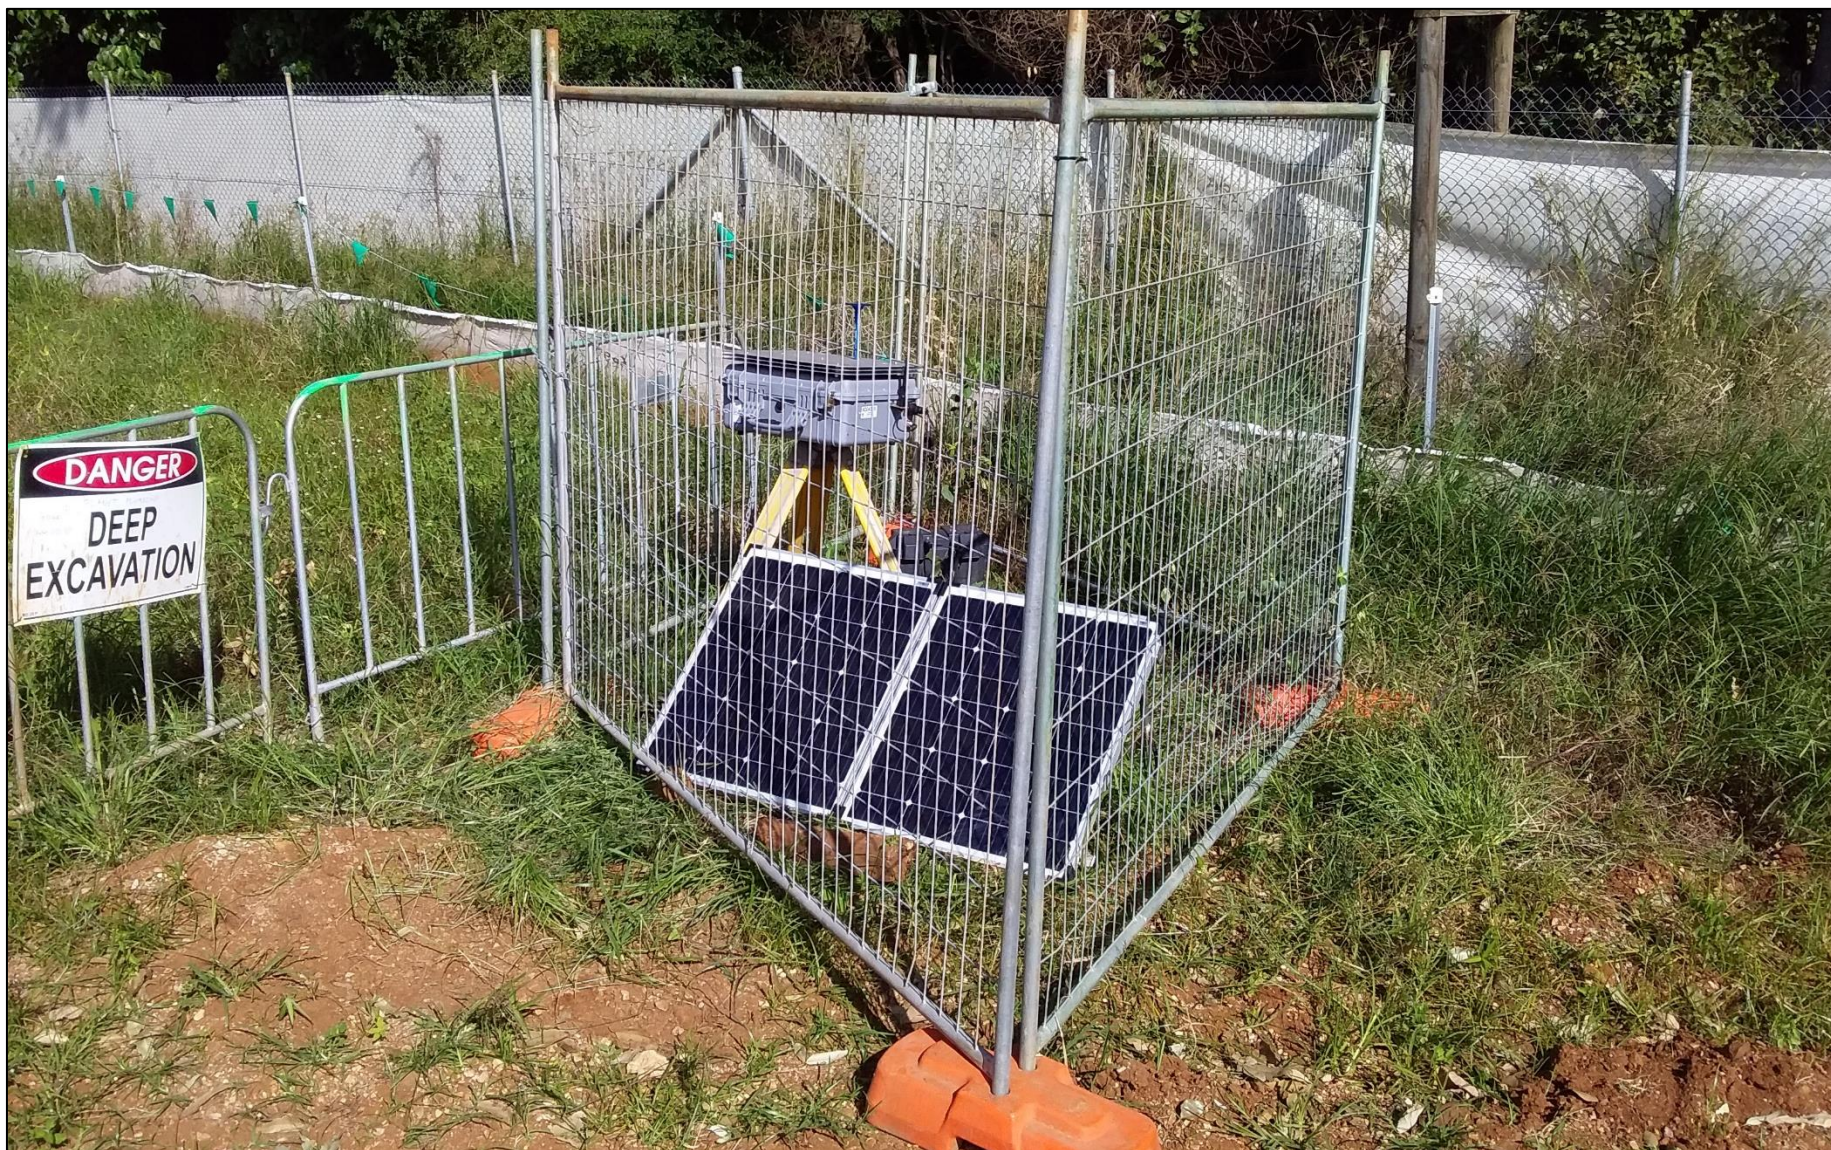
Photograph 6. Representative photo of the monitoring location 006 – South Western Section of Site, as observed on the 05.05.2020.

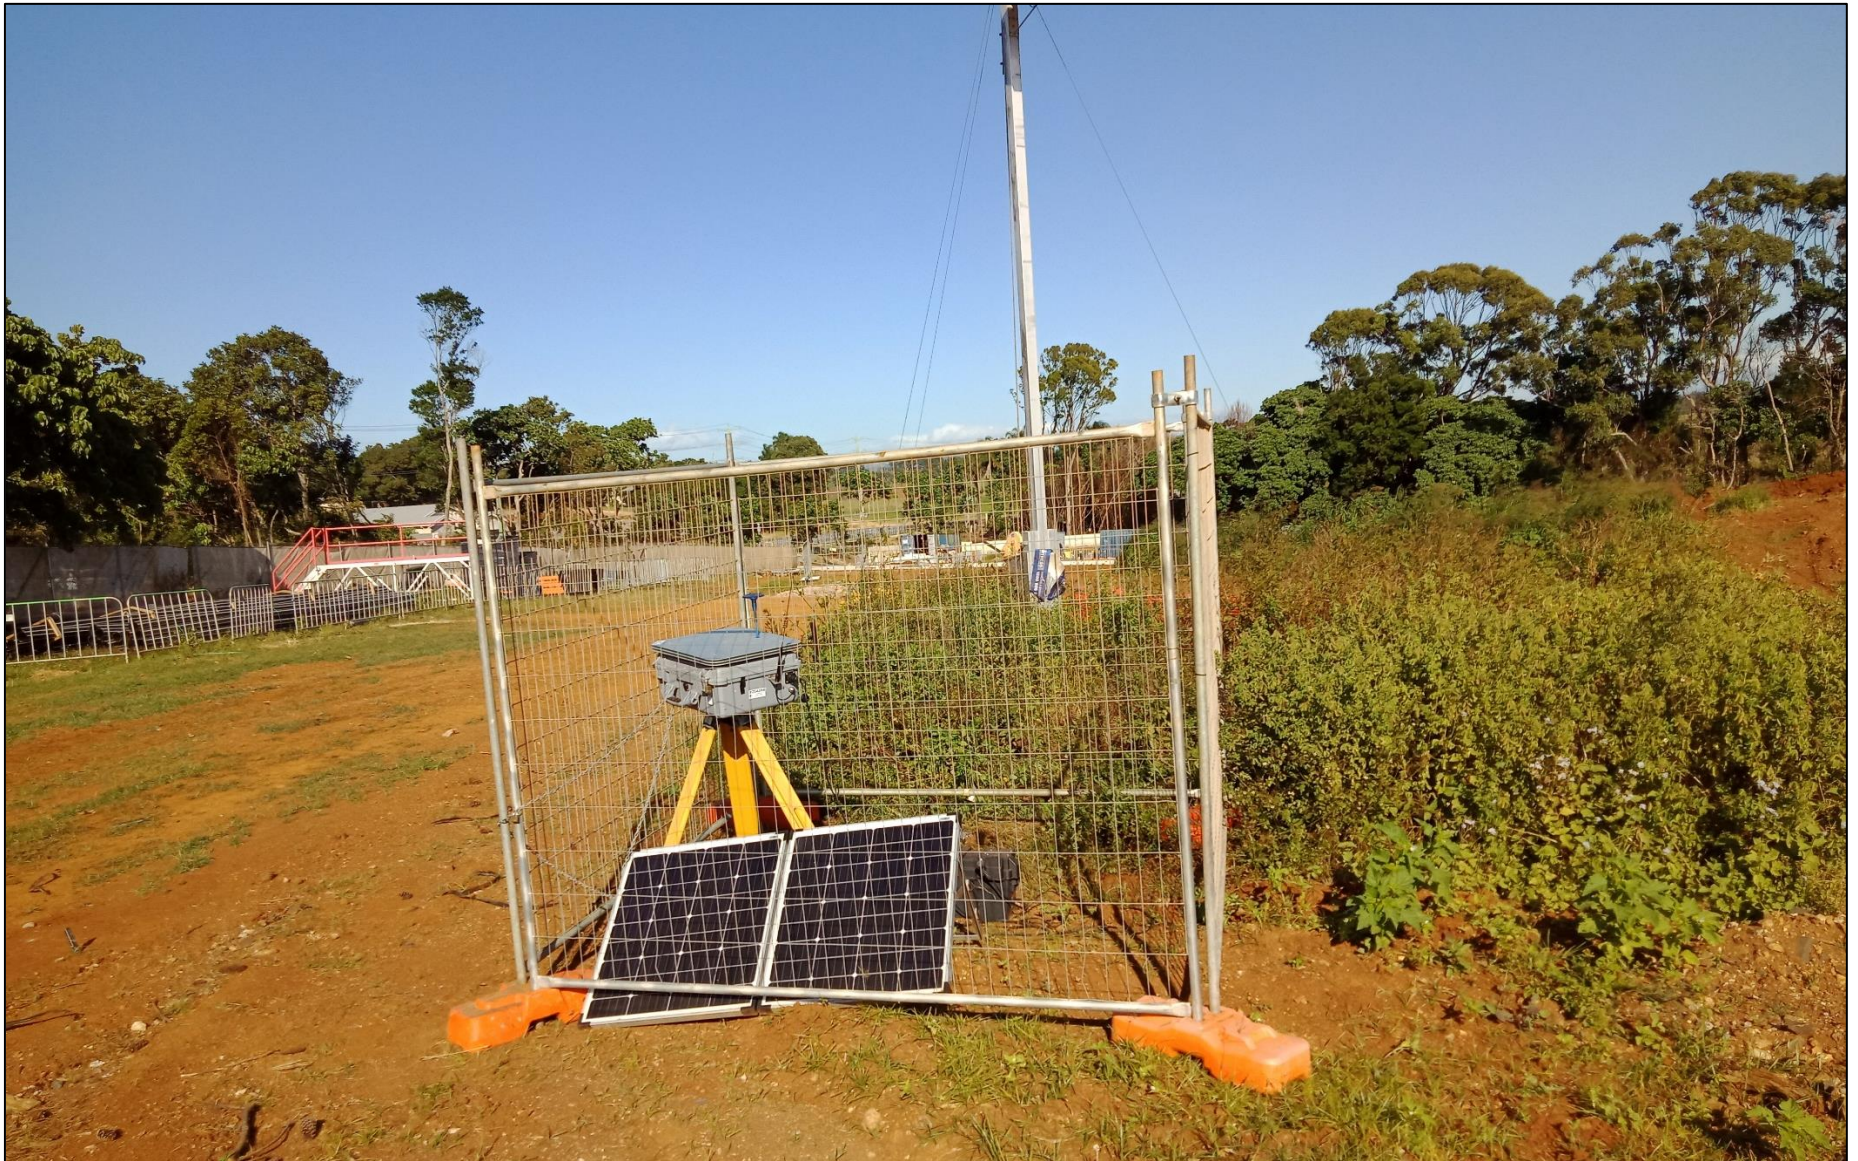
Photograph 7. Representative photo of the monitoring location 007 – Southern Section of Site, as observed on the 05.05.2020.
