Vibration Monitoring Assessment Report (February 2020)

771 Cudgen Road, Kingscliff NSW

Prepared for: Delta Group

DLT-01-Q1013 / VIB7 / v1.4f
23rd June 2020

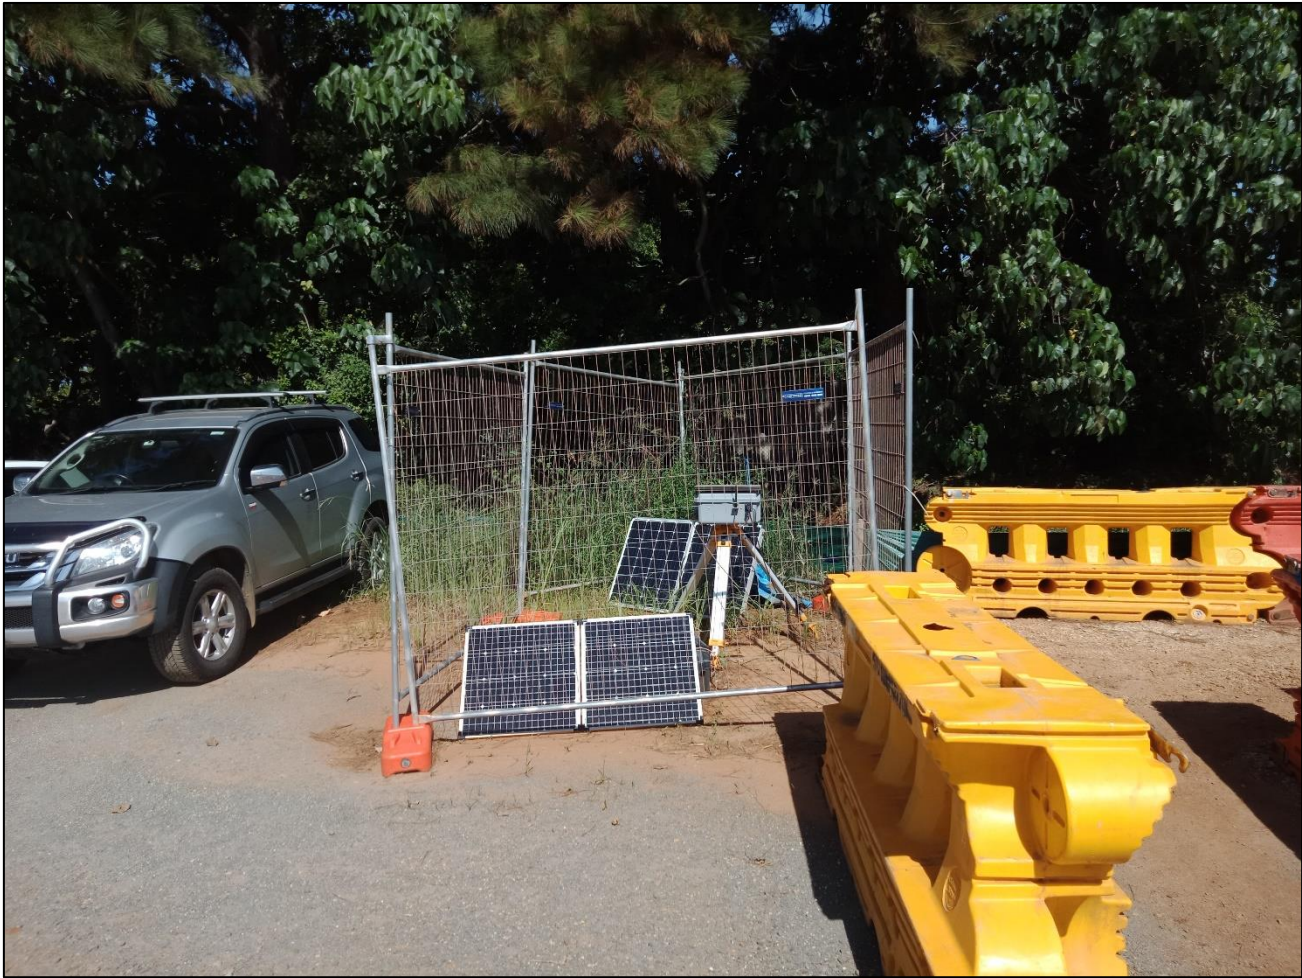
One (1) exceedance of Line 2 occurred on the 17th of February at monitoring location 001 due to the extension of the sub-contractor carpark. The cause of the exceedance was a vibratory roller operating within 10 metres of the monitor. As per Table 2 of the NSW Government *Construction Noise and Vibration Guideline (2016)*, a vibratory roller above 18 tonnes has a minimum working distance of 25m for cosmetic damage. The distance between the monitor and the sensitive receiver is 36m. Therefore, the vibration at the receiver would be below lines 1 & 2.

Photograph 1. Representative photo of the monitoring location 001 – Adjacent Carpark location, as observed on the 02.03.2020

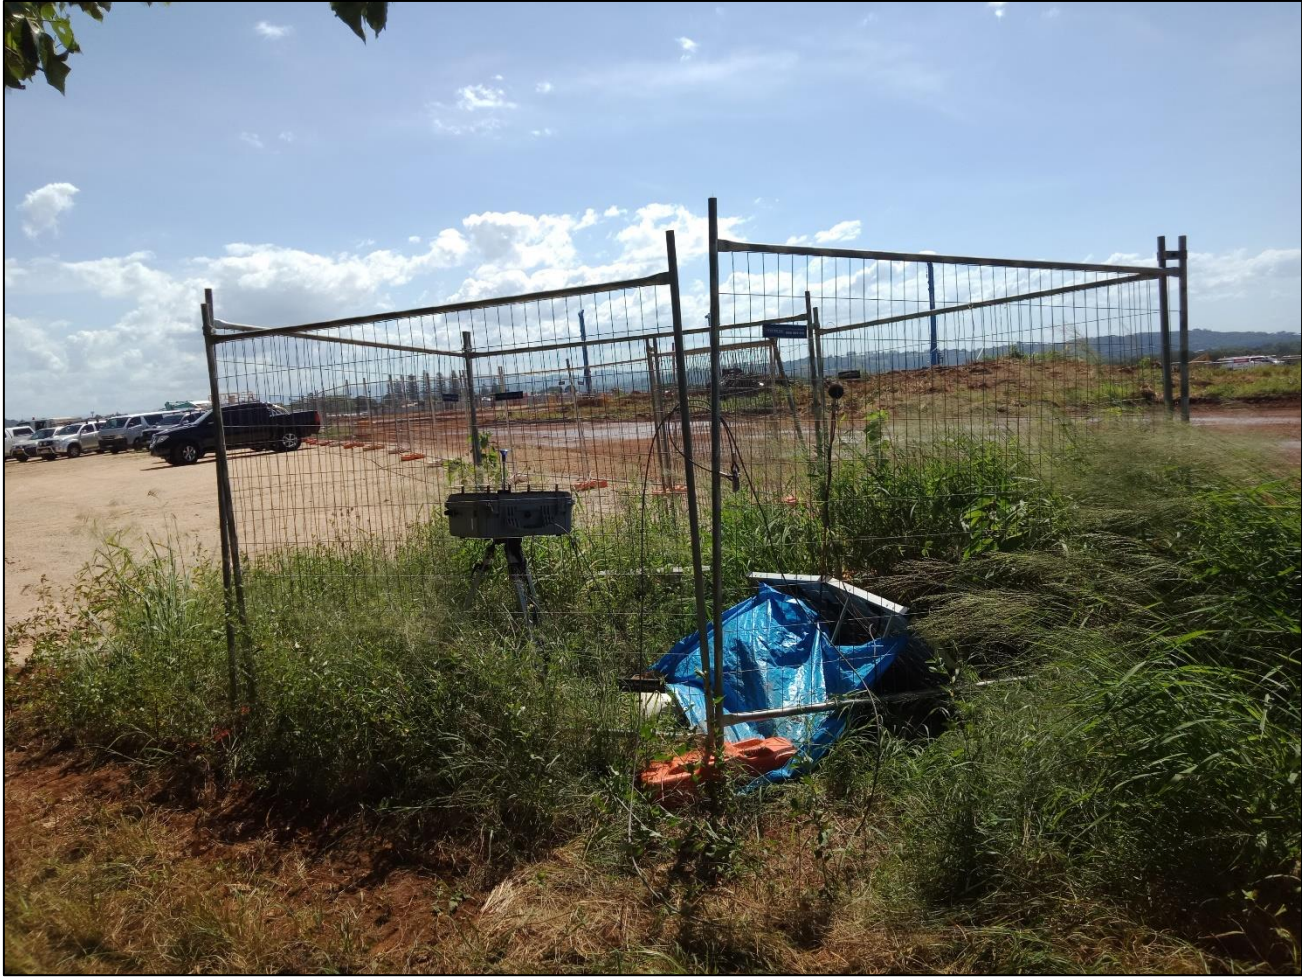
Photograph 2. Representative photo of the monitoring location 002 – Central location, as observed on the 02.03.2020

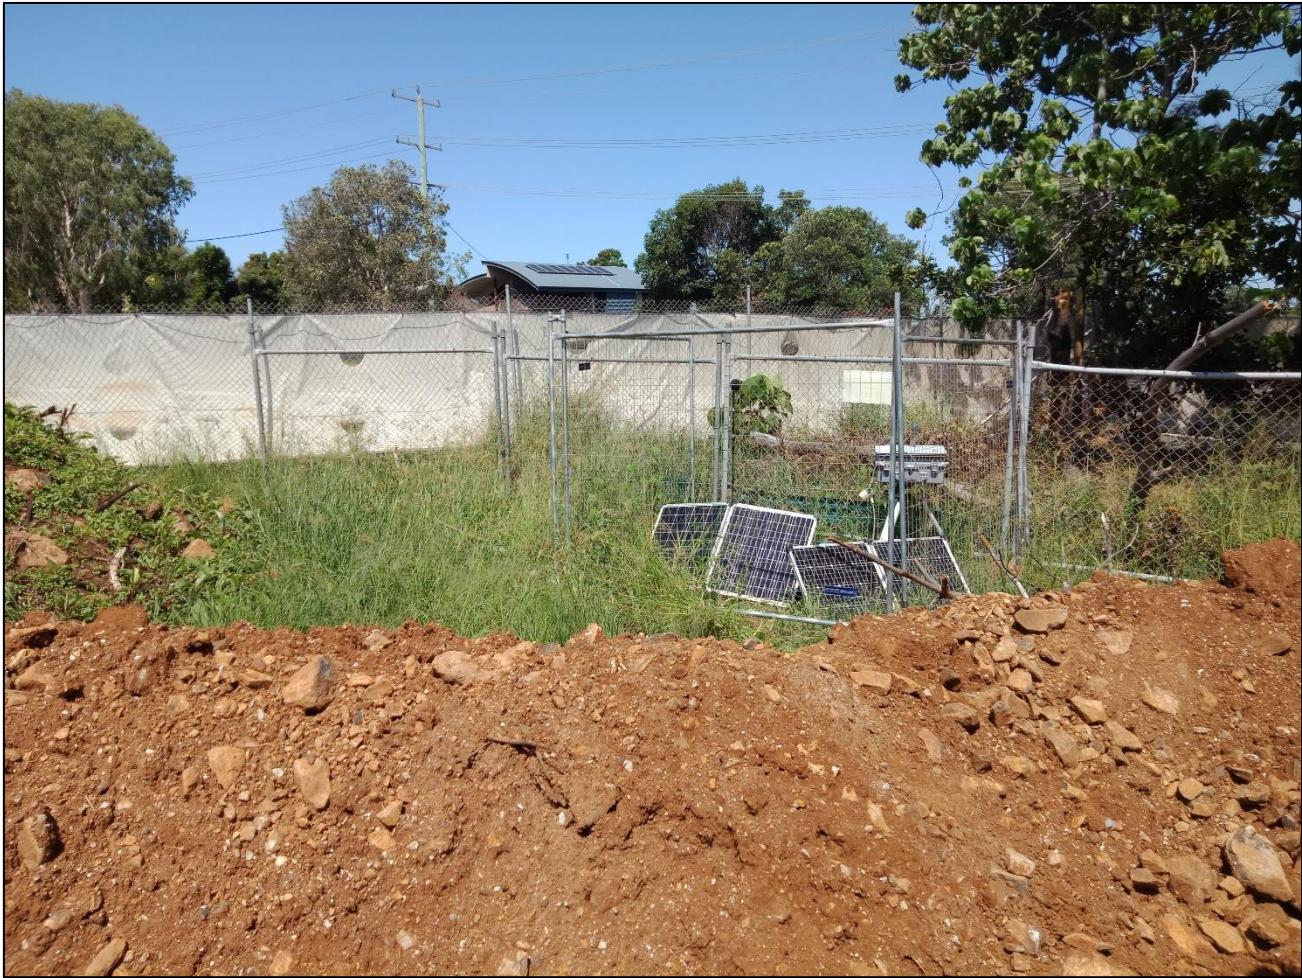
Photograph 3. Representative photo of the monitoring location 003 – Eastern Section of Site, as observed on the 02.03.2020
