## Tweed Valley Hospital Health Hub

### Construction Noise, Dust and Vibration Monitoring Monthly Report 3

03.10.2022 - 03.11.2022

| Document Title | Construction Noise, Dust and Vibration Monitoring |

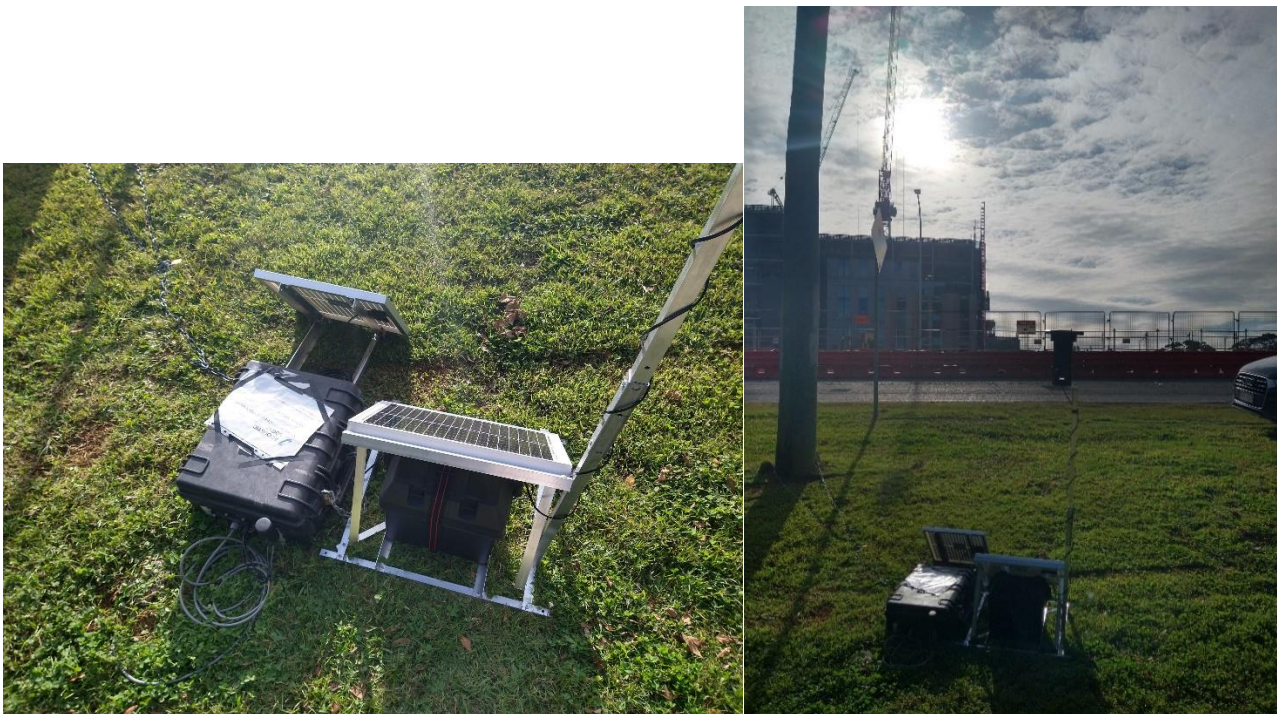
**Figure 3-1 Noise, dust and vibration monitor installation locations**

A vibration monitor (M7426) has been installed, representative of the potential impact for vibration transmission to the closest residential receiver **R2**, to the south of the construction site across Cudgen Road (at the ground level, also see Figure 3-1). The monitor was installed on Wednesday 3<sup>rd</sup> August 2022. If vibration levels at the measured location comply with the proposed criteria, all other receivers will comply.

A noise monitor has been installed, representative of the potential impact for noise transmission to surrounding residential houses, at the northern boundary of the construction site (at the ground level, also see Figure below). The monitor was installed on Wednesday 3<sup>rd</sup> August 2022.
